# Technical Service Information

## GM 6T70/75

### I/O SPEED SENSOR ISSUES

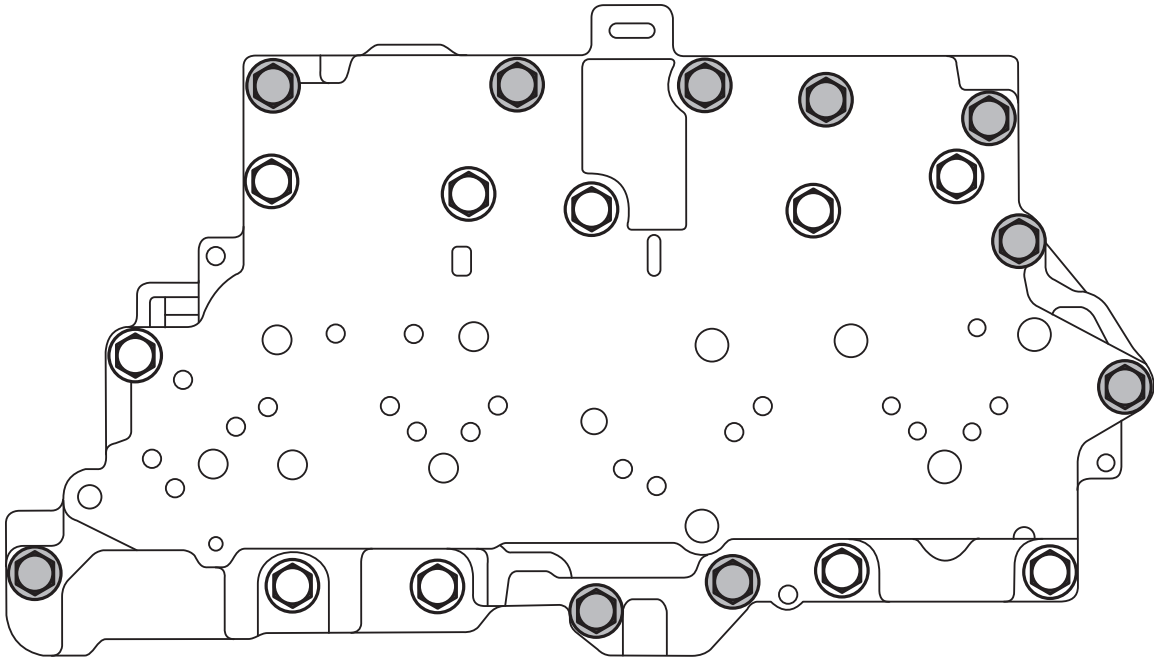
**REMOVE ONLY THE SHADED BOLTS TO REMOVE THE VALVE BODY ASSEMBLY**

To replace the ISS or OSS speed sensor, the valve body will have to be removed. Remove only the shaded bolts shown in Figure 1 to remove the valve body assembly.  
The location of the speed sensors is explained in Figure 2.

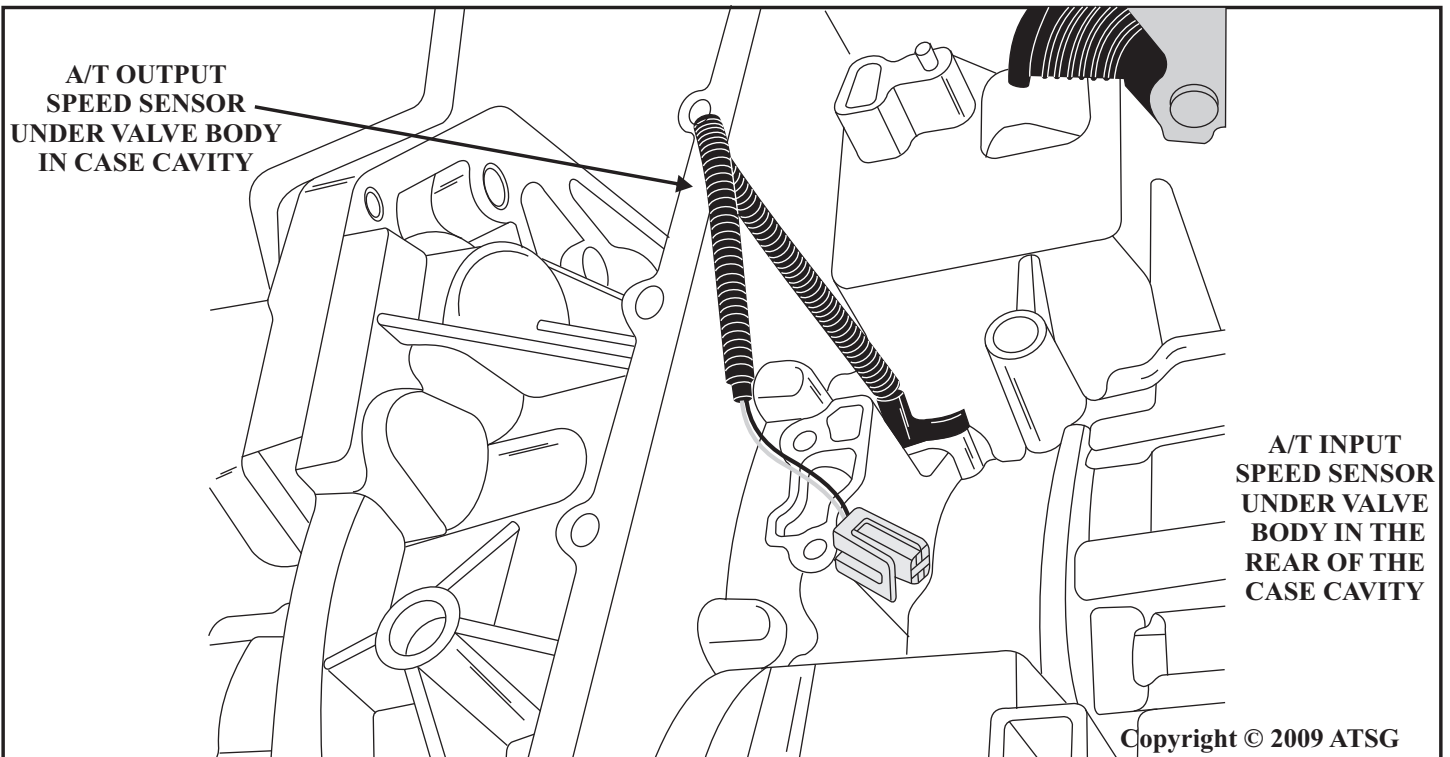
Figure 2

**CAUSE:** The Input and/or Output Speed Sensors are faulty.

**CORRECTION:** Use a scan tool to check input and output rpm and replace the defective speed sensor(s).
