4T65-E

P0742 TCC SYSTEM STUCK ON (*In depth Diagnosis*)

Technical Service Information

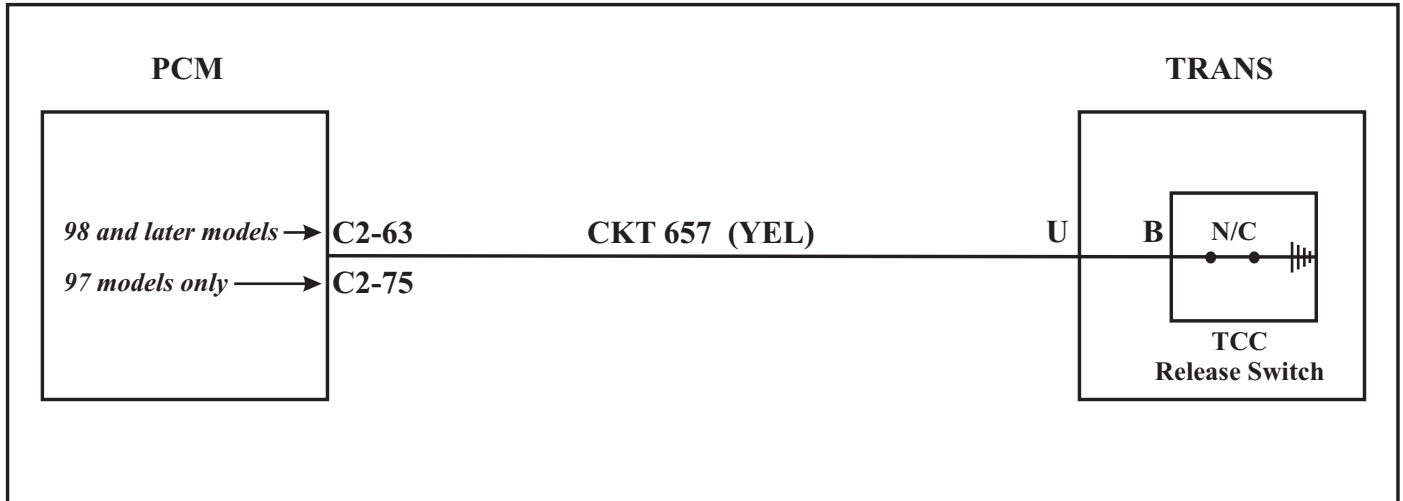
Figure 1

CAUSE: The PCM supplies 12 volts on CKT 657 to the TCC release switch with the ignition switch on or in the run position. (See figure 1) The TCC release switch is located inside the transaxle as part of the fluid pressure switch assembly. (See figure 2) This code is typically set when voltage on CKT 657 remains low, 6 times for 4 seconds, when TCC is commanded off during the current ignition cycle.

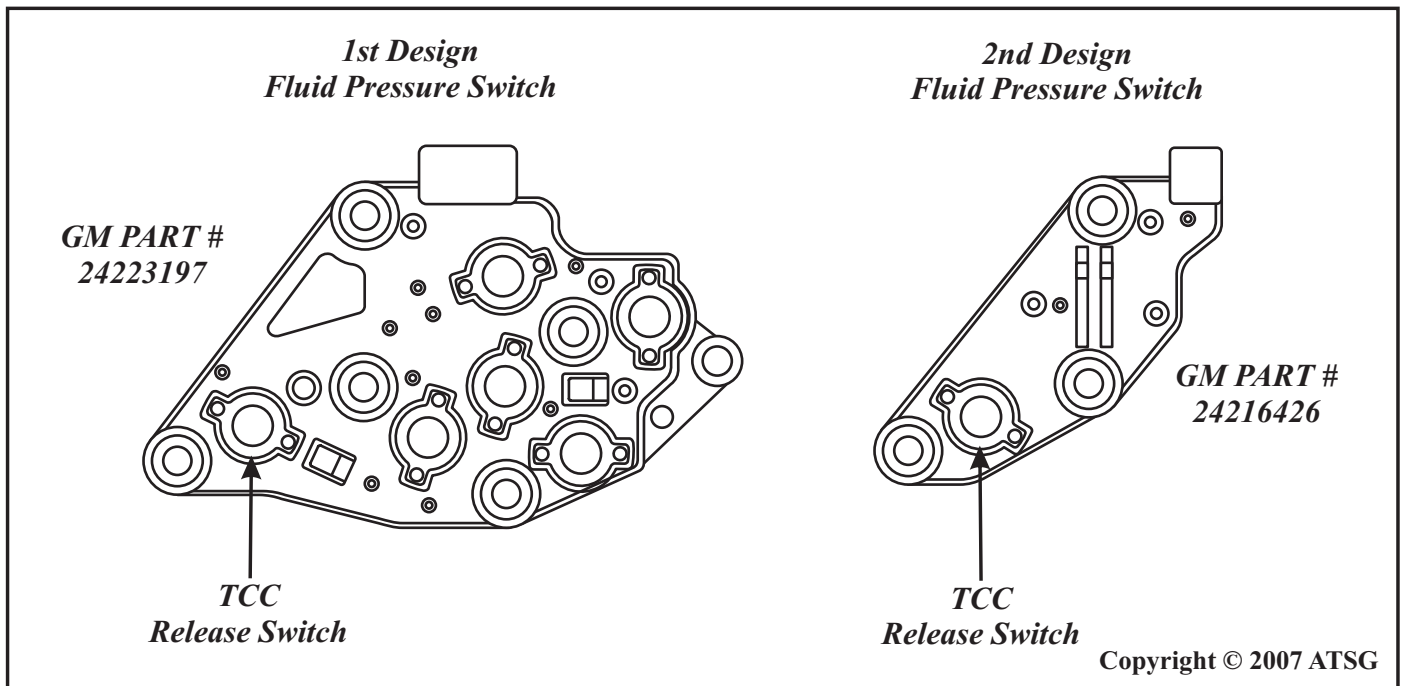
Figure 2

This switch is normally closed to ground without oil pressure present. With the engine running in Park or Neutral, TCC release oil acting on the switch should open the contact.

Repair internal harness or replace fluid pressure switch assembly as necessary.

SERVICE INFORMATION: (See Figure 2)

At the time of this printing, the current OEM part numbers are as follows:

24223197 = 1st Design Fluid Pressure Switch Assembly

24216426 = 2nd Design Fluid Pressure Switch Assembly

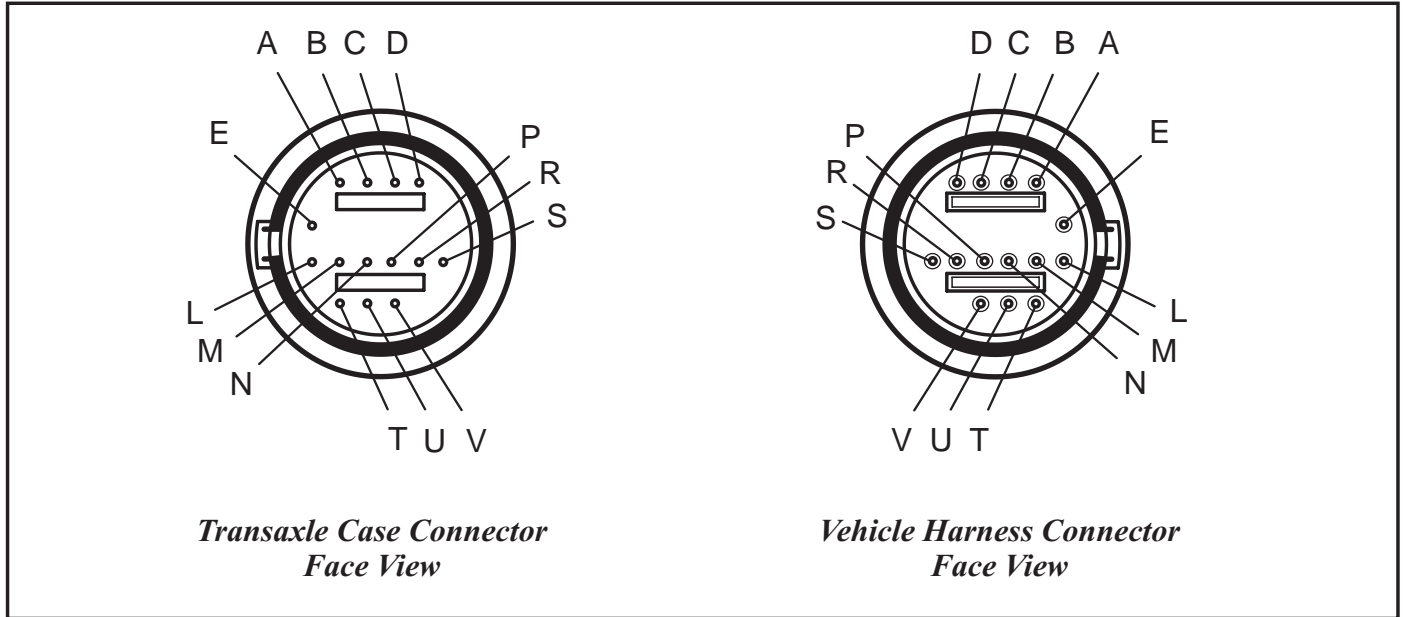
Figure 3

To test CKT 657, unplug the harness connector at the transmission and identify terminal U. (See figure 3) With a DVOM set to DC volts, place the negative lead to a known good ground and the positive meter lead to terminal U in the harness connector. Turn the **key on** with the **engine off**. Battery voltage should be seen.

Start the engine and recheck voltage while the engine is running. Battery voltage should be seen. If battery voltage is not seen at this time then either the internal harness is shorted to ground or the TCC release switch is defective.

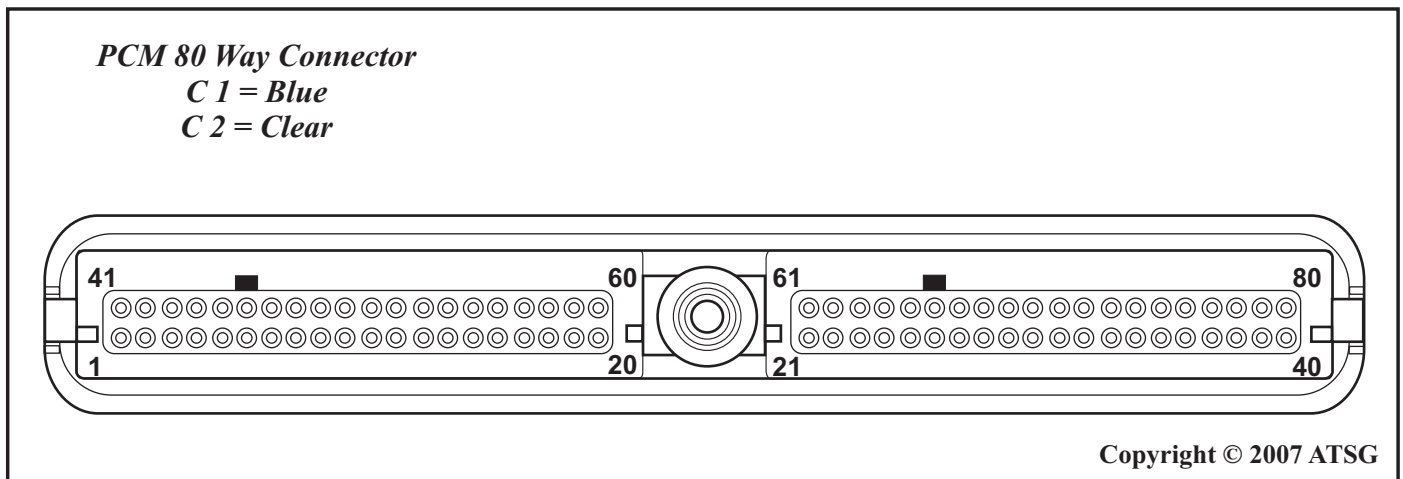
Figure 4

For 98 and newer models, cut the wire at terminal 63 in the PCM C2 connector, approximately 2 inches from the connector. For 97 vehicles use terminal 75. (See figure 4) Recheck voltage on the piece of cut wire that is protruding from the PCM connector. If battery voltage is now present, then trace and repair short to ground in wire between PCM connector and trans connector terminal U. Or, run a new wire to the trans harness connector in place of the existing wire. Cut the old wire out of the harness at both ends and tape it back. Be sure to solder and shrink wrap the new wire and tape it into the existing harness for neatness. This is usually a yellow wire from the PCM to the trans harness connector.

If no voltage is present on the cut wire at PCM connector, then the PCM will require replacement as the circuit would be shorted to ground inside the PCM.

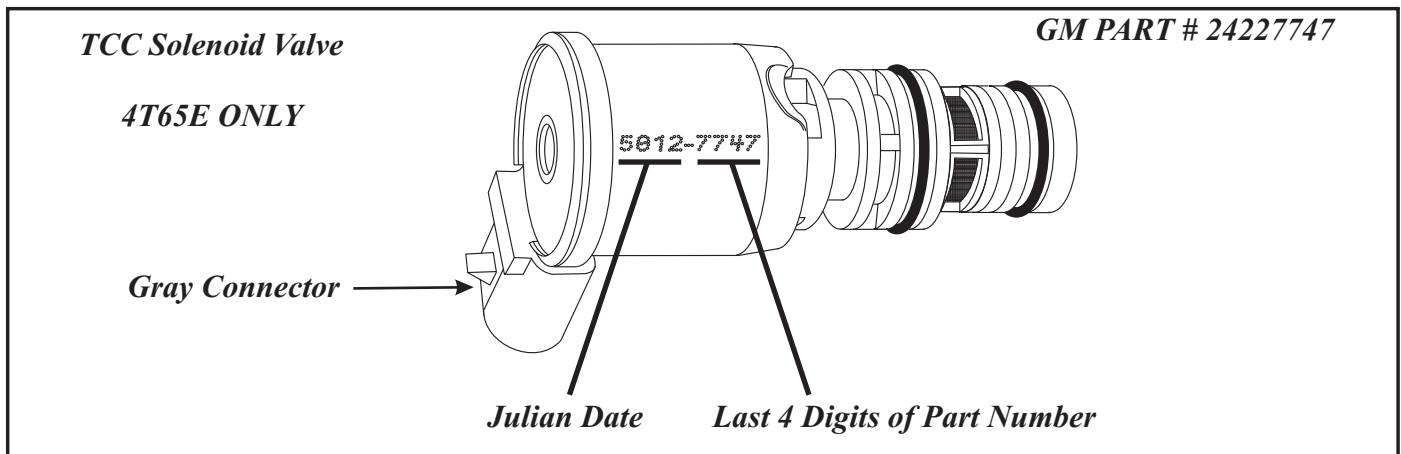
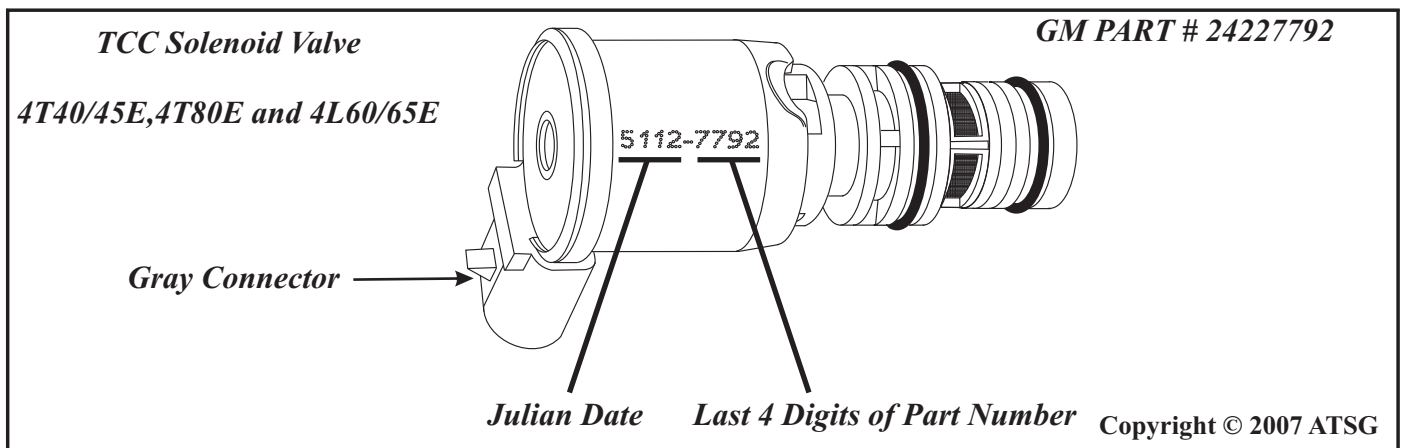
If all external electrical checks test good at this time, then unplug the harness connector at the transmission. Start the engine, step firmly on the brake pedal and place the shift lever in Overdrive. If the engine stalls out or if it feels like the converter clutch is dragging, then replace the TCC/PWM solenoid. It is stuck right now.

SERVICE INFORMATION: (See Figures 5 and 6) Identify the correct TCC/PWM solenoid for your application. It is very easy to use the wrong solenoid as both solenoids have a gray plastic connector with the same configuration and appear to be identical. They are not. Both solenoids will have 2 groups of 4 numbers etched on the can surrounding the solenoid winding. The first group indicates the Julian Build Date and the second group are the last 4 digits of the part number. Refer to GM TSB 02-07-30-039A dated Dec/2002. At the time of this printing, the correct OEM part numbers are as follows:
 24227747 = TCC Solenoid Valve for 4T65-E ONLY. This number supercedes previous part number 24214974.
 24227792 = TCC Solenoid Valve for 4T40/45-E and 4T80-E. This number supercedes previous part number 24212690. Refer to GM TSB 02-07-30-039F dated Aug/2005.
 Part number 24227792 is currently listed for use in 4L60/65-E units as well.

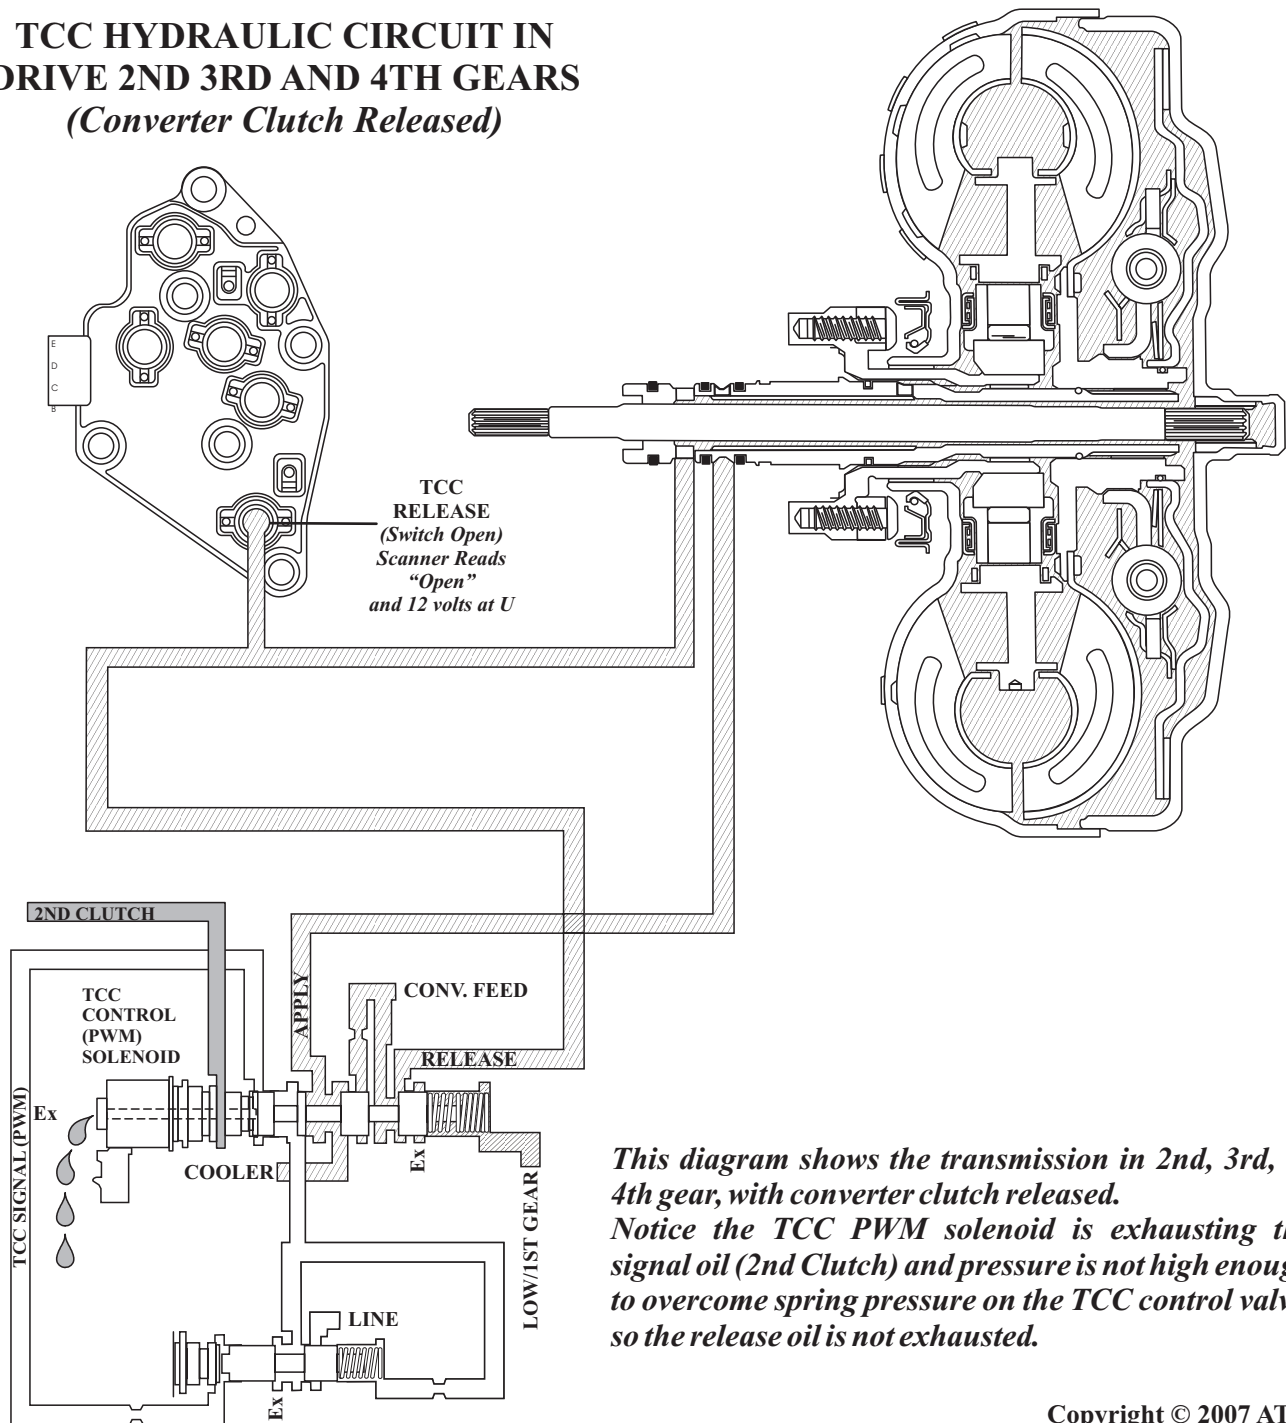
Figure 7

With the trans connector unplugged and both shift solenoids off, the transmission will be forced to 3rd gear allowing 2nd clutch oil to feed the TCC/PWM solenoid. (See figure 7)

This does not necessarily mean that the solenoid is good if the engine does not stall out or drag at this time.

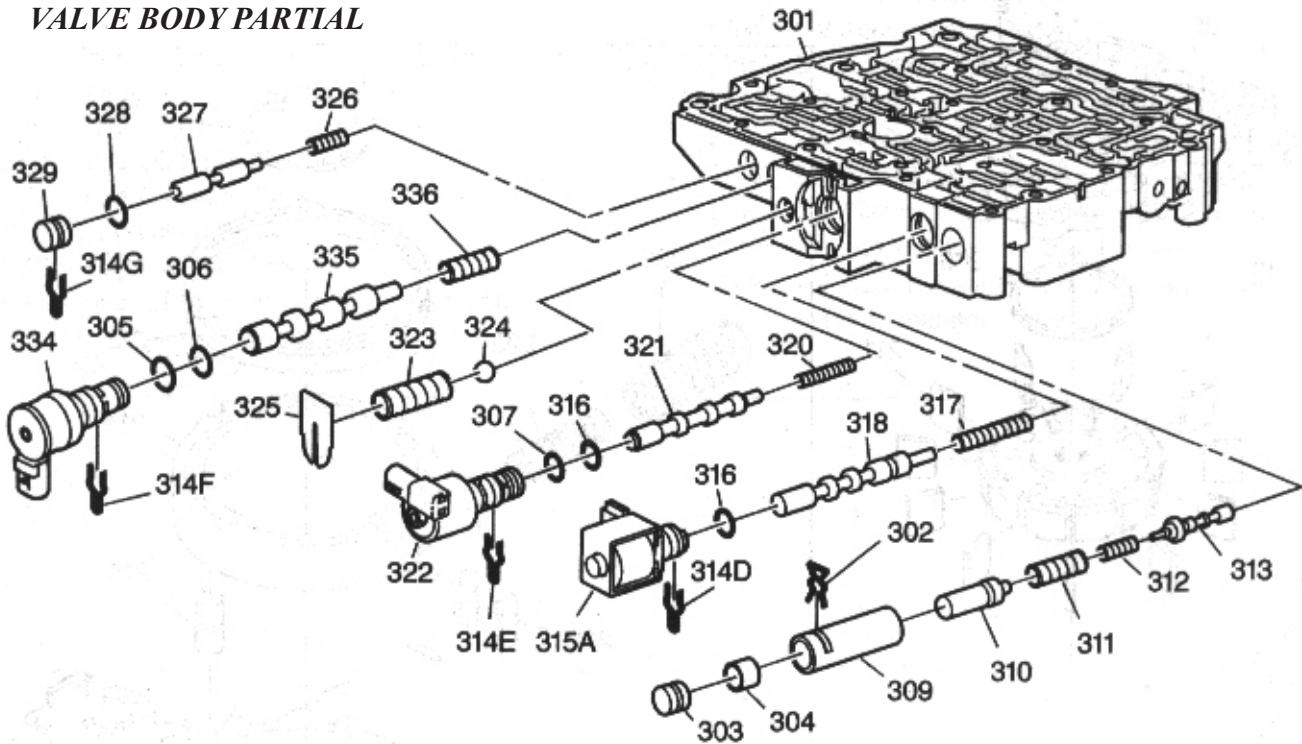
Figure 8

Valve body concerns such as a sticking TCC control valve may cause the vehicle to stall in a Drive range 1st gear or Reverse. The TCC regulator apply valve can cause a surge or harsh TCC engagement. Problems with the torque signal regulator or pressure regulator valve can result in harsh engagements and shifting. (See figure 8)

Disassemble and clean valve body. Free up sticking valves or replace control valve assembly as necessary if valves or bores are badly scored or damaged beyond repair.

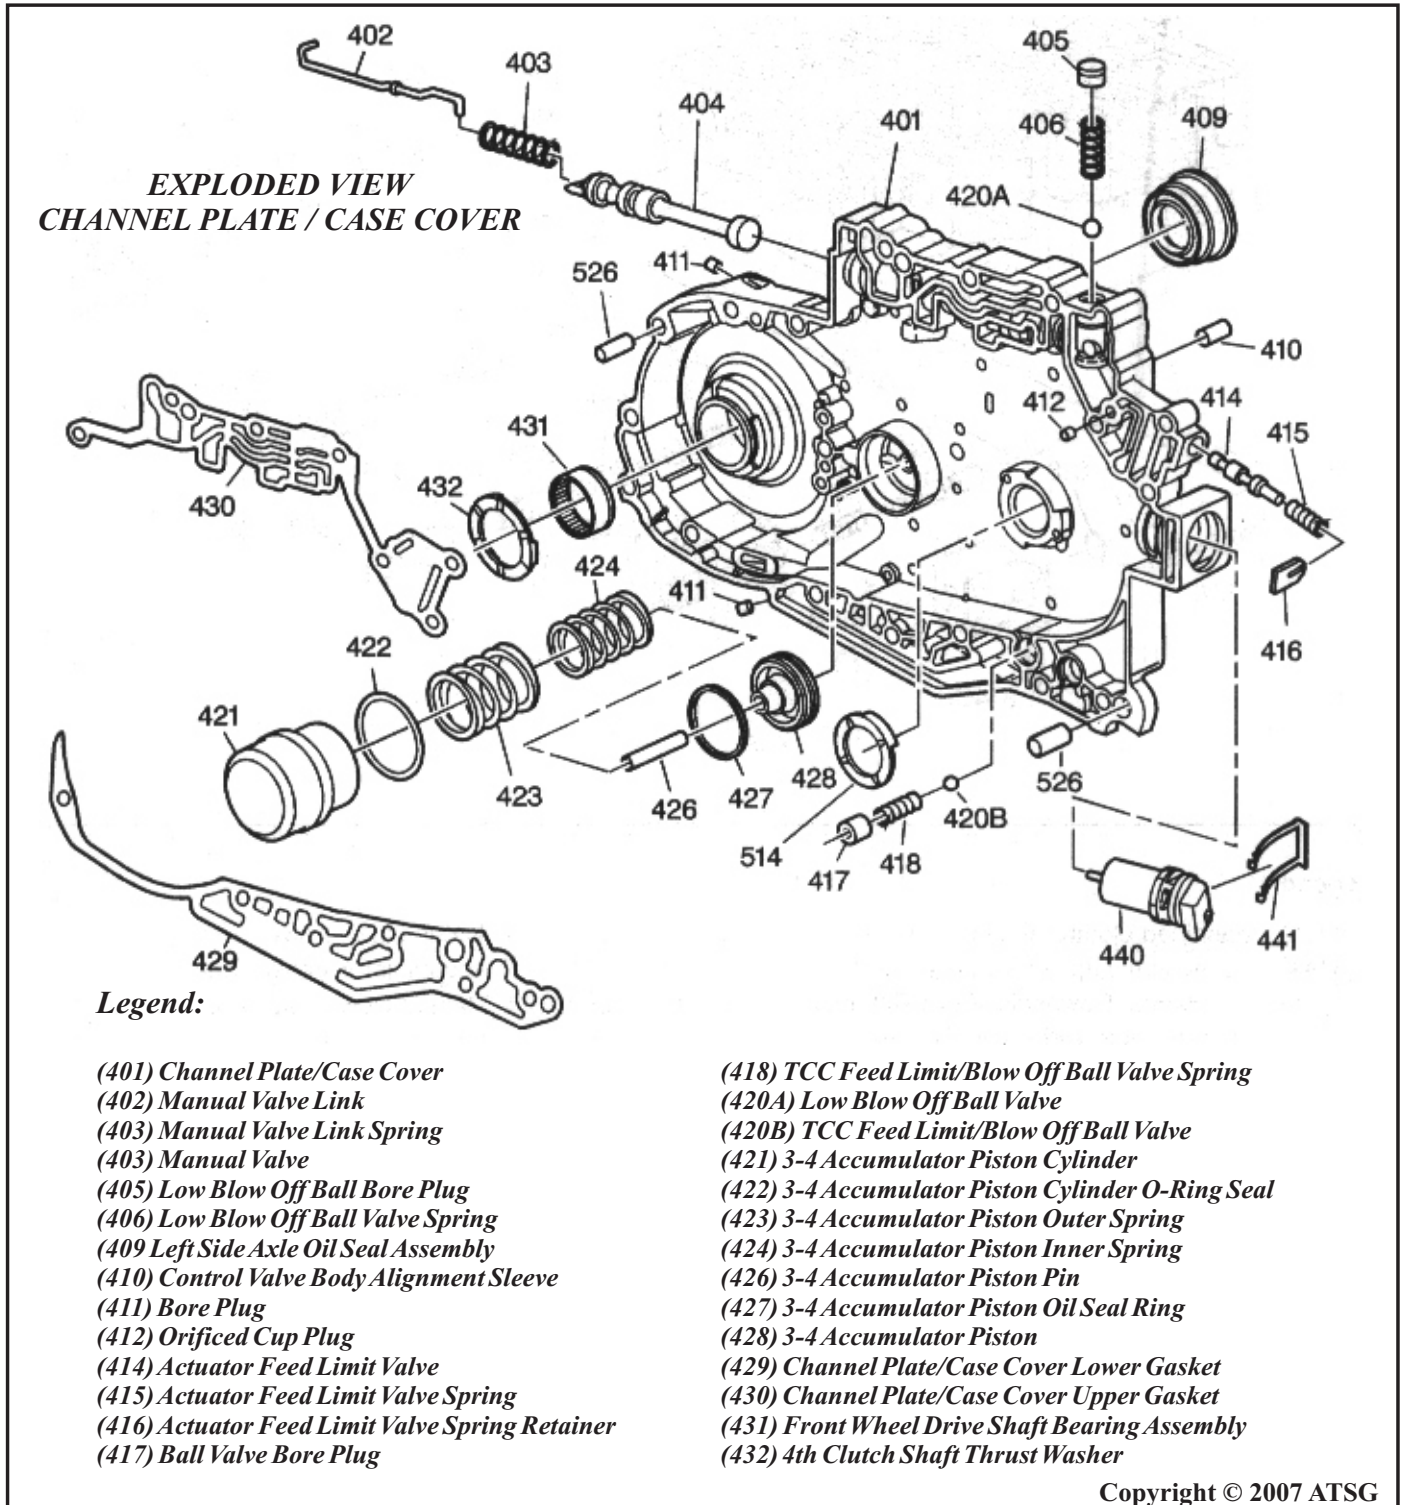
Figure 9

The TCC feed limit/blow off ball valve in the case cover/channel plate is stuck closed.

Check to see if the TCC feed limit/blow off ball valve in the case cover/channel plate is stuck and repair as necessary. (See figure 9)
