# Technical Service Information

## CHRYSLER 46RE

### REOCCURRING P1740 OR P0740 WHEN HOT

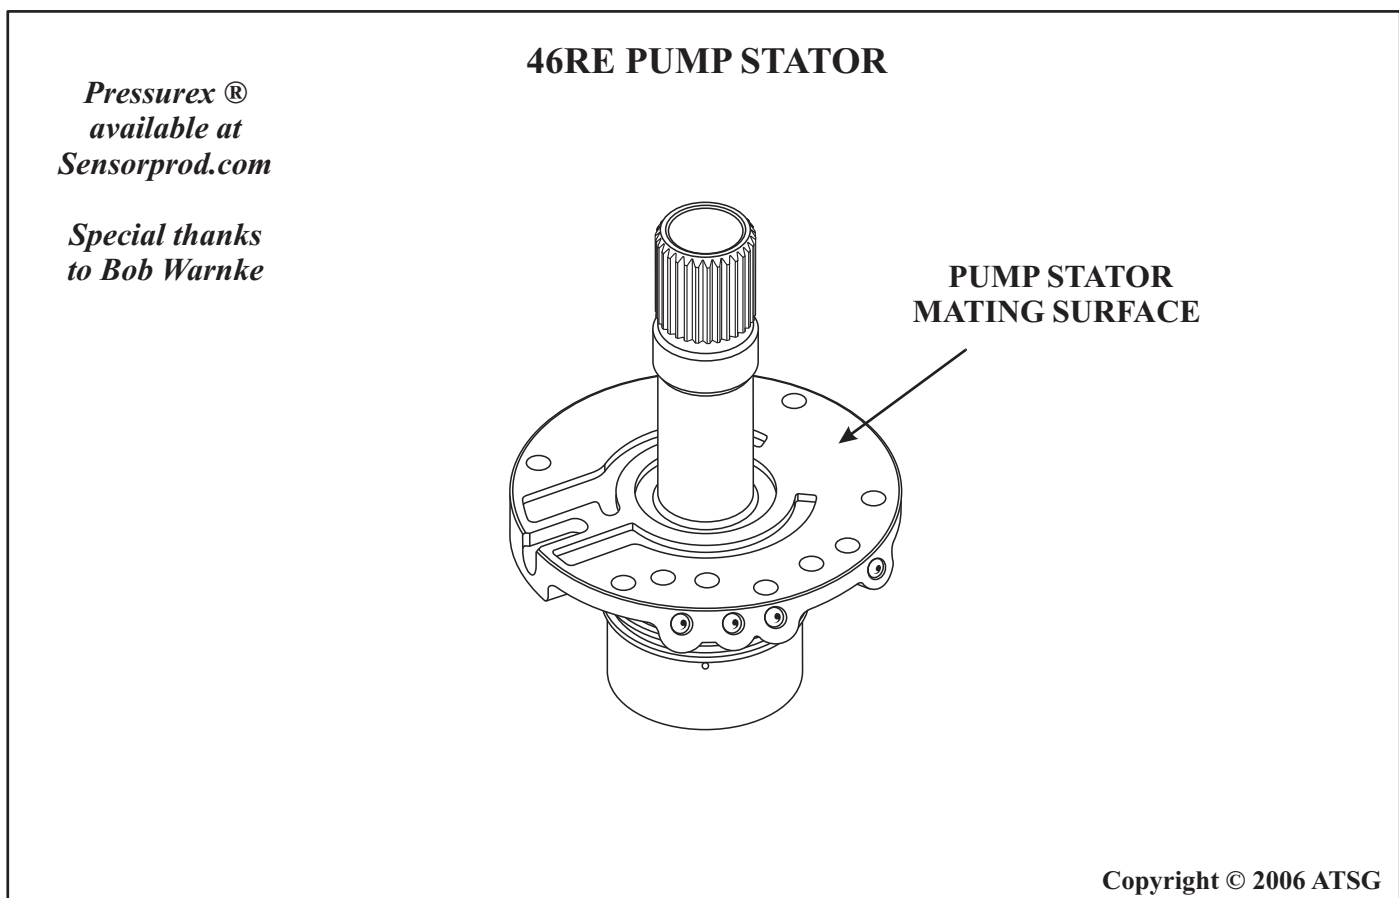
Figure 1

**COMPLAINT:** Vehicles equipped with the 46RE may exhibit a reoccurring Diagnostic Trouble Code P1740 or p0740, Torque converter clutch or Overdrive solenoid performance, or Torque Converter slip, before or after overhaul.

**CAUSE :** The cause may be, that the mating surface, as shown in Figure 1, between the Pump Body and the Pump Stator is not flat, causing a loss of line pressure and Torque Converter apply pressure. Refer to Figure 2 for port identification of the Pump Body and Pump Stator.

**CORRECTION:** To verify that the stator surface is flat, Pressurex<sup>®</sup> Film may be used. This is a product from Sensor Products Inc., which uses microcapsules of a paint like substance that changes color intensity depending on pounds per square inch. The higher the psi., the brighter the color. To repair this condition, have the face of the stator machined so that it is flat.

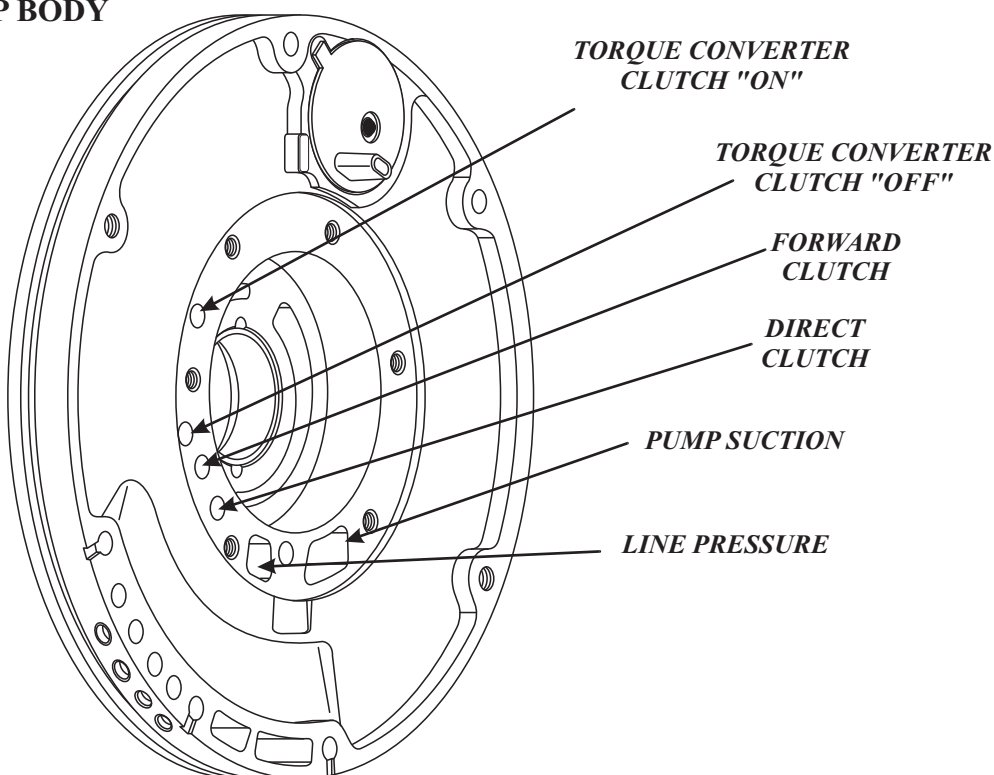
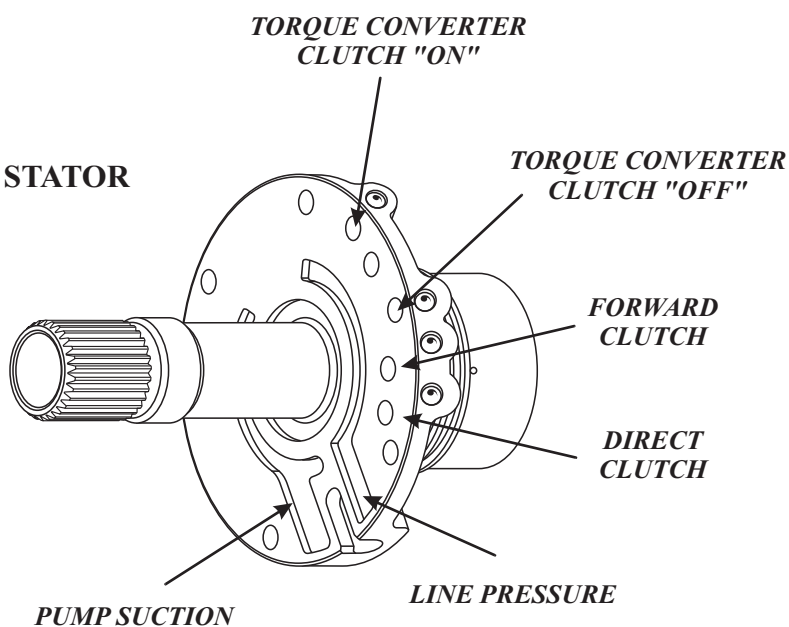
Figure 2

## 46RE PUMP BODY AND STATOR PASSAGE IDENTIFICATION
