TOYOTA A140 NO REVERSE AFTER OVERHAUL

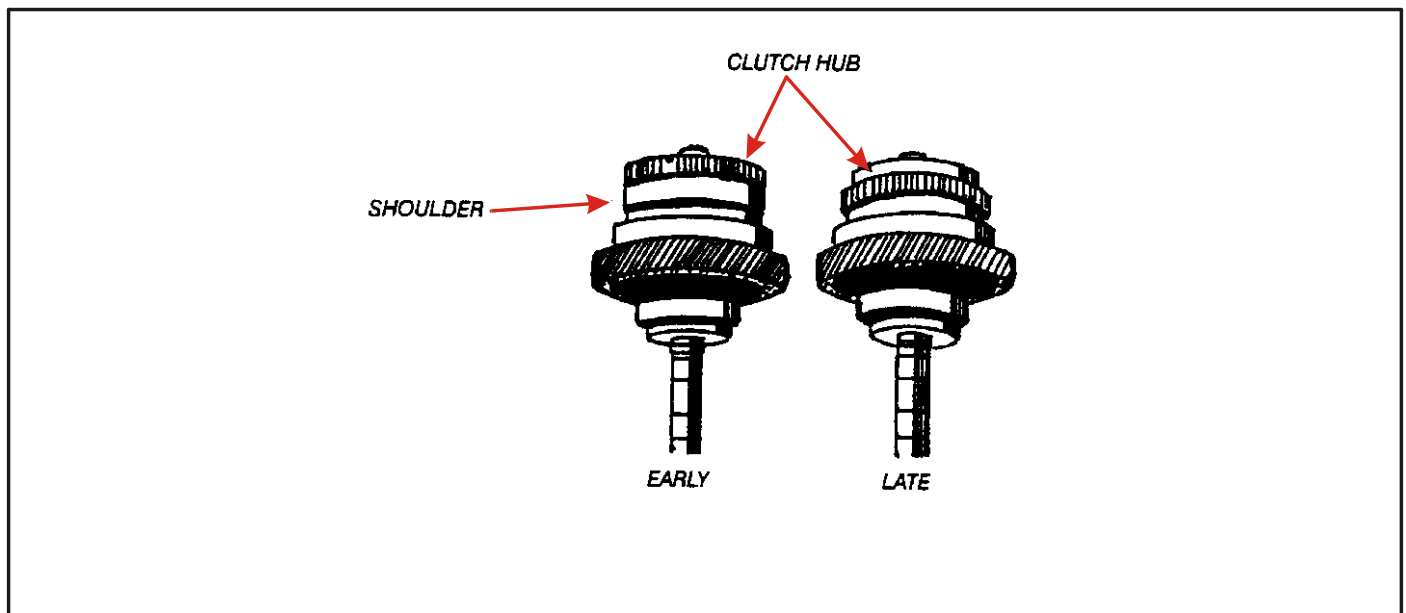
Figure 1

COMPLAINT: No reverse all forward ranges good. (Overdrive planetary assembly changed during rebuild).

CAUSE: One cause may be a late planetary assembly installed in an early transaxle. The over-run clutches can no longer hold the planetary assembly as the hub for the clutches are in different location.

CORRECTION: Install the correct planetary assembly.
