5R110W

DELAYED FORWARD ENGAGEMENT/SHUDDER ON TAKE OFF

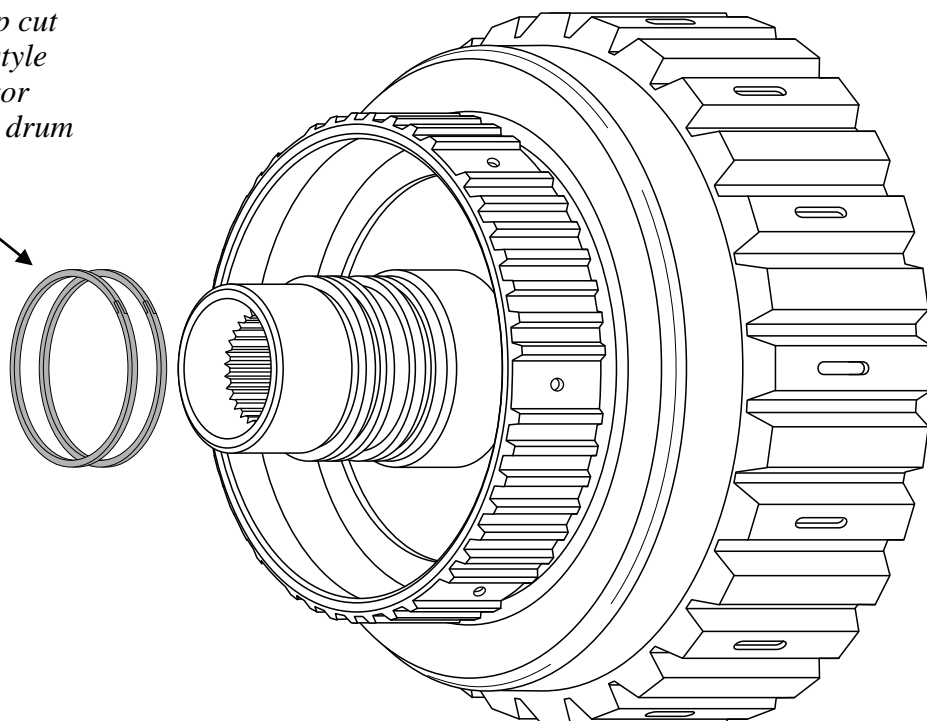
Figure 1

CAUSE: The cause may be a poor seal at the forward clutch sealing rings. (See figure 1)

CORRECTION: Check and verify that there are no line pressure and rise problems that may indicate a faulty pressure control solenoid, sticking PR valve, boost valve or faulty oil pump. Carefully inspect the forward clutch housing, piston and the seal ring area in the center support for any wear or damage and repair or replace as necessary. Place the completely assembled forward clutch housing into the center support and air check the forward clutch through the support to see if excessive leakage is revealed with the air check. If excessive leakage is detected, then the problem may be resolved by replacing the original step cut style sealing rings with a pair of solid endless style rings used for the stator support to reverse input clutch drum in a 4L60E transmission. The sizing tool for the 4L60E rings can also be used to ensure proper fit. After installing and sizing the new rings, check for a slight drag when installing the forward clutch housing into the center support and perform the air check again to see a noticeable difference.

Replace the original style step cut rings with the solid endless style rings used for a 4L60E stator support to reverse input clutch drum
