Technical Service Information

ZF 4HP-18 FLE/FLA NEUTRAL AFTER A3-4 UPSHIFT

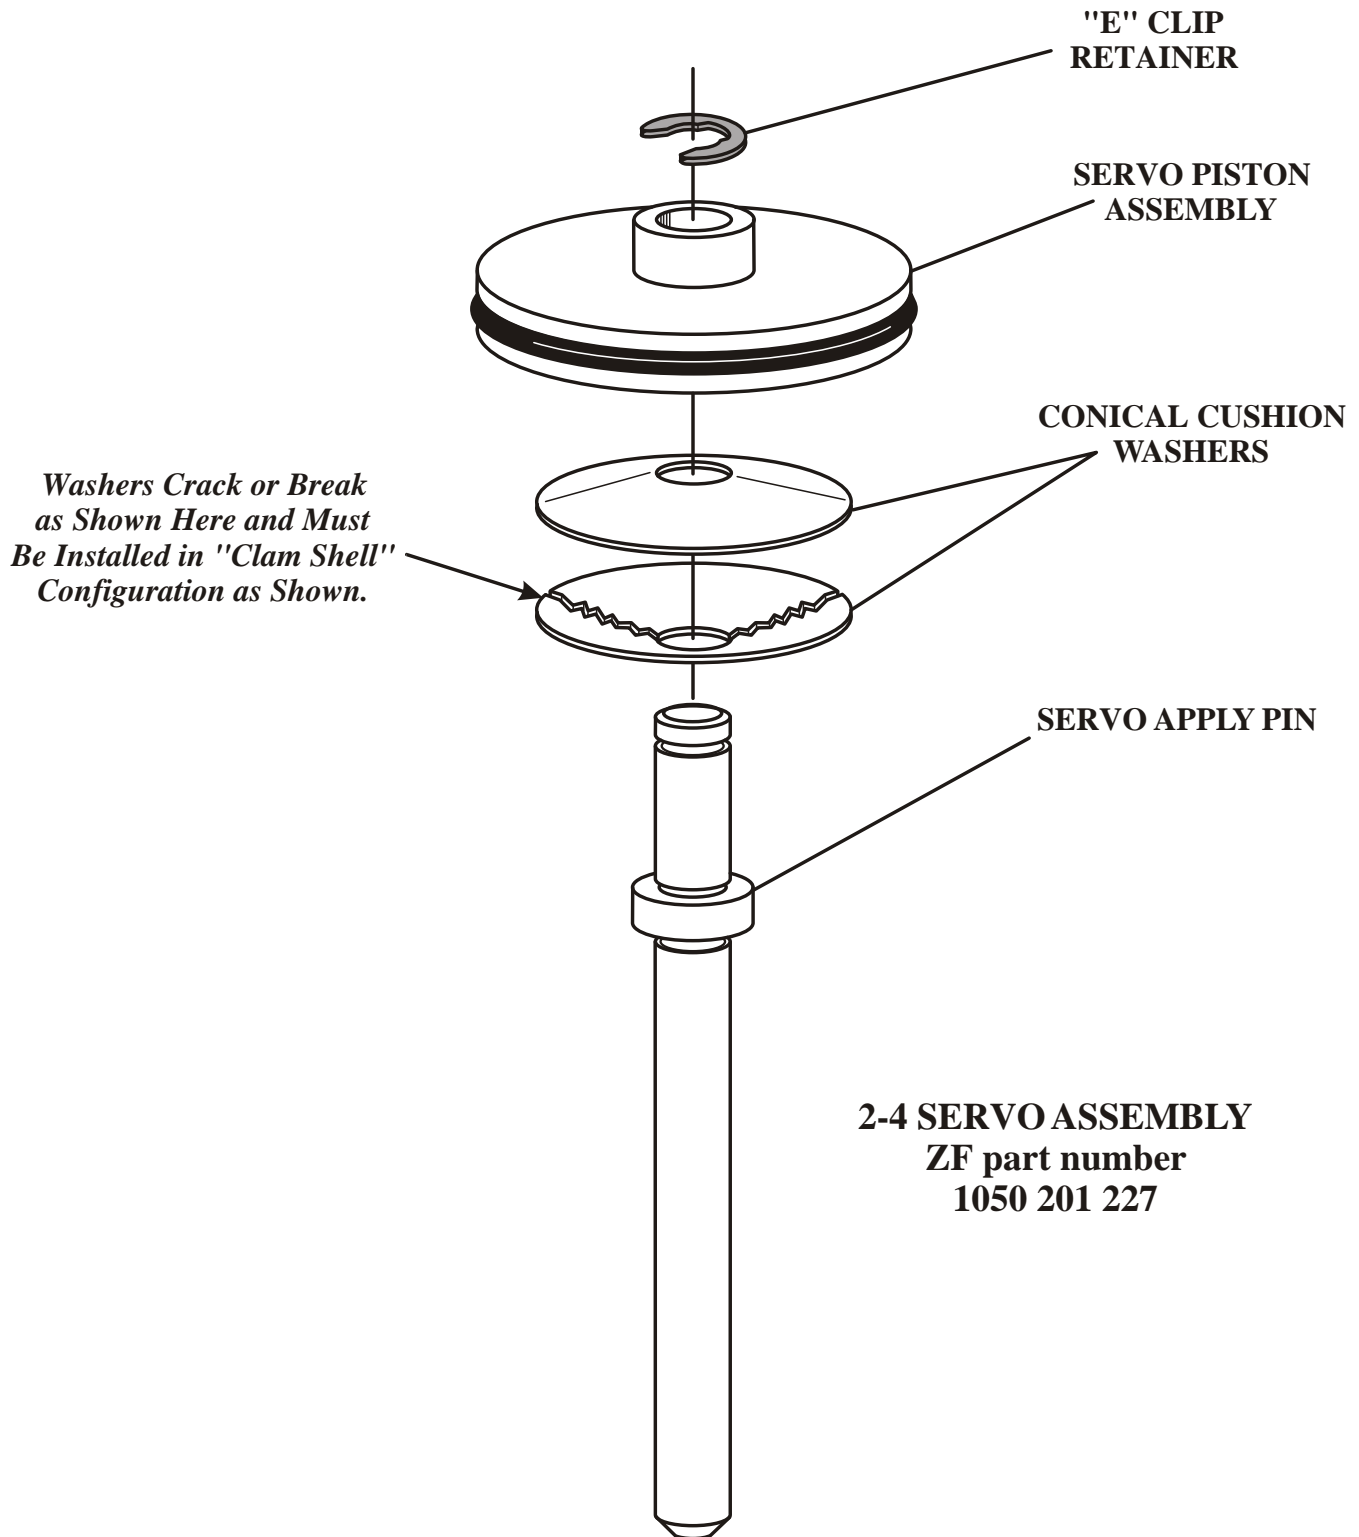
Figure 1

CAUSE: The cause may be split conical cushion washers in the 2-4 servo assembly as shown in Figure 1. This will create a neutral condition when the band is re-applied in 4th gear, because of the broken cushion washers limiting the travel of the servo. **NOTE: The 2-4 servo is also applied in 2nd gear but only provides engine braking because of the application of the "C" clutch in 2nd gear. See Figure 2 for the Clutch and Band application chart.** The Transmission Control Module will put the transmission in a "Fail Safe Mode" when it neutrals out in 4th. In this situation, this is a 4th gear command (all solenoids OFF), which is now Neutral. The driver of the vehicle will have to cycle the ignition switch to regain forward application.

2-4 SERVO ASSEMBLY

CORRECTION: Replace the conical washers, as shown in Figure 1. The entire 2-4 servo assembly can be purchased through an authorized ZF parts distributor, as the conical washers are not sold separately. If good used conical washers are found, ensure that the washers are assembled in a "clam shell" configuration, as shown in Figure 1.

2-4 SERVOASSEMBLY1050 201 227

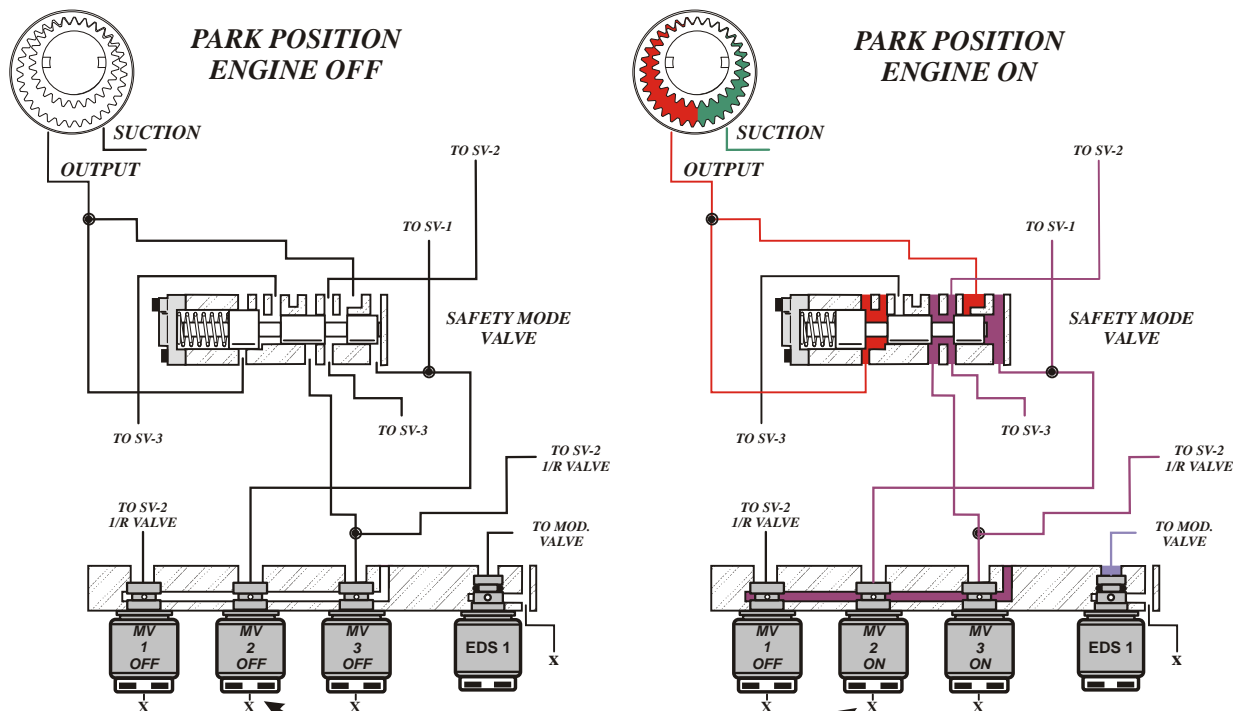
Figure 3

MV-2 IS TURNED "ON" ONLY TO STROKE THE SAFETY MODE VALVE. PUMP PRESSURE WILL KEEP THE SAFETY MODE VALVE STROKED AS LONG AS THE ENGINE IS RUNNING
