Technical Service Information

BMW/ISUZU 4L30E INADEQUATE LINE RISE

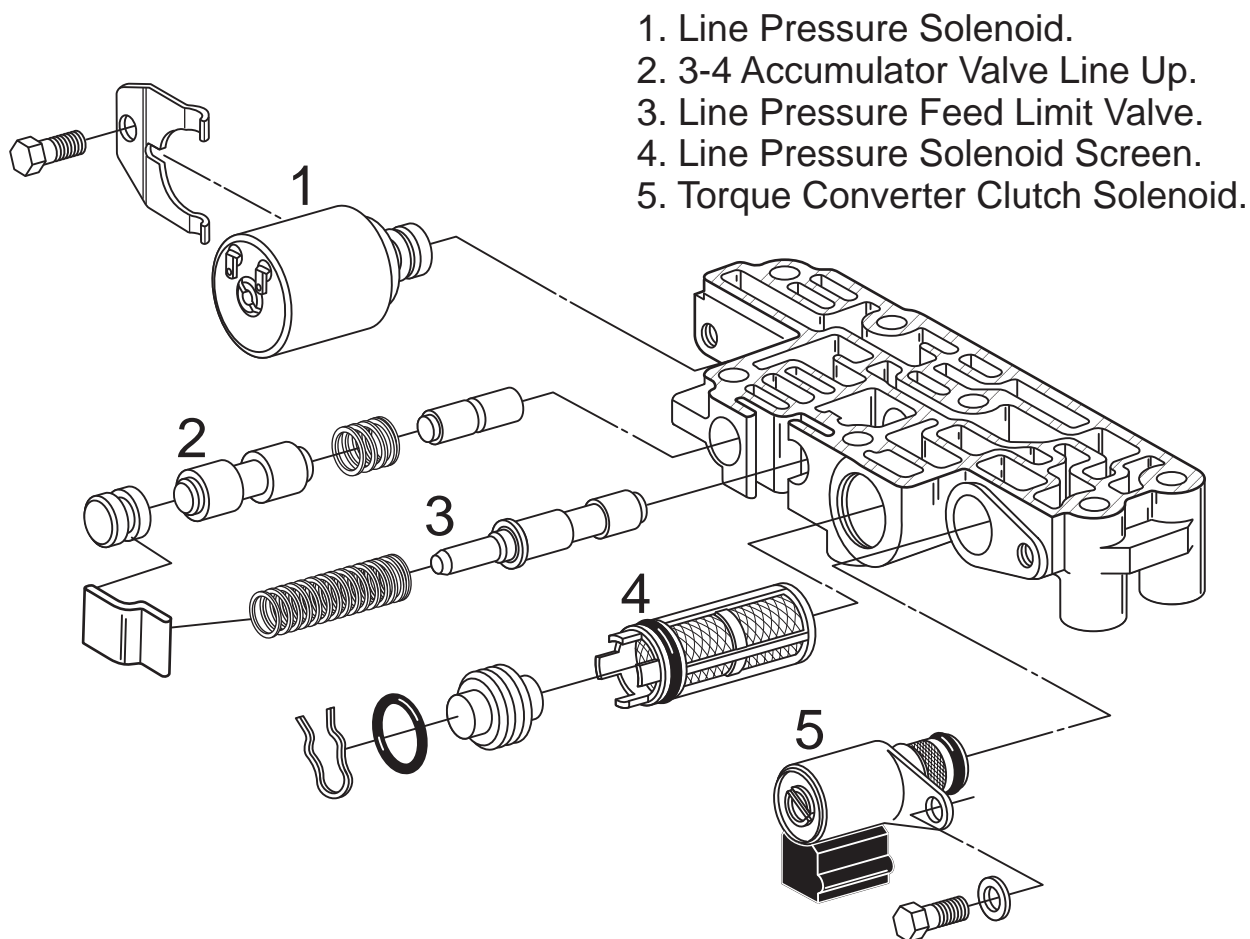
ADAPTER CASE VALVE BODY

CAUSE: One cause may be a worn Feed Limit Valve bore in the Adapter Case Valve Body.

The responsibility of the Feed Limit Valve is to regulate line pressure before it is fed to the Force Motor/Pressure Control Solenoid. As the valve bore wears, the valve and spring will lose it's ability to regulate properly, as bore wear becomes more severe, excessive exhaust of line pressure occurs creating the soft or flared shifts, slipping and other complaints.

CORRECTION: Replace the Adapter Case Valve Body.

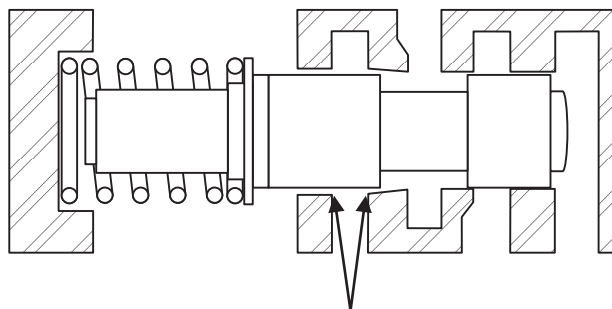
PARTIAL CUTAWAY OF FEED LIMIT VALVE BORE

Valve body casting may wear in this location
allowing line pressure to exhaust excessively.
