# Technical Service Information

## NISSAN RL4F02A FLARE 2-3 SHIFT OR NO 2-3 SHIFT HOT

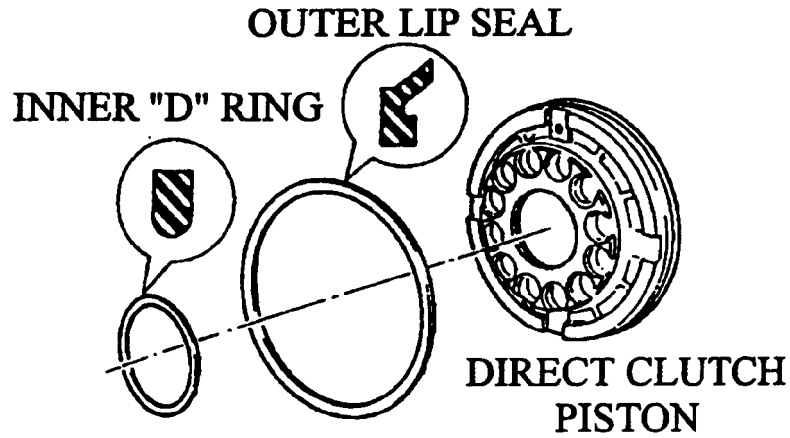
Figure 1

**CAUSE:** NO. (1) - It has been determined that the inner "D" ring on the direct clutch piston wears badly and/or shrinks, creating a leak of direct clutch oil at the inner seal (See Figure 1).

**CORRECTION:** NO. (1) - Remove the outer lip seal from the direct clutch piston and install the piston back into the direct drum with only the "D" ring in the piston. Rotate the piston and check the "D" ring for "Drag", as shown in Figure 3. "D" ring wear and/or shrinkage is what normally creates this complaint, and simply replacing the "D" ring solves the problem.

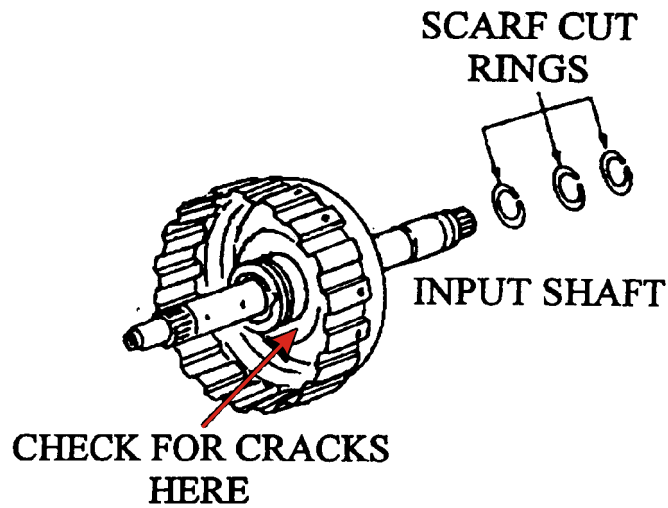
Figure 2

NO. (2) - It has also been found that the direct drum is prone to cracking in the area around the inside diameter of the drum where the input shaft is attached to the drum, and is sometimes difficult to see visually (See Figure 2).

NO. (2) - If when checking the "D" ring for "Drag" as explained above, you determine the "D" ring DOES have sufficient "Drag", then a close inspection of the direct drum for cracks, in the area shown in Figure 2, is MANDATORY. Replace the direct drum as necessary.

NOTE: ATSG has found that the Chrysler A04/413 scarf-cut Teflon seal rings provide much better sealing of direct clutch oil, when they are used on the input shaft in this unit (See Figure 2).
