Technical Service Information

CHRYSLER A604

NO UPSHIFT AFTER FLUID AND FILTER CHANGE

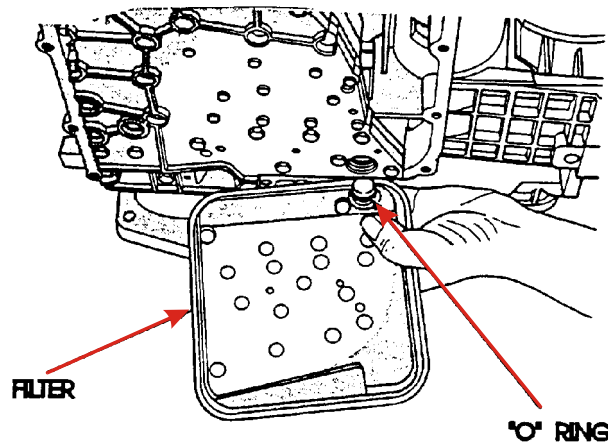
Figure 1

COMPLAINT: After a routine maintenance service, including fluid and a new filter, some A-604 transaxles will go to the limp mode after the first shift. Second gear will be the only forward gear possible.

CAUSE: if air is introduced into the hydraulic system, the A-604 controller may momentarily record no line pressure and enter the limp mode. This is especially true if the engine is restarted before adding sufficient fluid.

NOTE: Always replace the filter "O" ring and pre-fill the filter with clean fluid. (See figure 1)
