# Technical Service Information

## THM 3T40 (125C) FRONT SEAL POP OUT

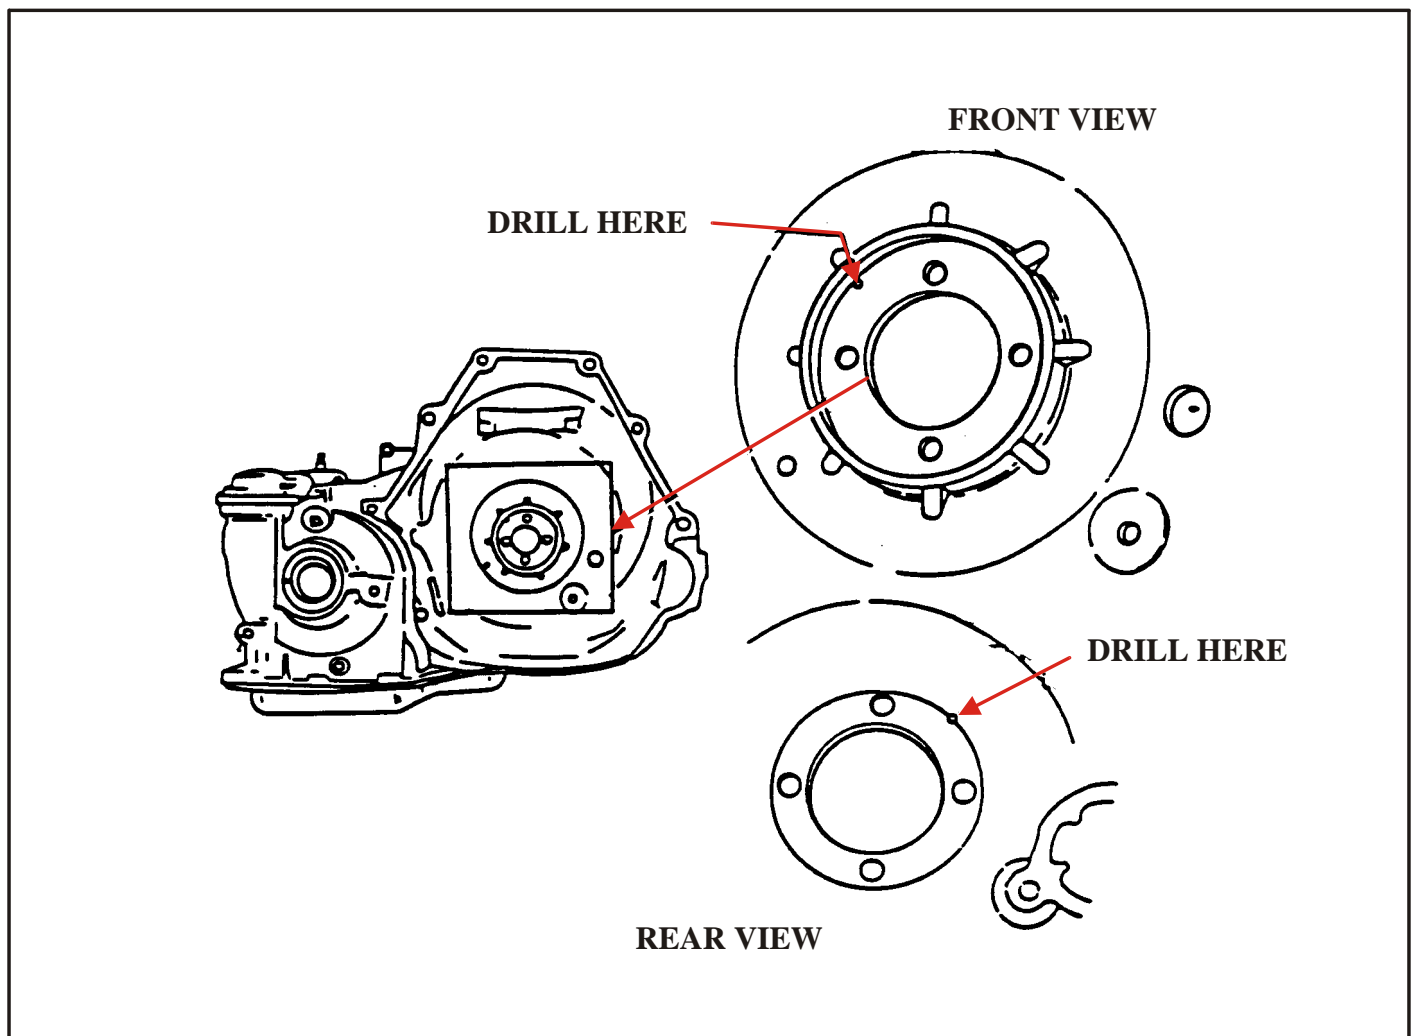
Figure 1

**COMPLAINT:** Front Seal Pop Out

**CAUSE:** One cause can be excessive clearance between the torque converter bushing and the stator support journal area. Wear on the stator support or distortion in the case bore can cause a build up of fluid behind the seal forcing it out of the case.

**CORRECTION** Drill a drain back hole at the 11 or 1 O-Clock position as shown to allow the fluid to drain back into the case before a fluid-pressure build up can cause the seal to pop Out. Use a 1/4" drill bit.
