Technical Service Information

CHRYSLER A604 DELAYED REVERSE ENGAGEMENT

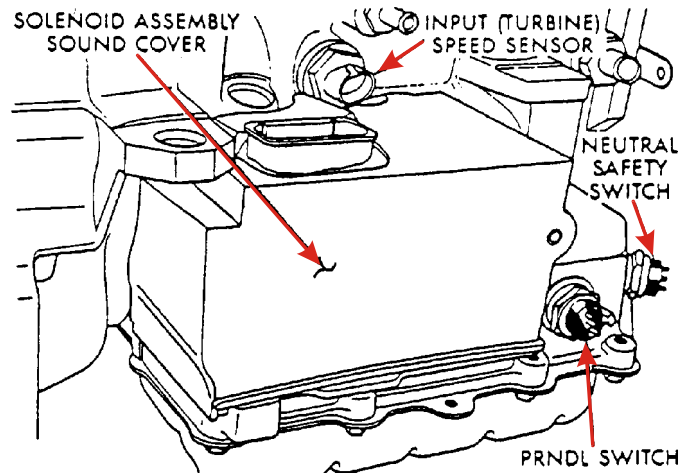
CAUSE: NUMBER ONE - The cause may be, a defective PRNODL Switch located in the case (See Figure 1 for Location), because of no signal to the controller that reverse was selected.

PRNDL SWITCH AND CONNECTOR

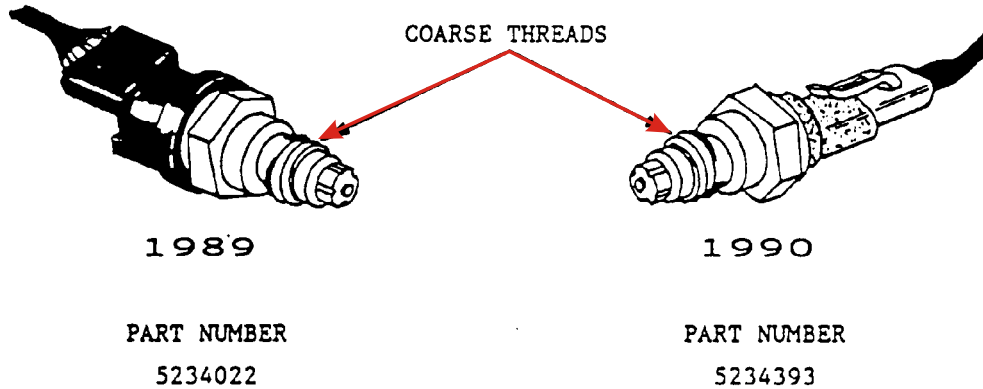
Figure 2

THESE PRNDL SWITCHES WILL NOT INTERCHANGE.

CORRECTION: NUMBER ONE - Replace the PRNODL Switch located in the case with the appropriate OEM part number (See Figure 2).

PRNODL Switch (1989 Model)	5234022
PRNODL Switch (1990-UP Models)	5234393
Neutral Safety Switch (1989 Model)	3747361
Neutral Safety Switch (1990-UP Models)	5234319

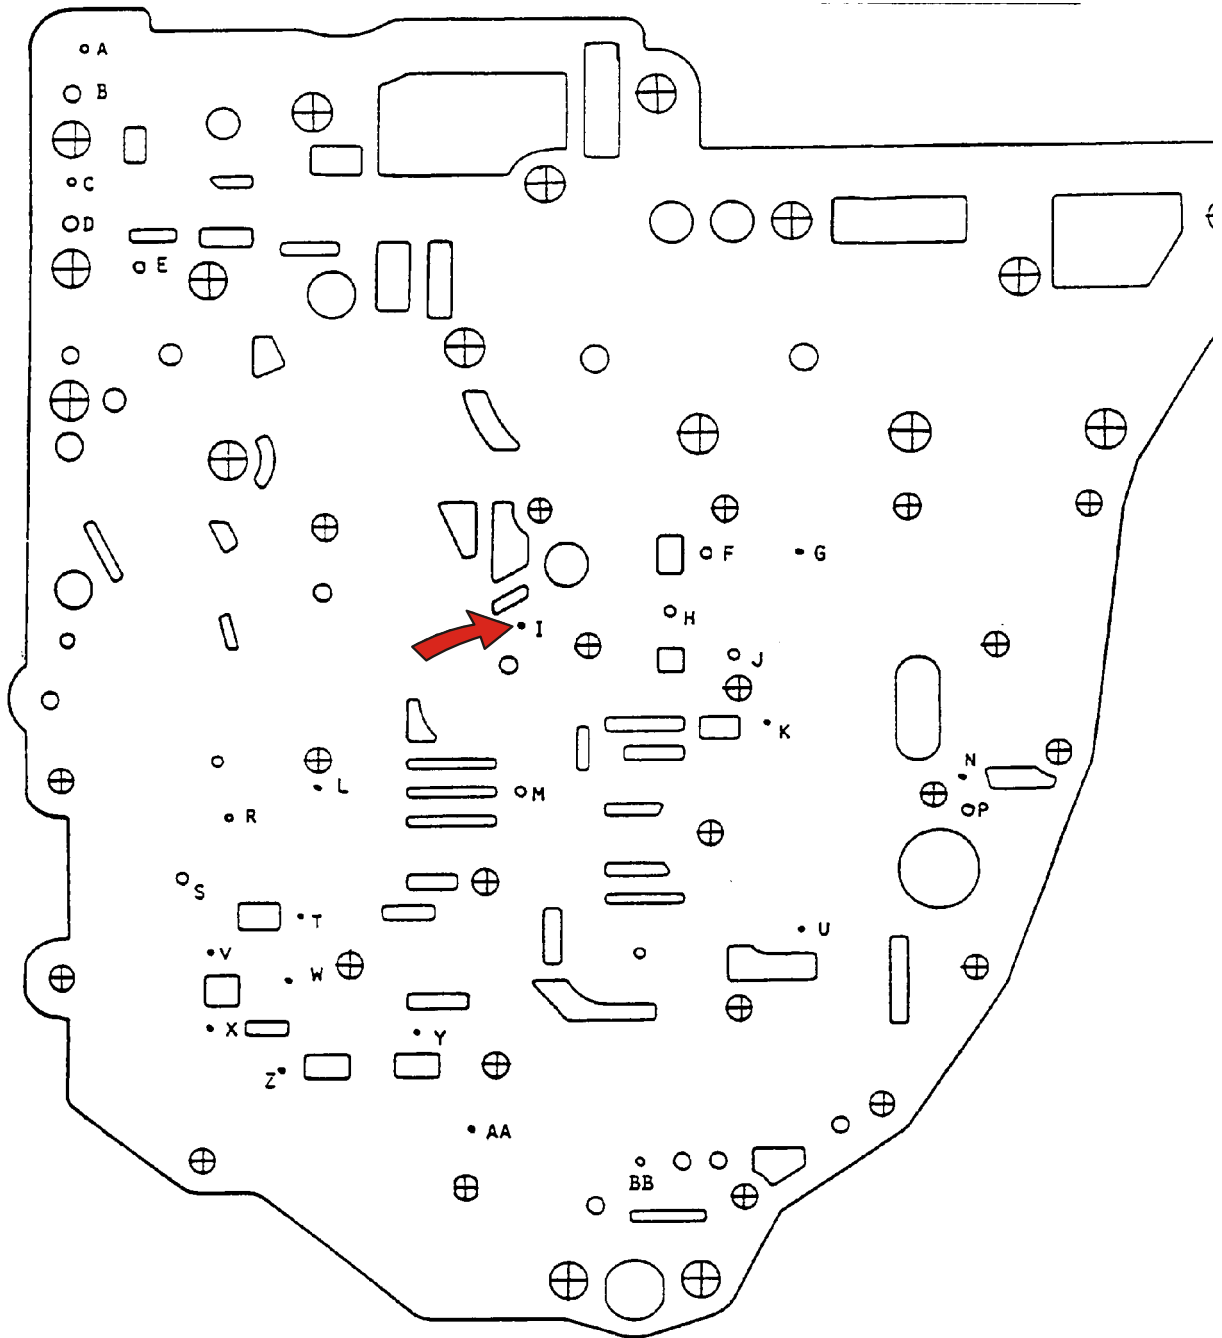
Figure 3
AUTOMATIC TRANSMISSION SERVICE GROUP

NUMBER TWO - The cause may be, not enough reverse oil flow through the orifice to the reverse clutch.

A604 SPACER PLATE

NUMBER TWO - If the condition still exists after checking, or replacing the PRNODL Switch, drill the hole in spacer plate marked "I", as shown in Figure 3.

DRILL HOLE MARKED "I" TO .093" AS SHOWN ABOVE
