Technical Service Information

MAZDA G4A-HL SLIPPING IN DRIVE POSITION ALL SHIFTS SOFT AND/OR SLIPPING LOW LINE PRESSURE

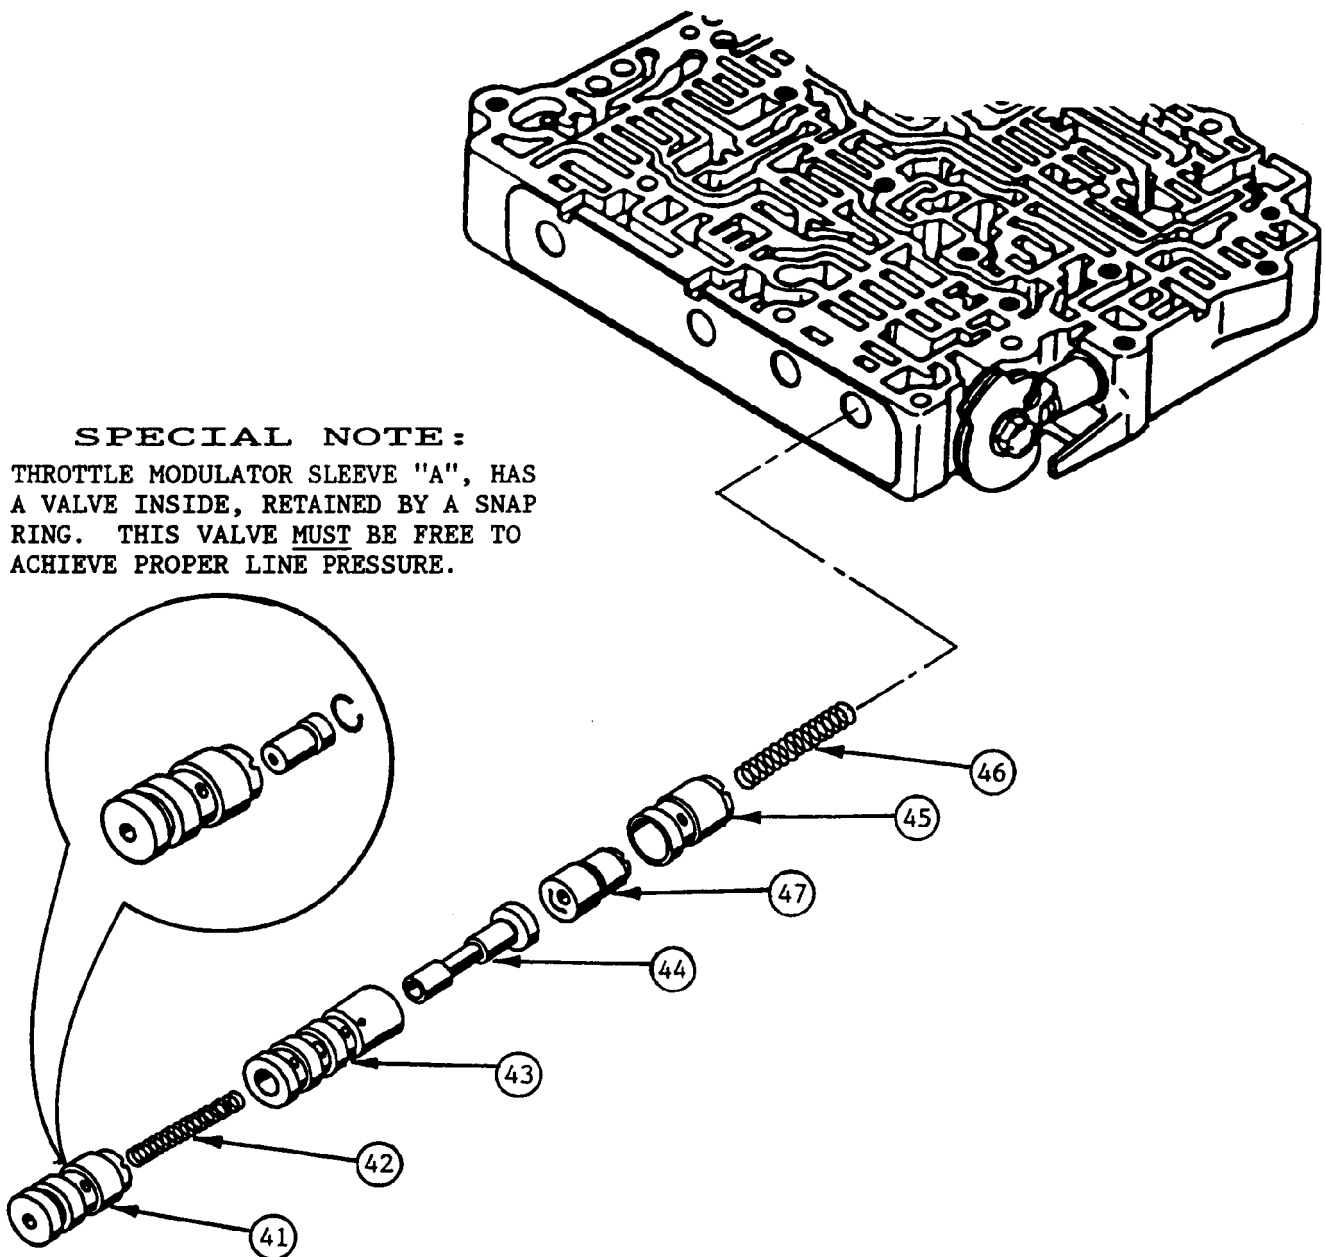
COMPLAINT: Some MAZDA 323 models equipped with the G4A-HL transaxle may exhibit a slipping condition with selector lever in the Drive (D) position, all shifts will be soft and/or slipping, and if line pressure has been checked, line pressure will be low.

CAUSE: The cause is low line pressure, and may be created by mis-assembly of the Throttle Modulator Line-up in the valve body.

THROTTLE MODULATOR SLEEVE "A", HAS A VALVE INSIDE, RETAINED BY A SNAP RING. THIS VALVE MUST BE FREE TO ACHIEVE PROPER LINE PRESSURE.

CORRECTION: Install the Throttle Modulator Valve Line-up into the valve body as shown in Figure 1.
Install throttle modulator sleeve "C", throttle modulator rear spring, throttle modulator plug, throttle modulator valve and throttle modulator sleeve "B", throttle modulator front spring, throttle modulator sleeve "A", and the retaining pin, as shown in Figure 1.
