# Technical Service Information

## FORD E4OD

### DELAYED FORWARD ENGAGEMENT AND/OR BURNT FORWARD CLUTCH AFTER INSTALLING FORD CENTER SUPPORT SERVICE KIT F4TZ7A130-B

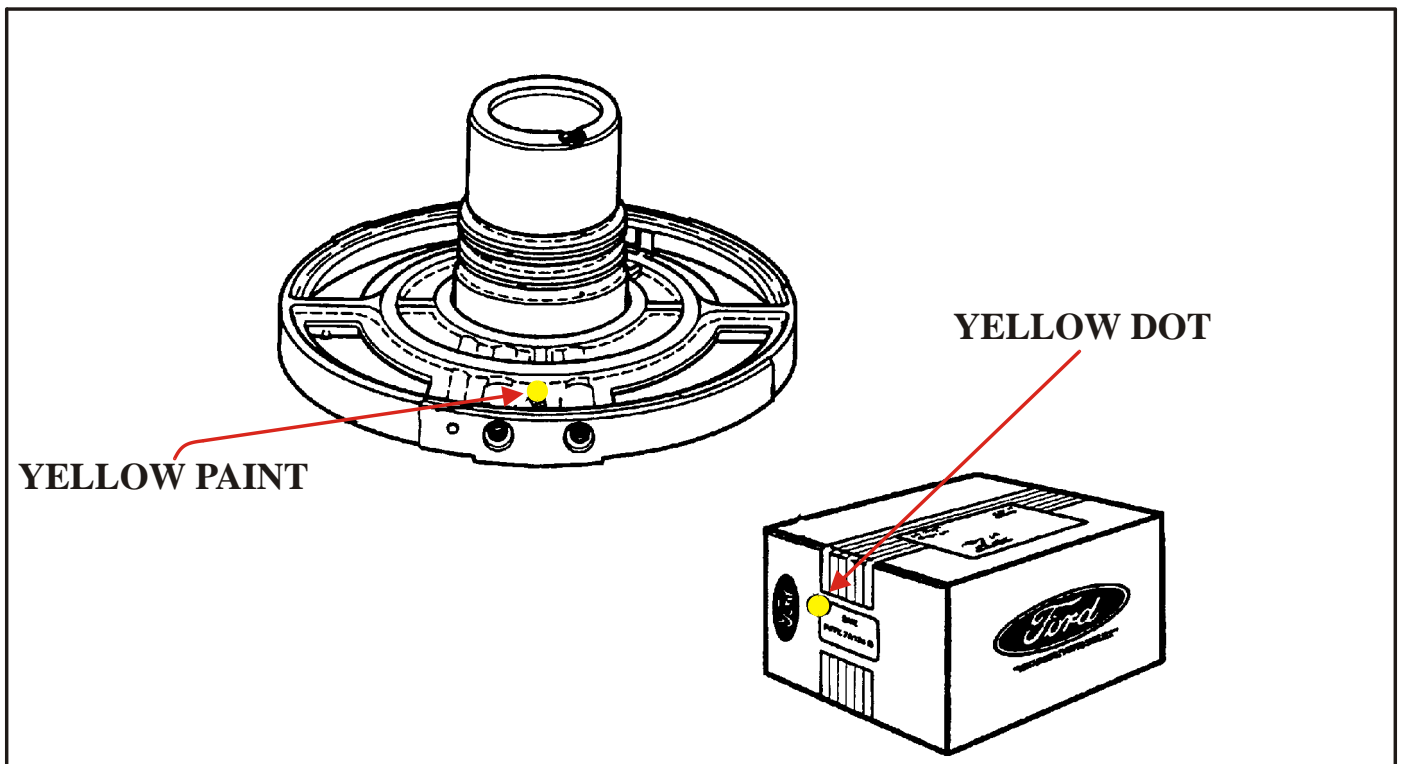
Figure 1

- COMPLAINT:** Delayed forward engagement and/or prematurely burnt forward clutch plates may be evident on vehicles which have had the new Ford Ball Bearing Center Support Kit, OEM part number F4TZ-7A 130-B.
- CAUSE:** The cause may be, forward clutch oil leaking between the steel hub and the aluminum support ring because of mis-machining of the aluminum support ring in the area where the steel hub bolts to it.
- CORRECTION:** Install a new Center Support Service Kit, F4TZ-7A130-B, that has yellow paint on the wide leg of the center support as shown in Figure 1, and a yellow dot on the shipping carton as shown in Figure 1. There was no part number change and Ford has since recalled and reboxed the defective part.
