# Technical Service Information

## THM 3L80 (400) FRONT PUMP SEAL LEAK

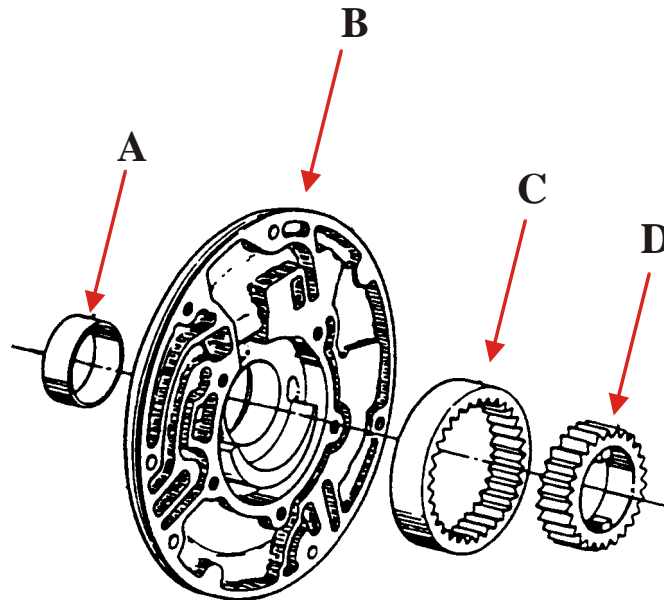
Figure 1

**COMPLAINT:** Fluid leaks out front pump seal.

**CAUSE:** The cause may be the front pump bushing walking forward into the front pump seal, resulting in fluid being forced out past the seal.

**CORRECTION:** A new front pump bushing is now available that has an increased specification which results in a higher push out load. Replace the front pump bushing with the new style bushing, available under OEM Part No. 8623940.

Front Pump Bushing (2nd Design).....8623940
