FORD 4R44E/4R55E/5R55E DELAYED REVERSE ENGAGEMENT

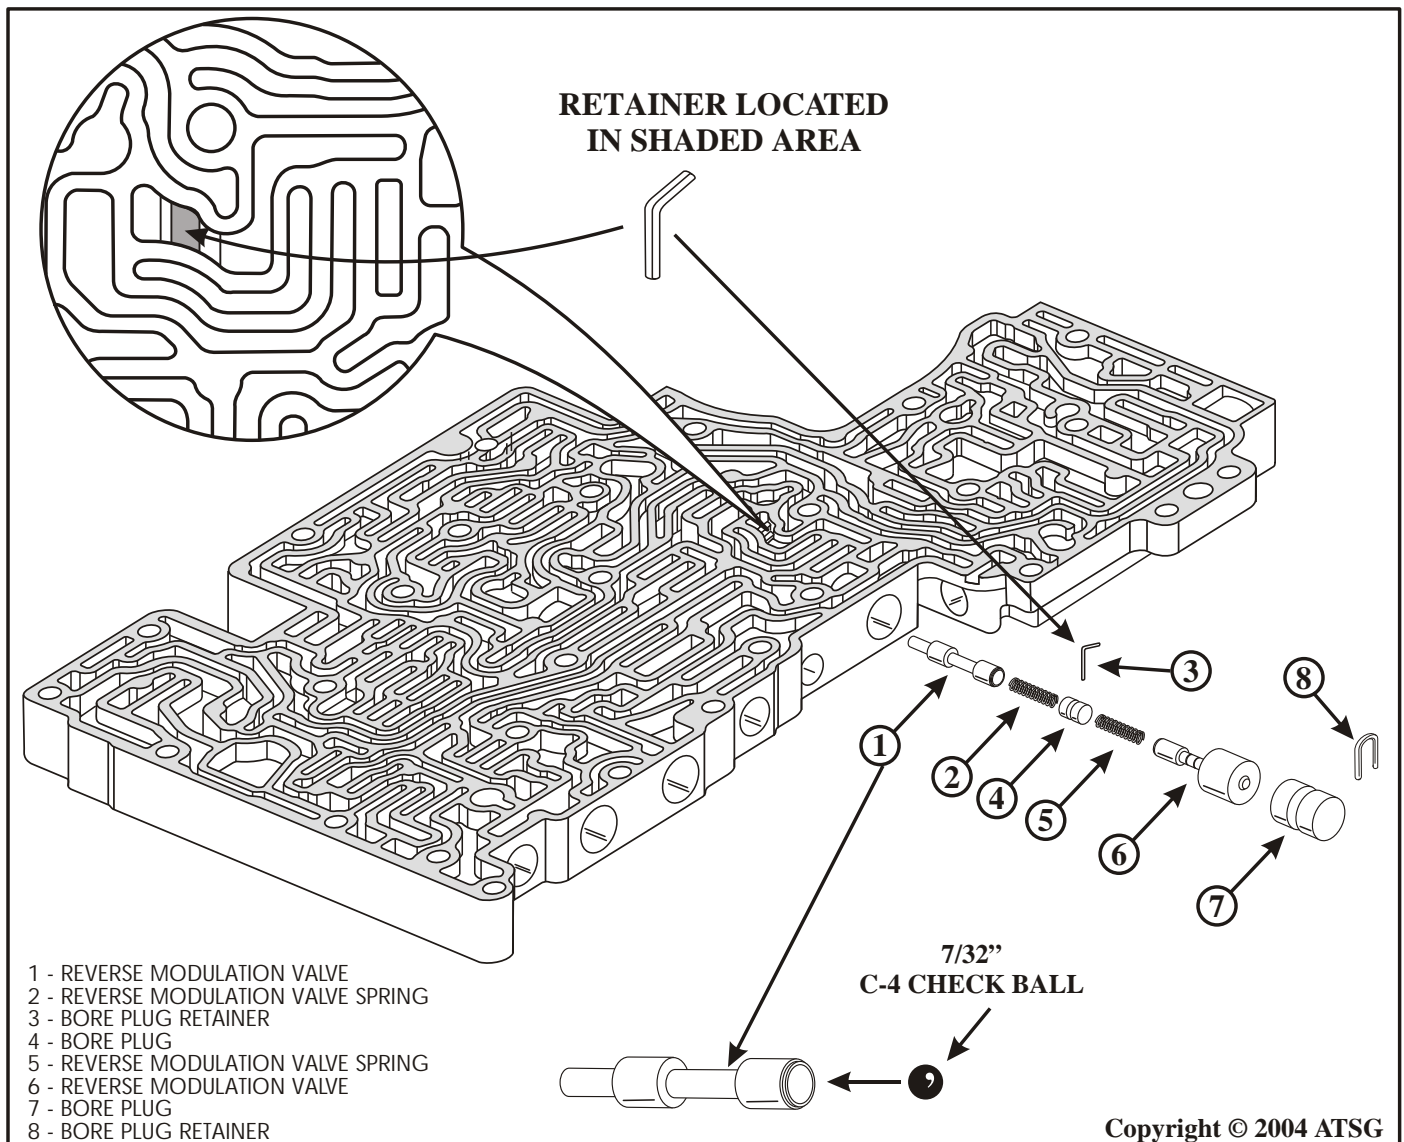
Figure 1

COMPLAINT: Some vehicles equipped with the 4R44E/4R55E/5R55E transmissions may exhibit a delayed engagement in reverse and no engine braking in manual low.

CAUSE: One cause may be, a weak reverse modulation valve spring.

CORRECTION: Install a 7/32" (C-4) check ball in the end of the reverse modulation valve as shown in Figure 1, to use as a shim to increase spring tension.
