# Technical Service Information

## **THM 4L60 (700-R4) PREMATURE 3-4 CLUTCH FAILURE**

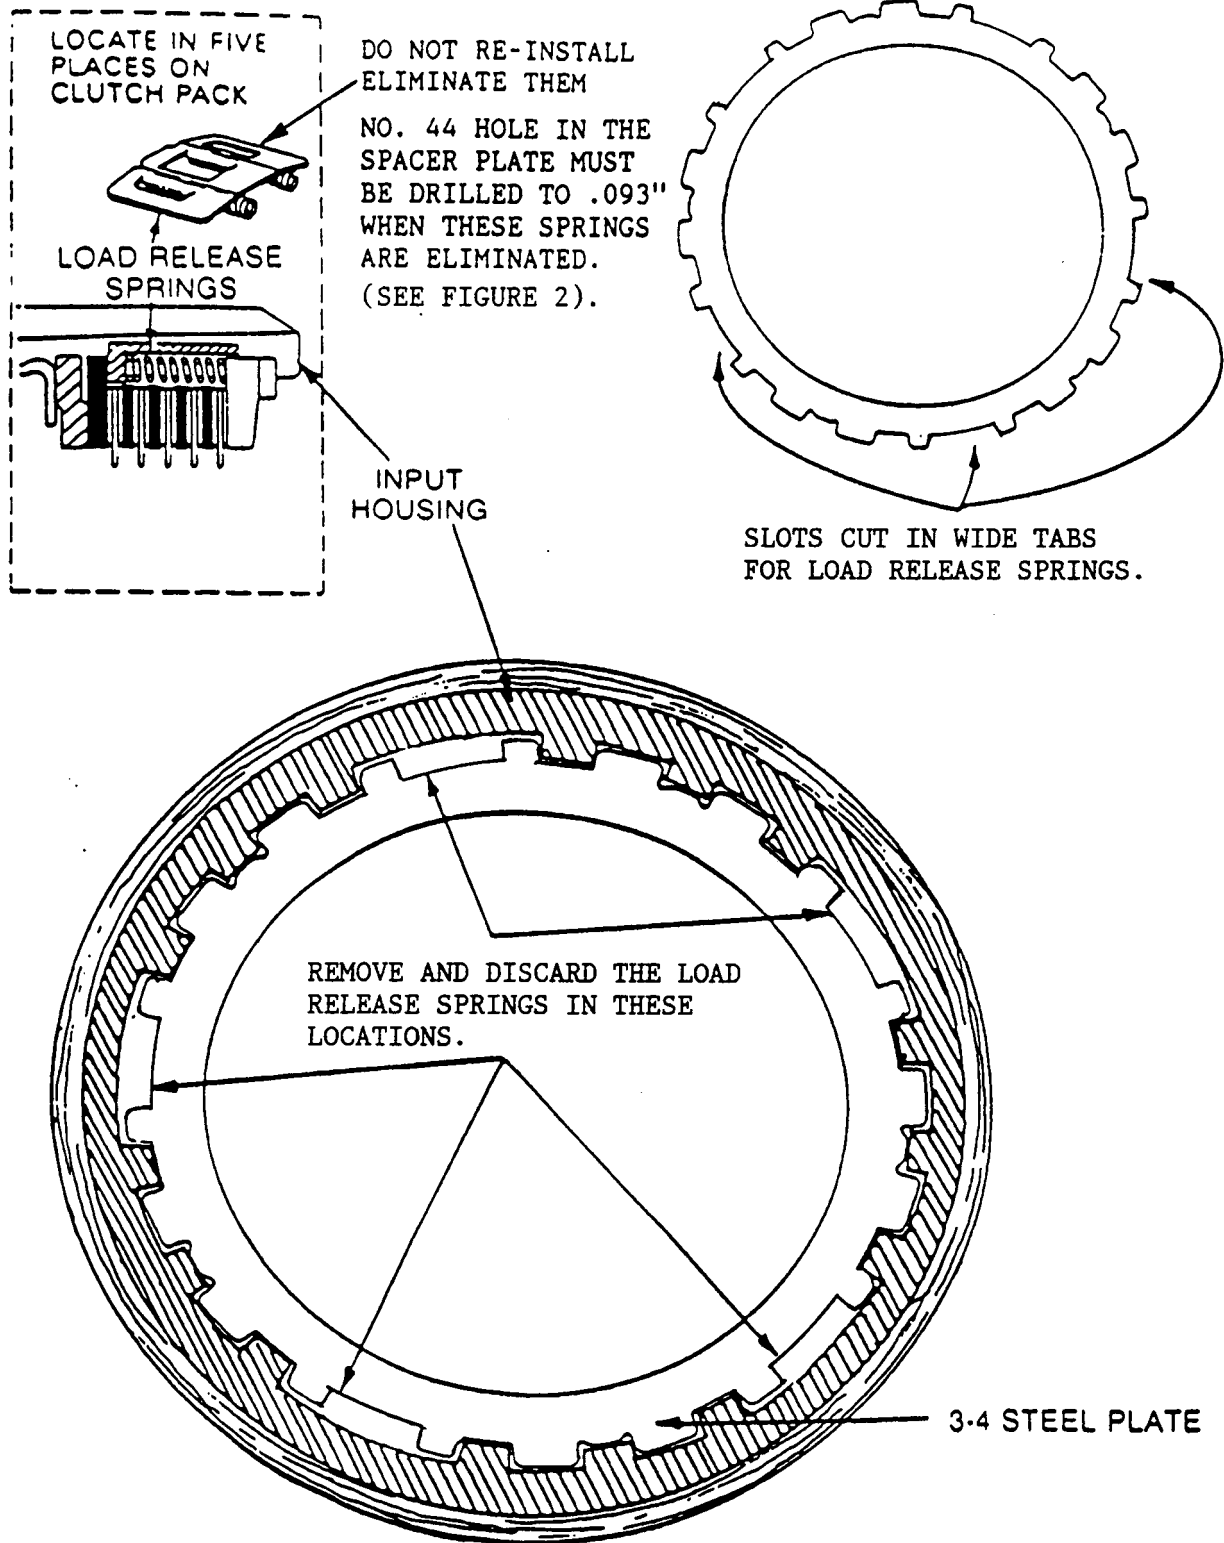
Figure 1

**COMPLAINT:** Premature 3-4 clutch failure on 1988 to 1992 model 700-R4 transmissions, and can occur as early as 200 miles on the unit.

**CAUSE:** The cause may be too much spring pressure for available 3-4 clutch oil pressure to overcome.

**CORRECTION:** Remove and discard the 3-4 Load Release Spring Assemblies, on ALL vehicles so equipped (See Figure 1). Drill hole marked 'ID' in the spacer plate out to .093", as shown in Figure 2. This hole was eliminated on 1988 and later 5.7L models. If your spacer plate does not have this hole, use the gasket as a template and drill it to .093" (See Figure 2). Set the 3-4 clutch clearance to .050"-.060".

**NOTE: WITH THE 3-4 LOAD RELEASE SPRINGS REMOVED, IT ALLOWS YOU TO INSTALL THE STEEL PLATES IMPROPERLY. PROPER INSTALLATION IS WITH THE STEEL PLATES INSTALLED SO THAT THE LOAD RELEASE SPRINGS WOULD FIT, IF WE WERE GOING TO USE THEM.**
