Technical Service Information

CHRYSLER A518 SERIES NO OR LATE THIRD GEAR

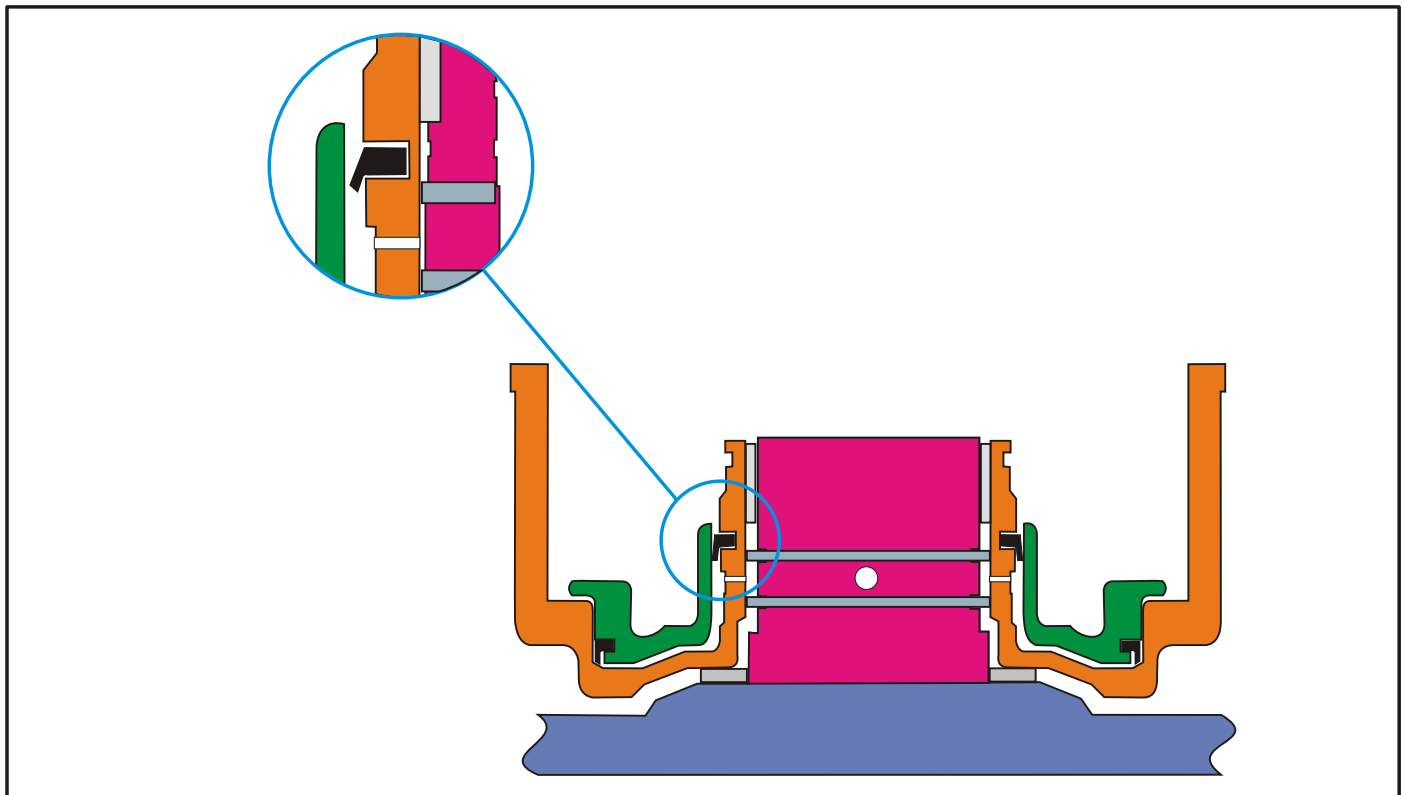
Figure 1

COMPLAINT: 1989 and later A518's, 46 and 47R units may exhibit a late or no shift into third under various temperature conditions. This complaint may also be accompanied with a delayed engagement into reverse when hot.

CAUSE: Some direct clutch drums had the inner seal groove cut too deep. This allows for the inner seal to be swallowed up into the groove causing poor retention of fluid (See Figure 1). Another possibility is the outer lip seal being worn due to a poor finish of the drum, in the contact area

CORRECTION: Replace the inner lip seal with a larger radial base. Aftermarket sources such as TransTec/Freudenberg-NOK and Precision International produce a wider base seal to accommodate the deeper depth of the groove. Also Shift Technology Products packages an inner lip seal in their K500-618 kit. Replace the outer seal after polishing the drum, in the contact area of the outer lip seal.
