# Technical Service Information

## THM 440-T4 DELAY/SLIPS FORWARD

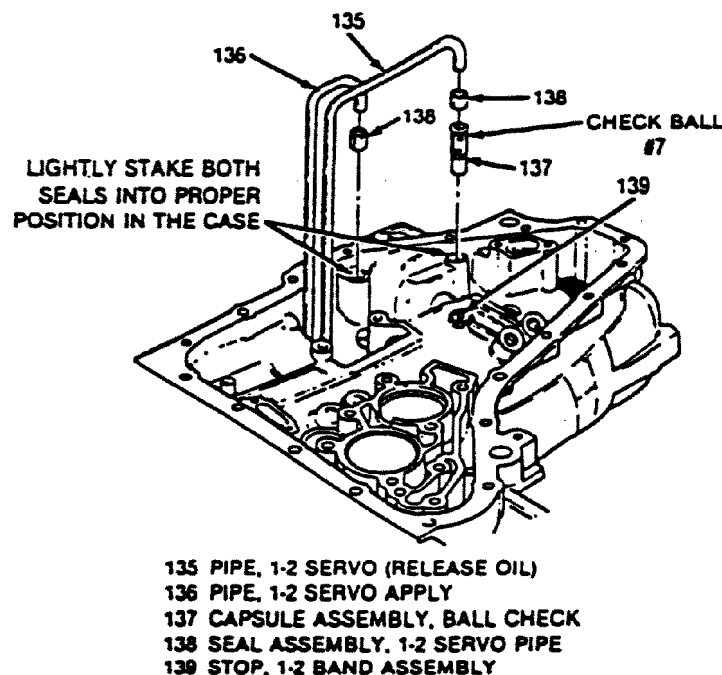
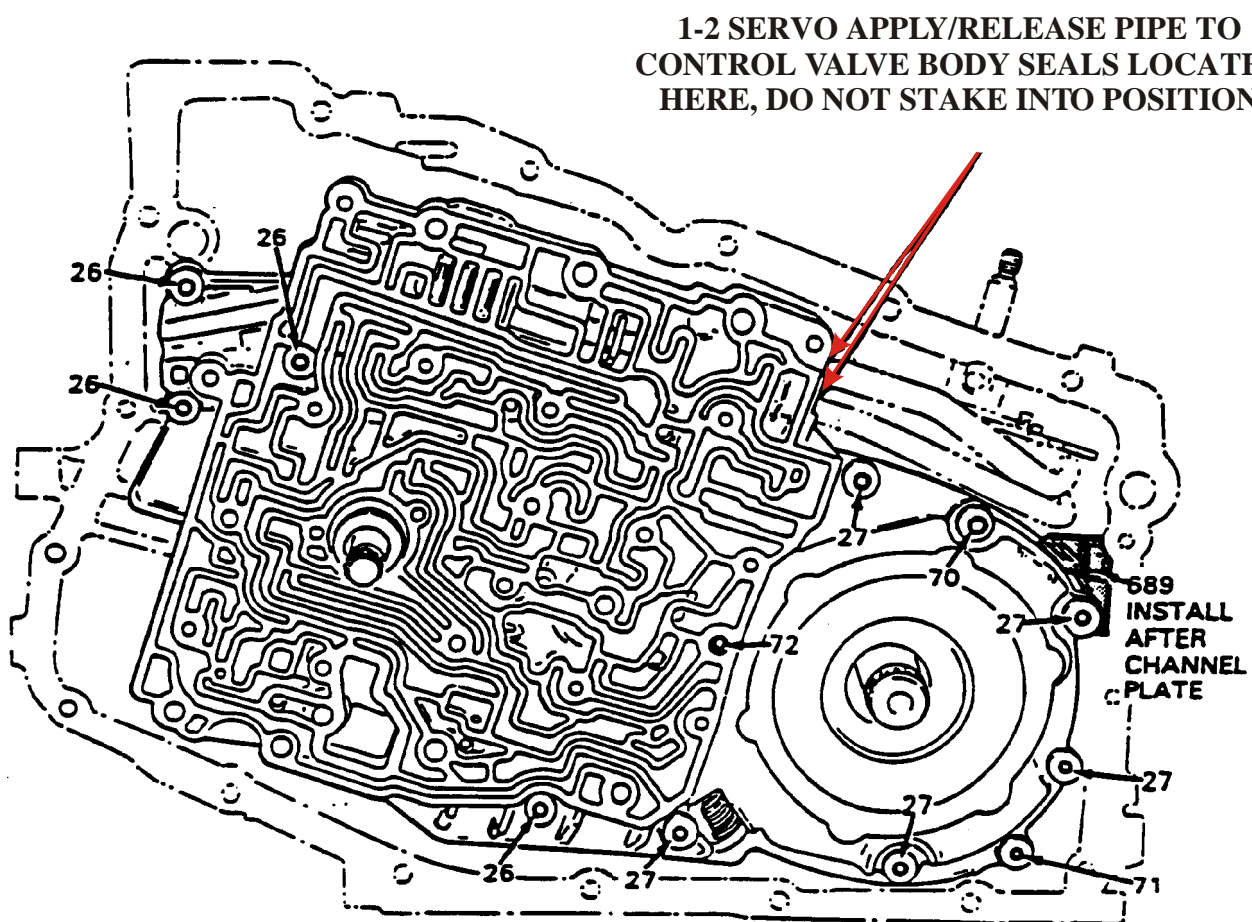
Some 1935 and 19S6 Cadillac equipped with a THM440-T4 transaxle may experience conditions of delayed forward engagement and slipping on take off from stops, or a 2-3 upshift bump, These conditions can be caused by a leak at the seals in the hydraulic circuits controlling apply and release of the 1-2 band.

Seals are included at both ends of the apply and release pipes (refer to Figures 1 and 2) and on the servo piston. Damaged seals in any position will effect operation of the servo. Leaking apply circuit seals will cause delayed engagement (forward only) and slipping when in first or second gears. Seal leaks in the release circuit will cause a 2-3 upshift bump, or tie up, due to inadequate band release (severe release circuit leak could result in a 2-3 upshift slip).

When performing transaxle service closely inspect the transaxle oil condition. Presence of burnt oil or metal debris indicates internal transaxle wear; Service via replacement with a SRT A transaxle or overhaul per procedures listed in the appropriate Service Information Manual. If the transaxle oil is not burnt and debris is not present inspect the servo pipe seals at both ends of each pipe and the 1-2 servo piston seals for damage. Replace any damaged seal as outlined in the appropriate Service Information Manual. When installing the servo pipes into the control valve body, ensure seal damage does not occur. Road test to ensure proper transaxle operation.
