Technical Service Information

FORD AX4S N-D DELAY/BANG 1999 & UP MODELS

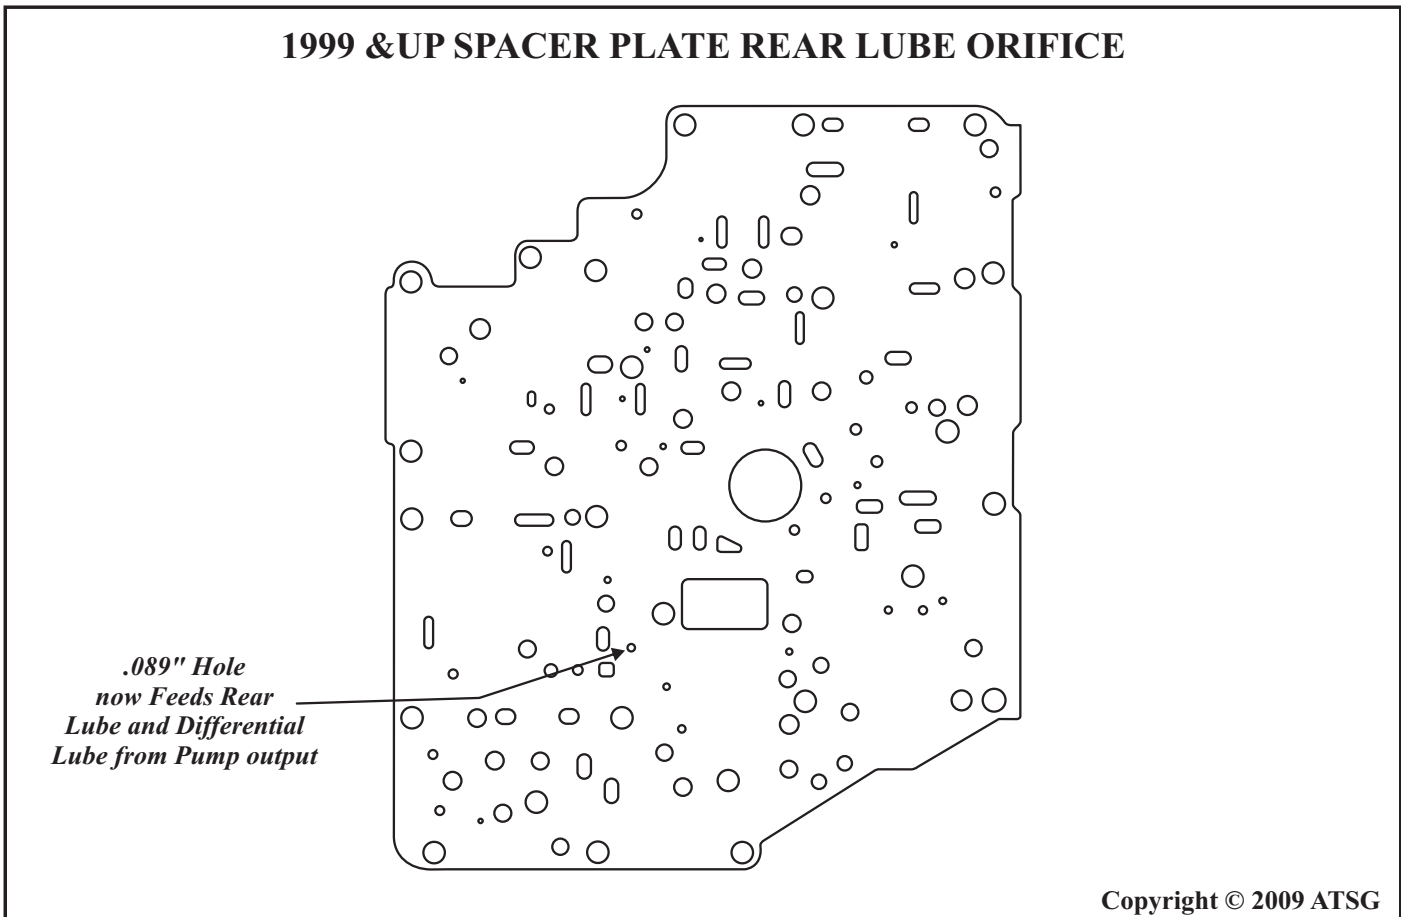
Figure 1

CAUSE: The cause may be, a leak in the lube circuit, which is now fed directly from pump output, through an .089" orifice in the main spacer plate, as shown in Figure 1. This leak may be from a broken o-ring on the lube pipe where it fits in the case or a crack in the braised area where it feeds the support, or a damaged "orange" lube seal in the support (see Figures 2 and 3). A leak in the lube circuit may cause a low overall line pressure condition, when the PCM notices that forward has not been engaged, it will elevate line pressure causing the bang when forward is finally engaged.

CORRECTION: To correct this condition, ensure that the lube pipe o-ring and the braised area of the pipe are in good condition, also make sure that the "orange" seal in the support is in good condition.

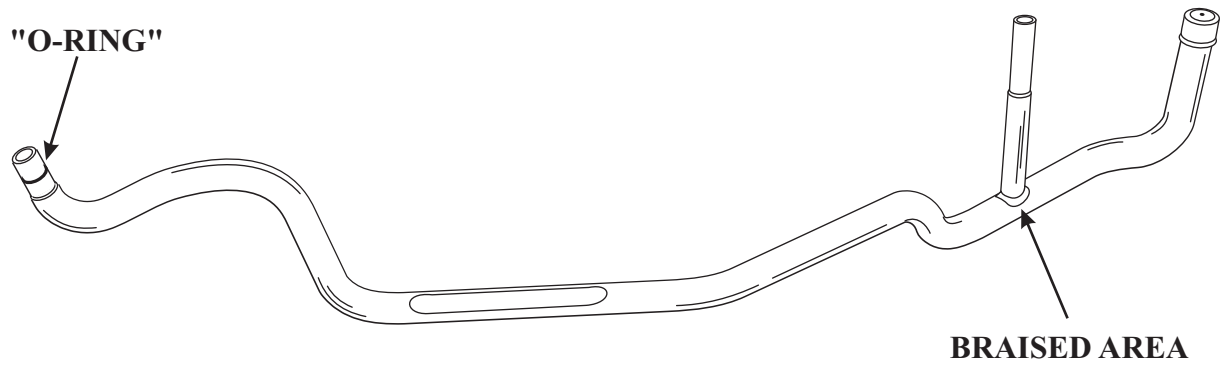
Figure 2

REAR / DIFFERENTIAL LUBE PIPE

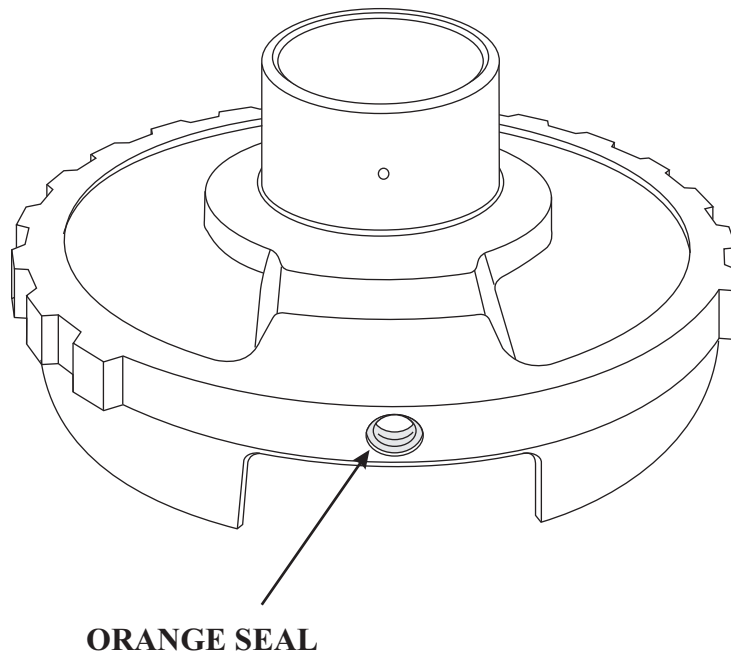
Figure 3

SUPPORT
