Technical Service Information

FORD CD4E **CODE P0741 STORED, AFTER REBUILD**

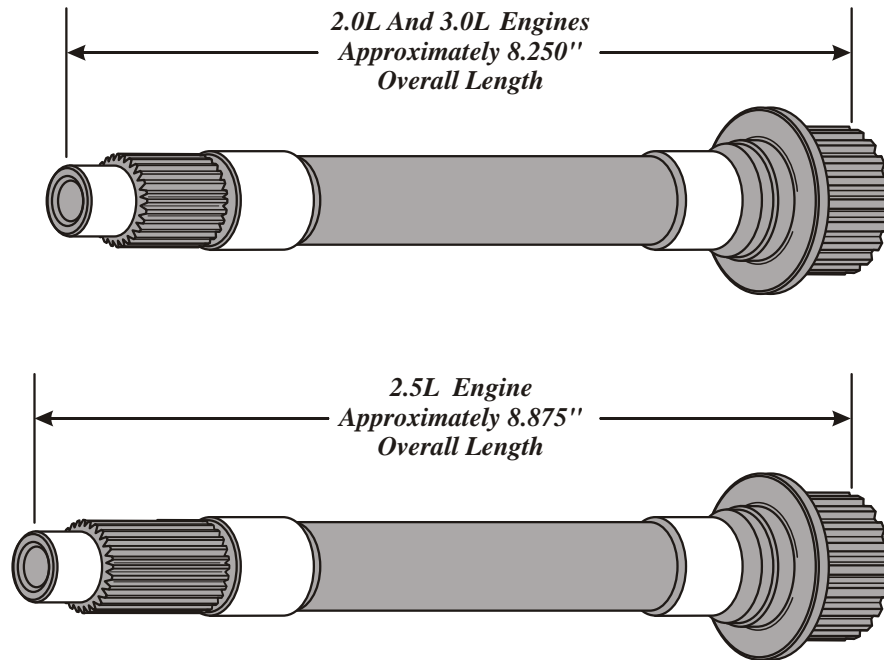
- CAUSE:** One cause may be, a mis-matched turbine shaft and torque converter that was mistakenly installed in the vehicle. The turbine shaft and oil pump drive shaft for the 2.0L and 3.0L engines are approximately 5/8" shorter than the turbine shaft and oil pump drive shaft for the 2.5L engine as shown in Figures 1 and 2. If the short turbine shaft is installed with the 2.5L or 3.0L engine and converter, the vehicle will exhibit the above concerns. Torque converter identification is provided for you in Figure 3, and as you can see in the height dimension chart, there is approximately 5/8" difference.

CD4E TURBINE SHAFT DIFFERENCES

- CORRECTION:** Remove transaxle and ensure that the proper turbine shaft and oil pump drive shaft have been installed for the engine size that you have. Refer to Figure 1 to identify the turbine shaft, Figure 2 to identify oil pump drive shaft and Figure 3 for converter identification.

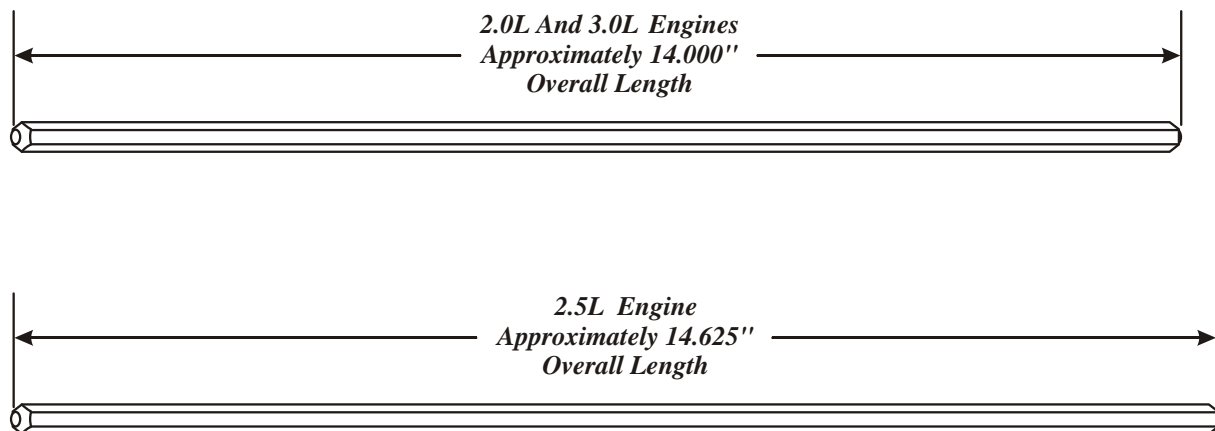
Figure 2

CD4E PUMP DRIVE SHAFT DIFFERENCES

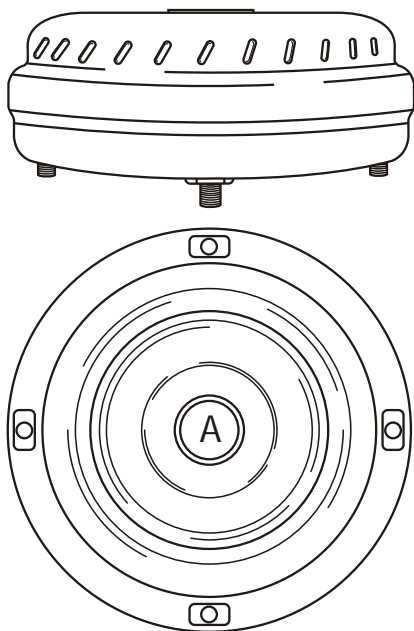
F-67

*This Converter "Requires"
The Short Turbine Shaft
And Pump Drive Shaft*

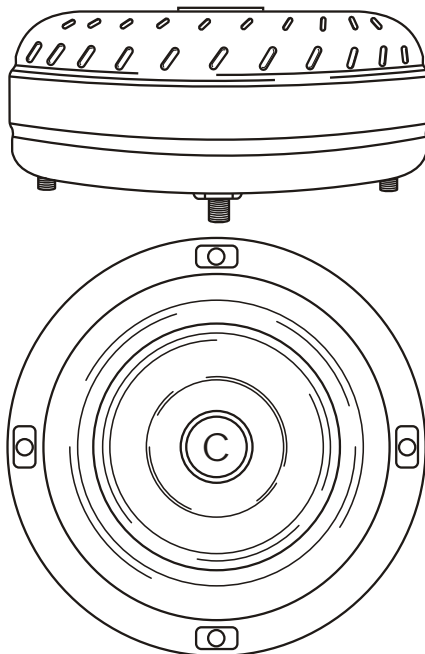
F-69

*This Converter "Requires"
The Long Turbine Shaft
And Pump Drive Shaft*

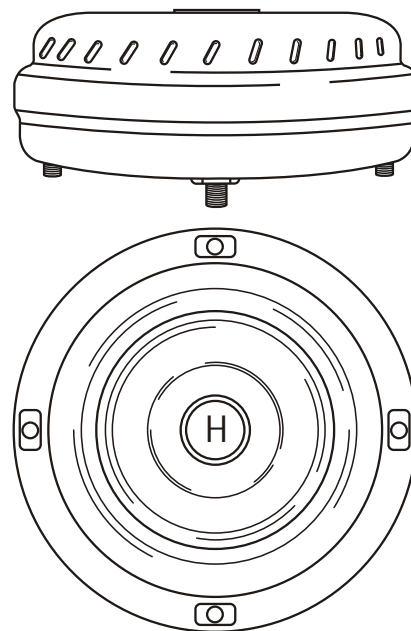
F-70

*This Converter "Requires"
The Short Turbine Shaft
And Pump Drive Shaft*
