# Technical Service Information

## CHRYSLER A500/518

### NO 3-4 UPSHIFT, AND ALL EXTERNAL ELECTRICAL CONTROLS CHECK OK

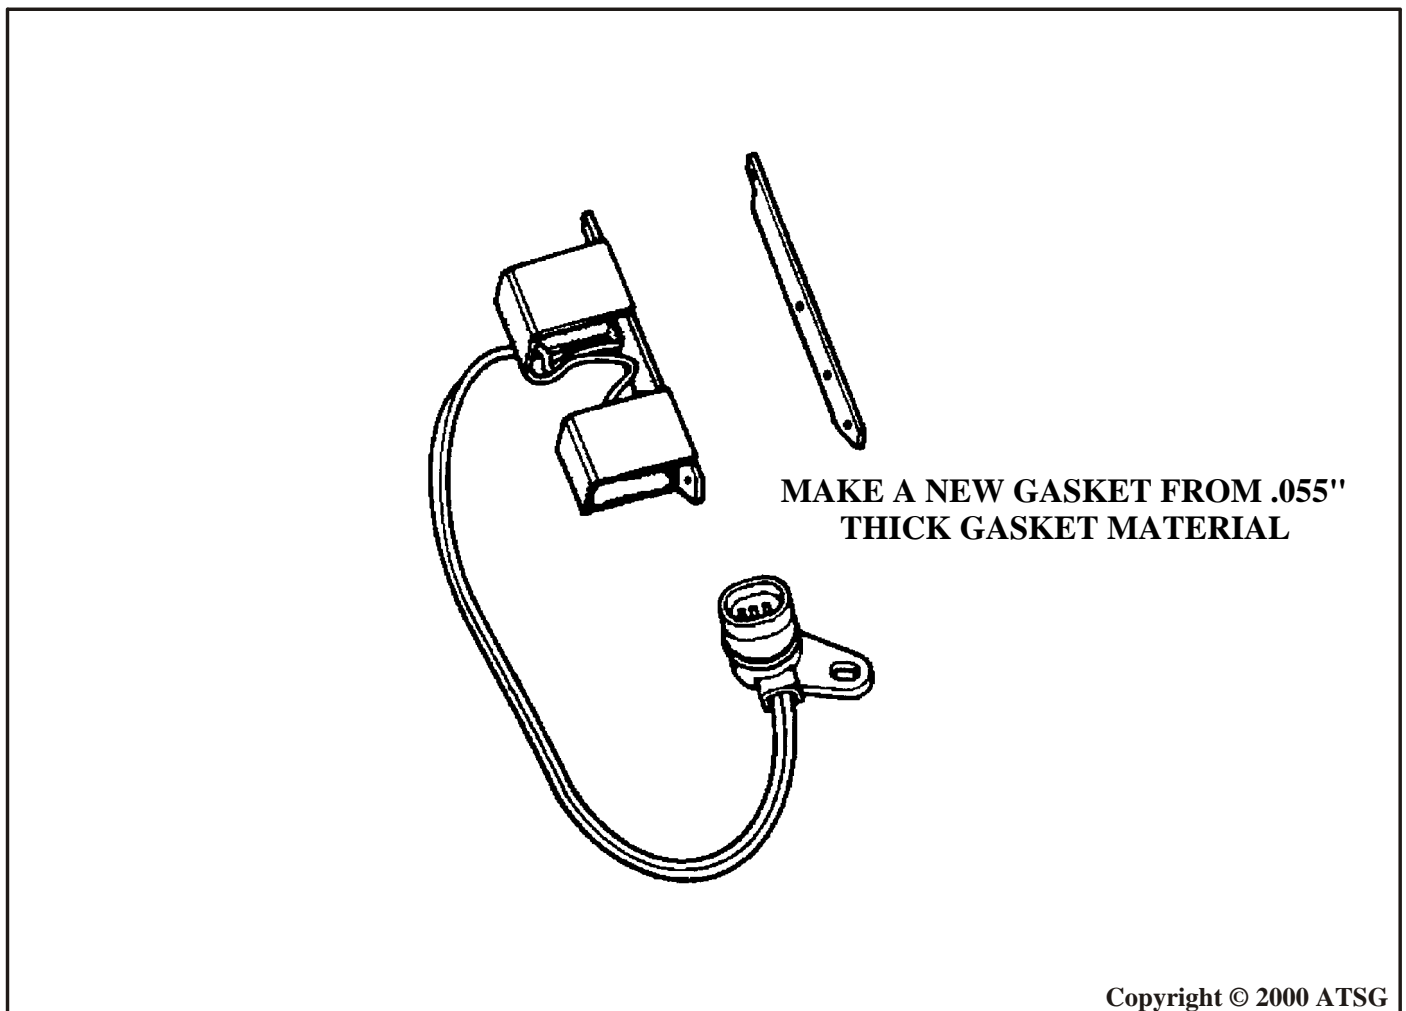
Figure 1

**COMPLAINT:** Some vehicles may exhibit a no 3-4 upshift condition, either before and/or after rebuild, and the computer is sending the ground signal to the solenoid pack at the proper time, which means that all external electrical components are functioning properly.

**CAUSE:** The cause may be, a leak between the solenoid pack and the valve body, due to the solenoid plate being slightly bent or damaged and/or the factory solenoid gasket is not capable of sealing 4th gear signal fluid.

**CORRECTION:** Replace the solenoid pack as necessary. The OEM gasket measures .030" thick, but you can make a replacement gasket out of .055" thick gasket material, to seal the leaks between the solenoid assembly and the valve body (See Figure 1).
