Technical Service Information

FORD AX4N SOFT 1-2 UPSHIFT

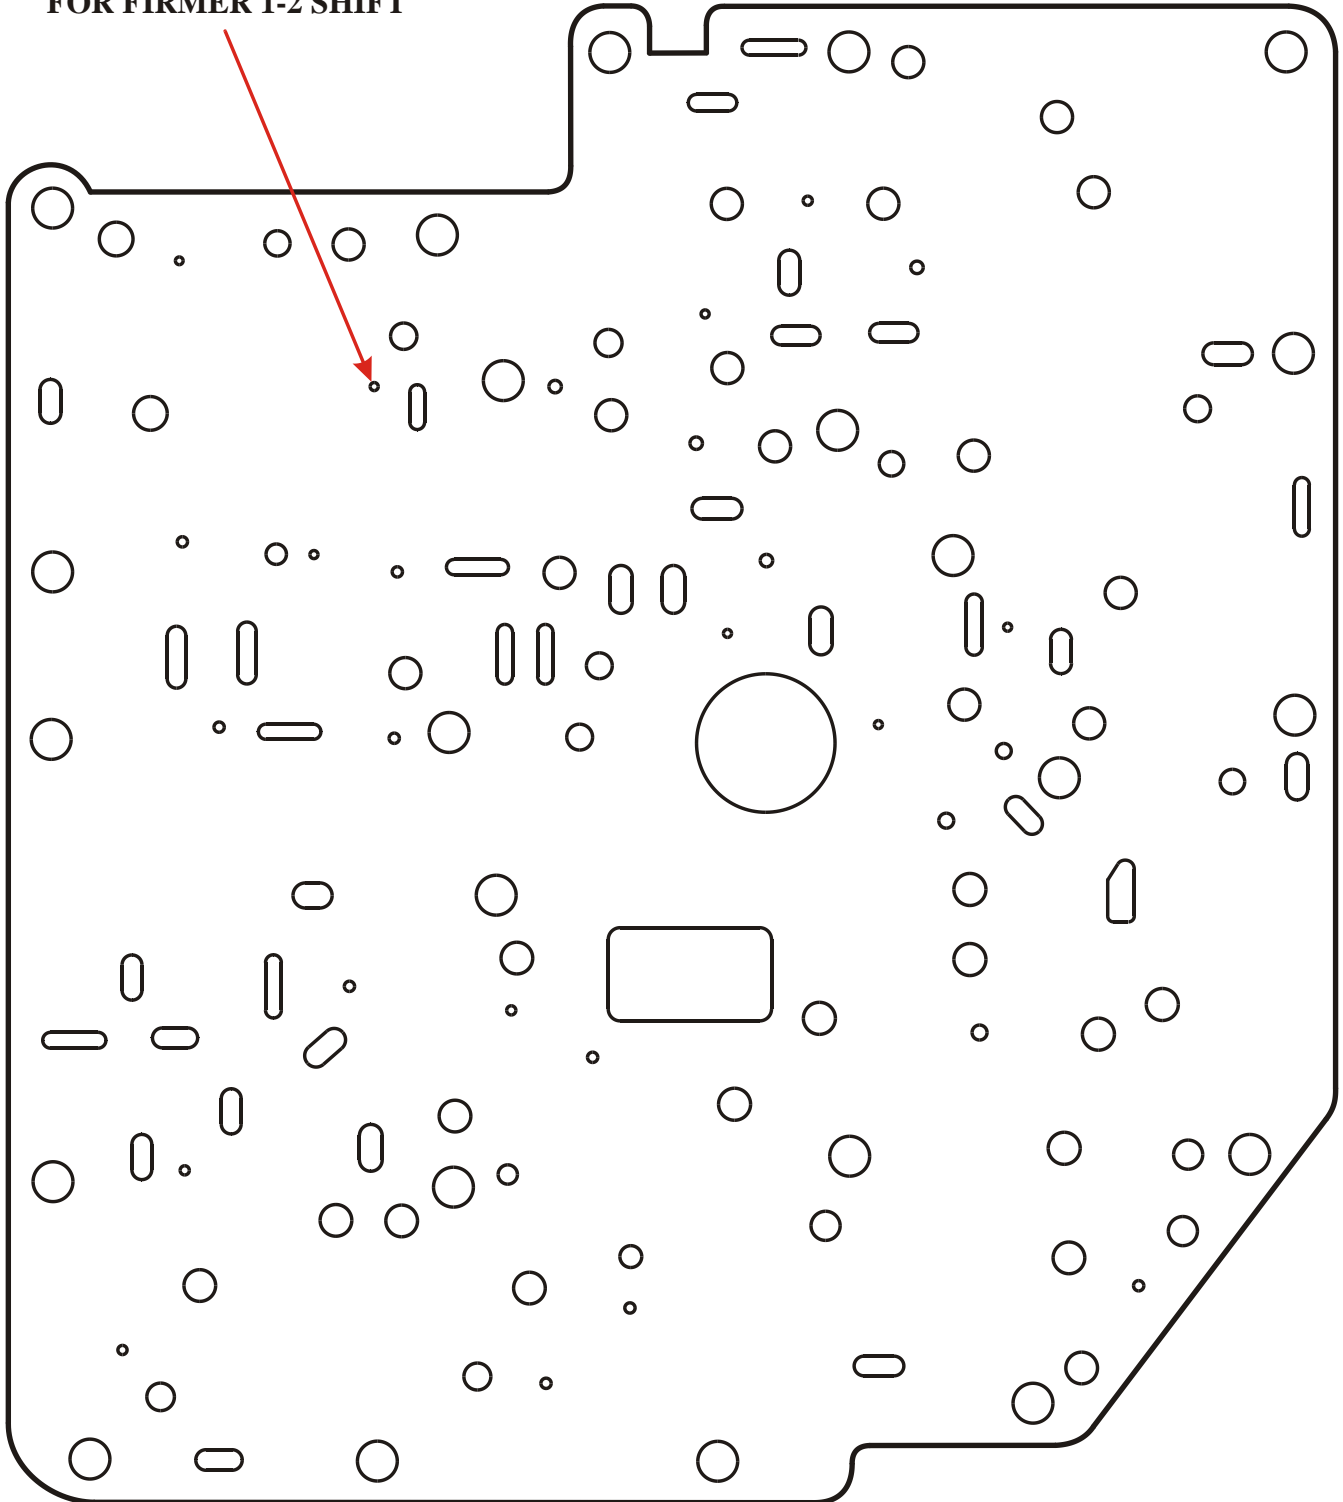
Figure 1

- COMPLAINT:** Before and/or after rebuild, the vehicle exhibits a soft 1-2 upshift, on Ford vehicles equipped with the AX4N transaxle.
- CAUSE:** The cause may be, not enough volume of oil being fed to the intermediate clutch pack.
- CORRECTION:** Drill the intermediate clutch feed hole in the valve body spacer plate out to .075"-.093" as shown in Figure 1. The size of the hole determines the quality of the shift, the larger the hole, the firmer the shift will be.

FORD "AX4N" VALVE BODY SPACER PLATE

**DRILL THIS HOLE
OUT TO .075"-.093"
FOR FIRMER 1-2 SHIFT**
