Technical Service Information

THM 440-T4 DELAYED ENGAGEMENT COLD ONLY

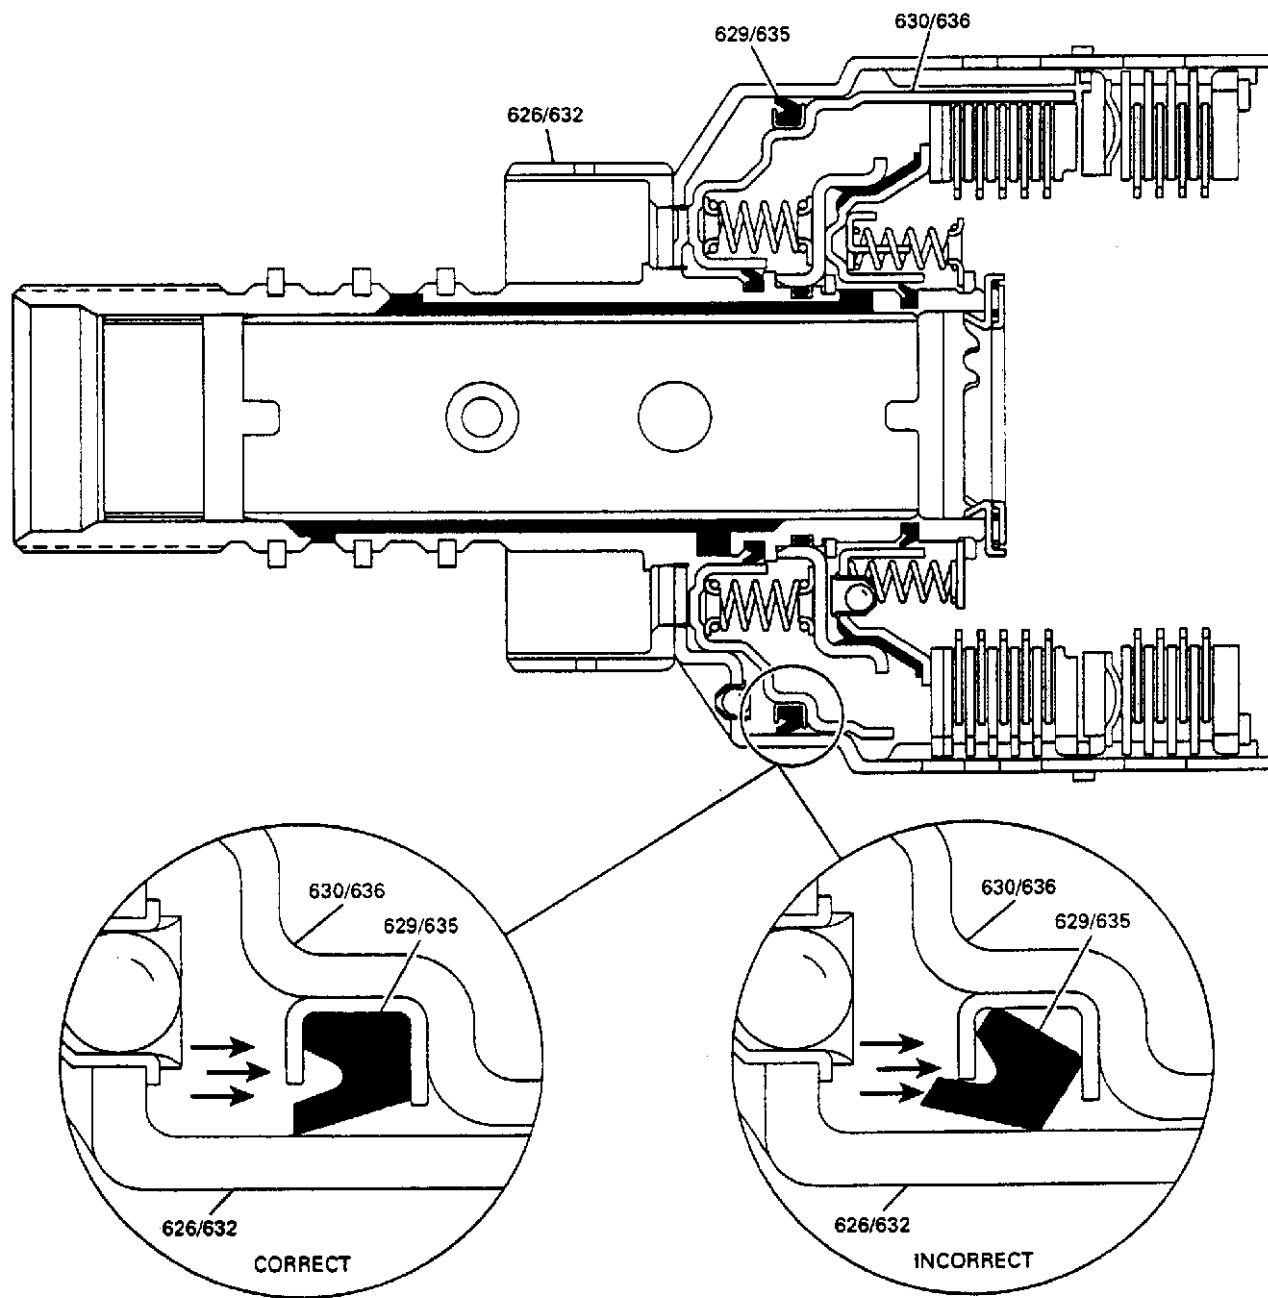
Figure 2

CAUSE: The cause may be a rolled or cut input clutch piston outer lip seal (See Figure 2). Caution, the seal may roll back into the proper position during disassembly.

CORRECTION: Replace the input clutch piston outer lip seal. Inspect the input clutch piston seal groove, and the input clutch housing for any damage and replace as necessary.
