Technical Service Information

FORD/MAZDA F4A-EL / F4EAT UPSHIFTS 1-3 IN DRIVE

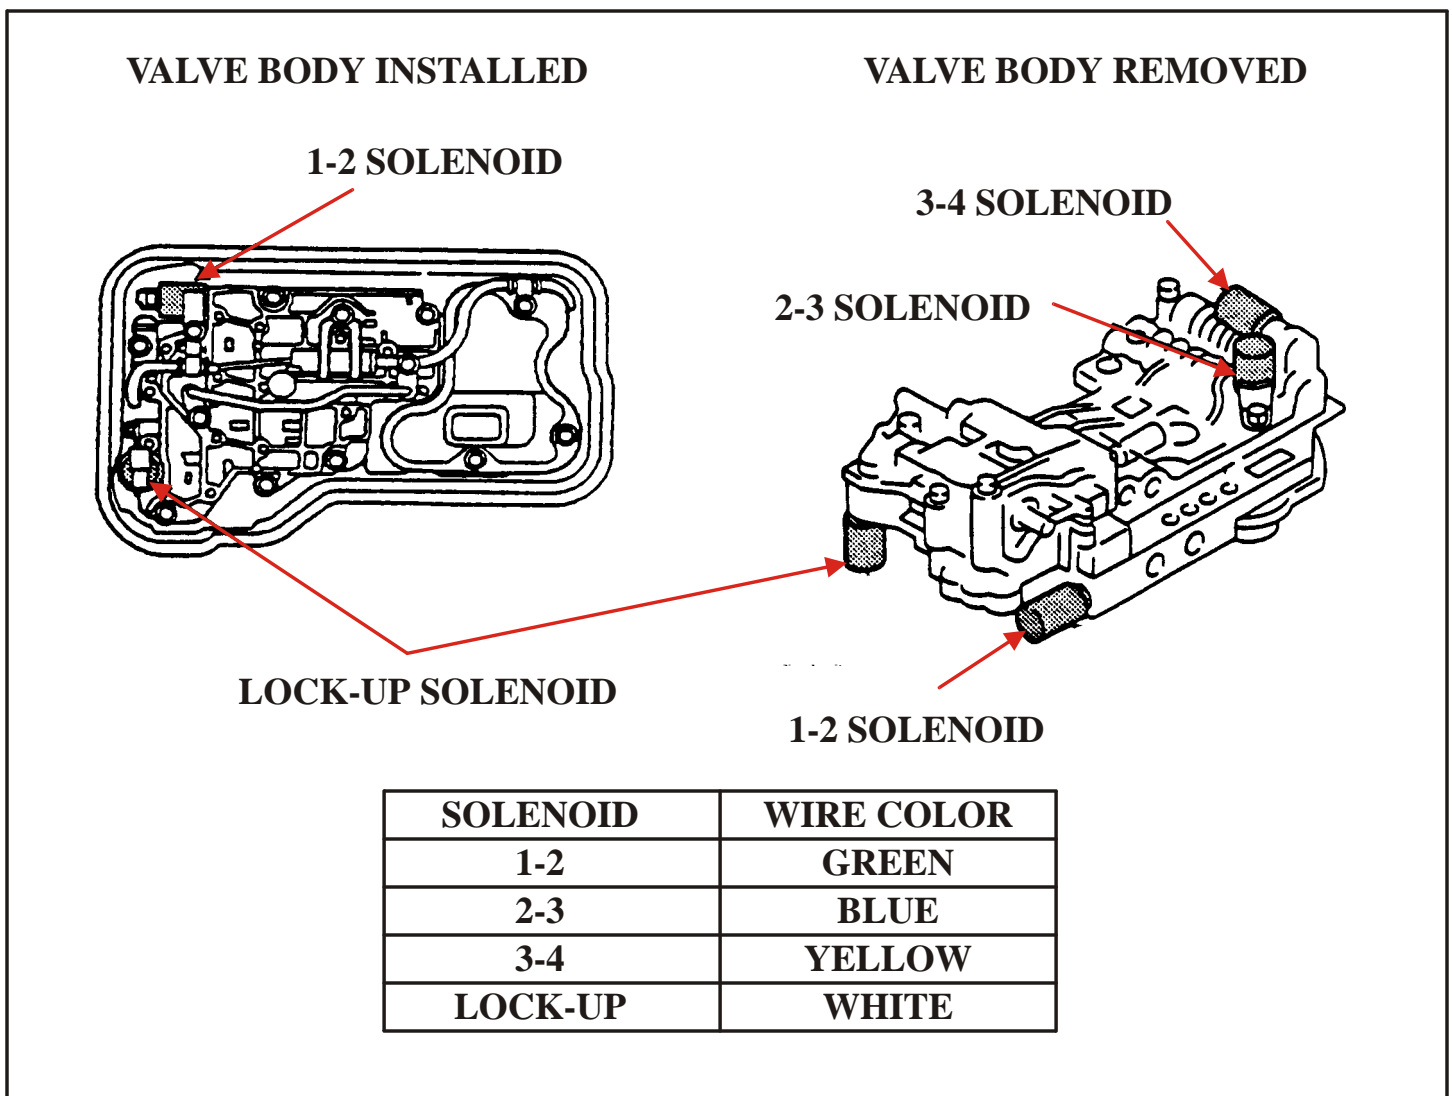
COMPLAINT: Vehicles equipped with F4A-EL or F4EAT exhibit, what seems like, a 1-3 upshift in the “Overdrive” or “Drive ranges after overhaul.

CAUSE: The cause may be, the 1-2 shift solenoid wire was placed into the Lock-up Solenoid and the Lockup Solenoid wire was placed into the 1-2 Shift Solenoid. When the solenoids are connected backwards it produces a 1 -Lockup-3 upshift.

CORRECTION: Refer to the color code and solenoid application chart in Figure 1 to correctly identify and connect each solenoid.
