Technical Service Information

THM 440-T4 HARSH 1-2 UPSHIFT ONLY

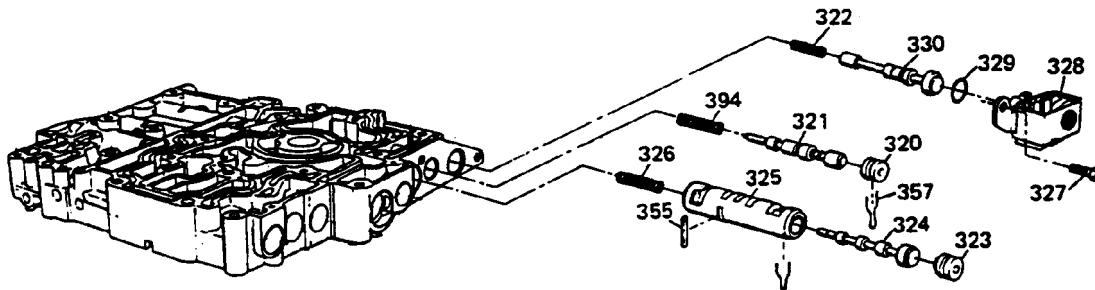
Figure 1

- COMPLAINT:** Some 1990 - 1991 model THM 4T60 (440-T4) transaxles may exhibit an extremely harsh 1-2 shift, while all other shifts are normal.
- CAUSE:** The cause may be the roller pin (355) missing from the 1-2 accumulator valve line-up in the valve body, allowing the bushing to rotate in its bore. Refer to Figure 1.
- CORRECTION:** Remove the TCC solenoid, rotate the bushing back to its proper position, and install a new roll pin. Refer to Figure 1.
