Technical Service Information

BMW ZF-5HP-18 **"BIND-UP" WITH SELECTOR IN** **MANUAL "2" POSITION, 1st GEAR**

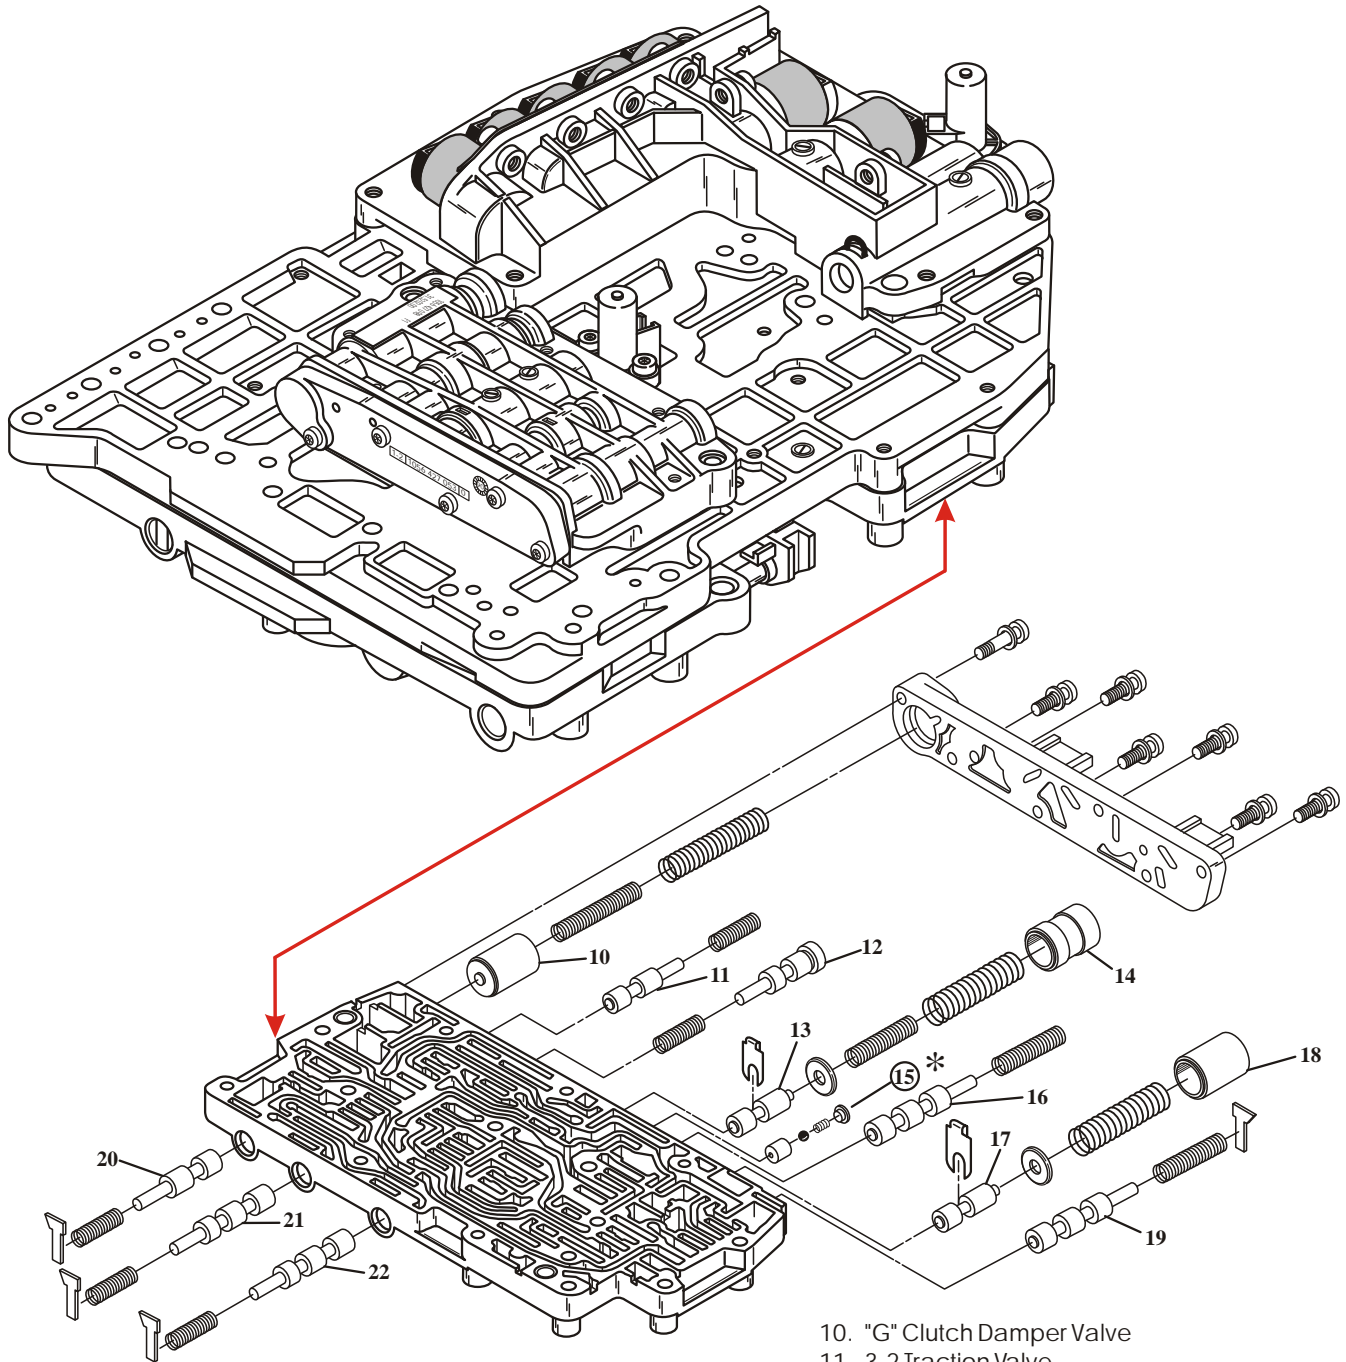
Figure 2

CAUSE: The cause may be, the plastic "D" Clutch One-way Check Valve assembly located in the Lower Rear valve body, shown in Figure 2, may be broken allowing the "B" Clutch (Reverse Input Clutch) to be on while the "D" Clutch (Low/Reverse Clutch) is on in 1st gear.
