Technical Service Information

THM 3T40 (125C) CONVERTER CLUTCH SHUDDER 1987 OR LATER ONLY

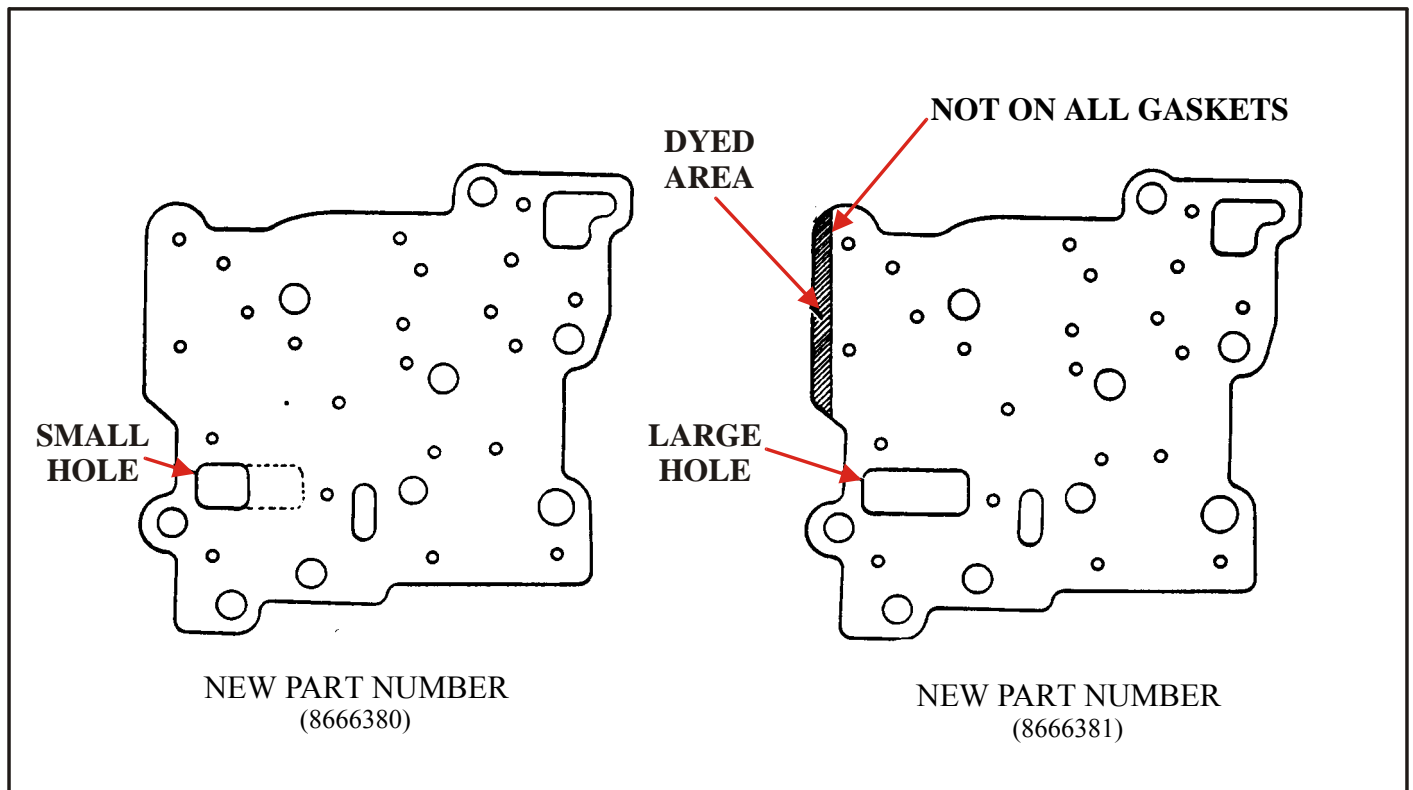
Figure 1

COMPLAINT: Converter clutch apply shudder, only on 1987 or late THM 125C (3T40) Transaxles.

CAUSE: Not enough converter clutch apply oil.

CORRECTION: Install the 1988 (KDC) auxilliary valve body gasket with the large hole (See Figure 1), or modify the 1987 gasket with the small hole, by cutting on the dotted line (See Figure 1).
