Technical Service Information

5R55W/S

WATER IN THE TRANSMISSION

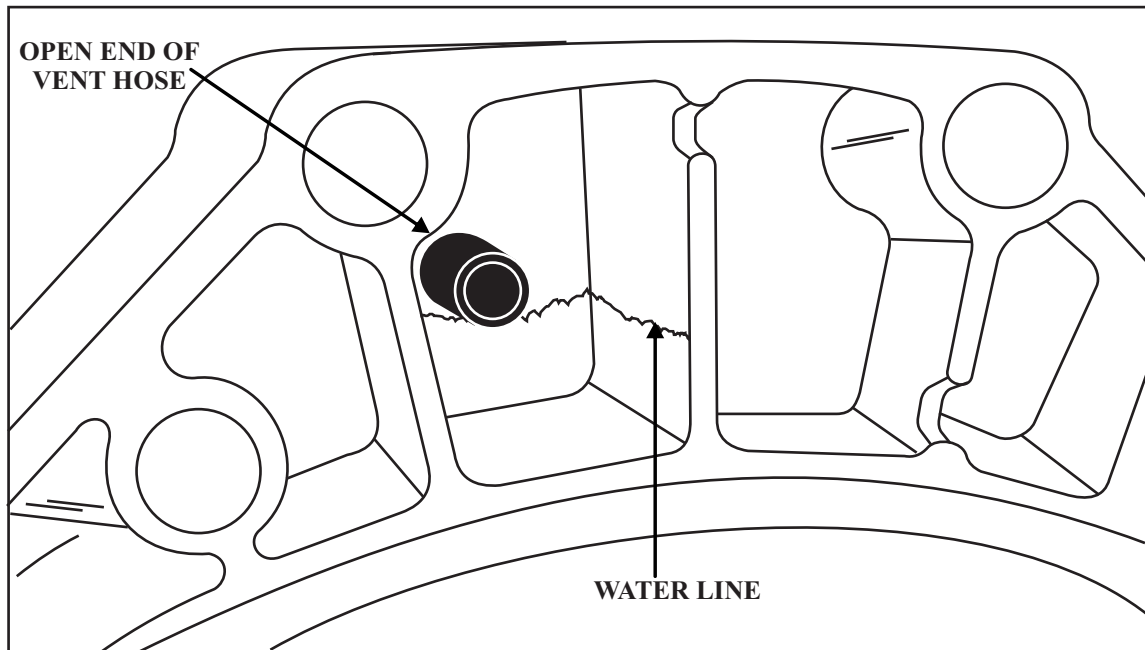
CAUSE: The transmission vent hose is routed to the upper front of the bellhousing where it exits into a casting pocket of the case.
Directly above this area is an AC pipe which is constantly dripping condensate onto the top front of the bellhousing. This water fills up the cavity in the case where the open end of the vent hose is located and water pours into the vent line which allows this water from the AC pipe to get into the transmission. In Figure 1 the water line can be seen in the vent hose pocket from the accumulation of water from the AC line.
The water runs down the back of the engine turning all in it's path to rust as seen in Figure 2.

CORRECTION: In order to prevent this from happening again, a good fix would be to cut the vent hose just behind the bellhousing and install an extra length of hose and a plastic vent cap into the end of the hose to relocate it out of harms way preferably far away from the exhaust system as shown in Figures 3 and 4.
