# Technical Service Information

## FORD CD4E PREMATURE BUSHING FAILURE AND/OR NO FORWARD OR REVERSE

**COMPLAINT:** Before or after overhaul, vehicles equipped with CD4E transaxles may exhibit premature Reverse Input Clutch Housing bushing failure, repeated Forward Clutch snap ring groove blow out or breakage of the Low Reverse Clutch snap ring lugs located in the case.

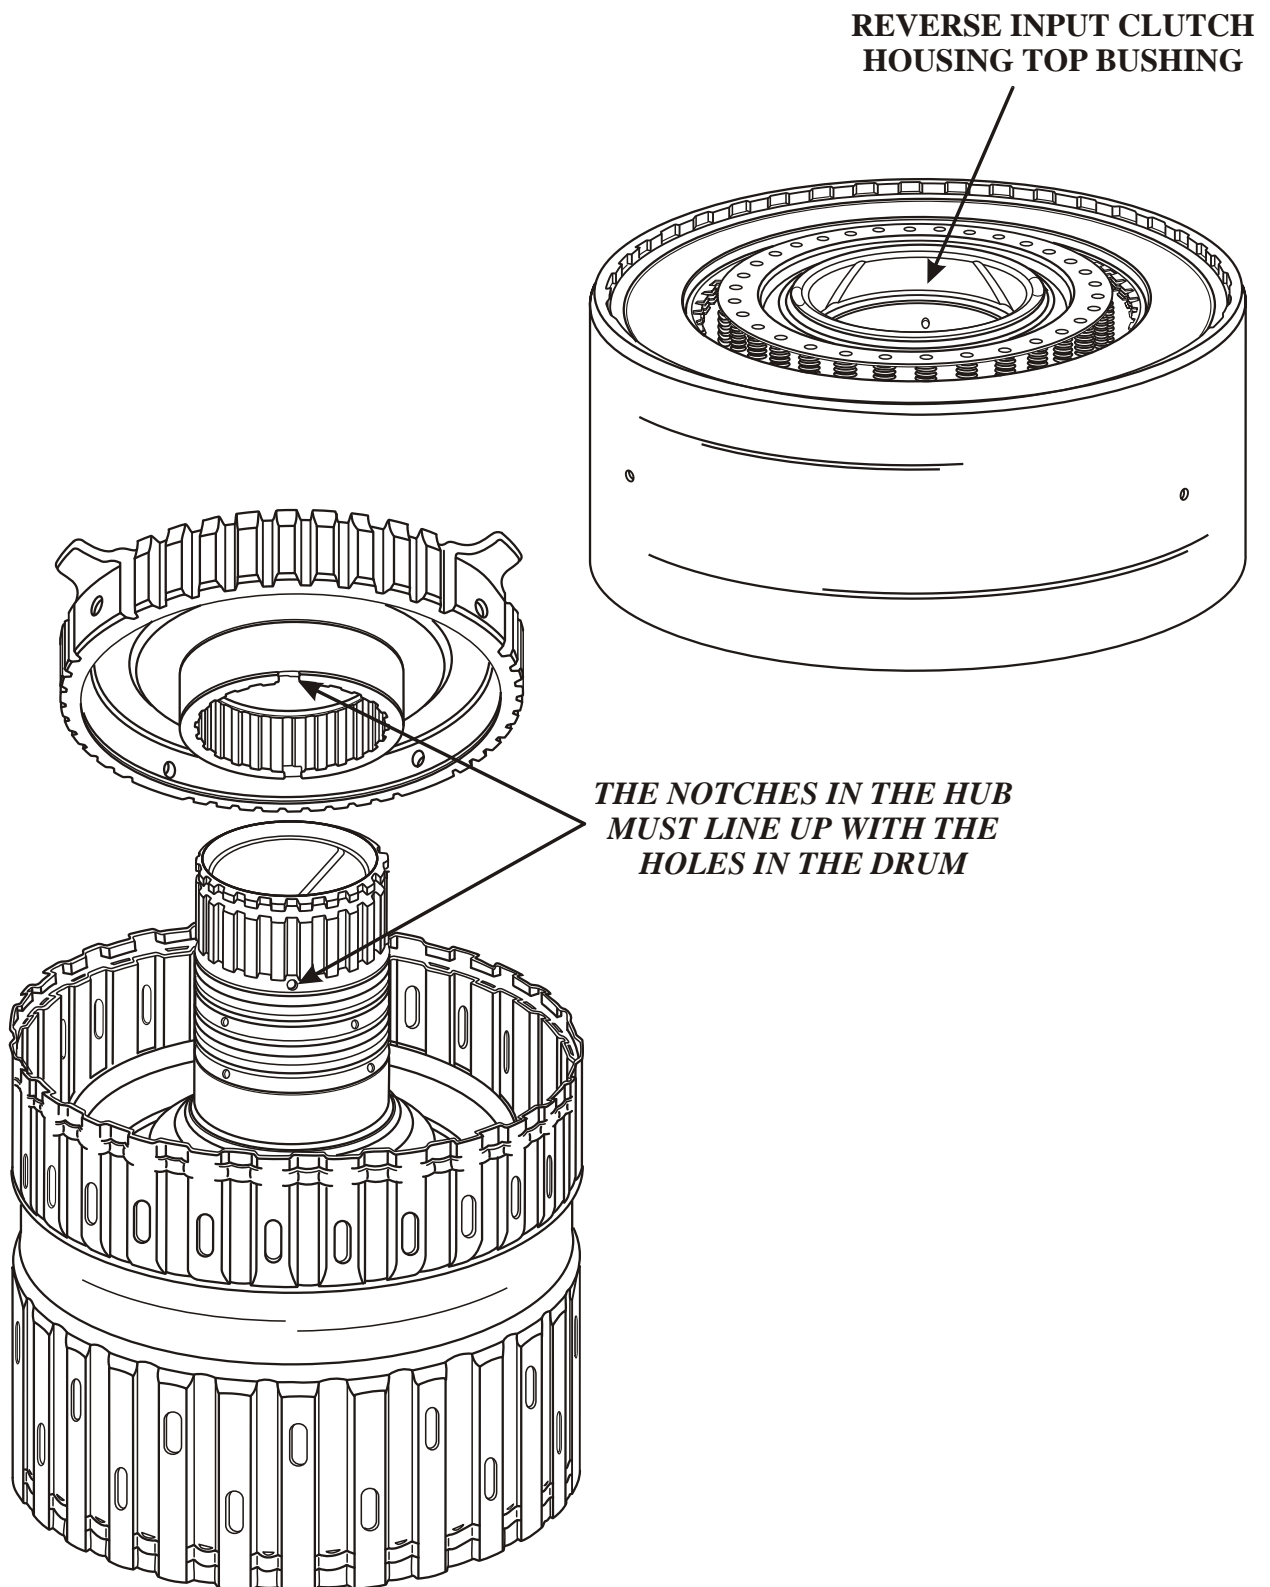
- A. Mis-alignment of the Reverse Input Clutch Hub to the Forward/Coast/Direct drum splines, as shown in Figure 1. When this mis-alignment occurs the lube holes in the drum and the slots in the hub are not lined up causing a loss of lube to the bushing.

- A. Refer to Figure 1 for the correct alignment of the Reverse Input Clutch Hub and Forward/Coast/Direct drum splines.
- B. Check and clean main ground cables from the battery to the engine block. Add an extra ground strap from the firewall to the bellhousing of the transmission.

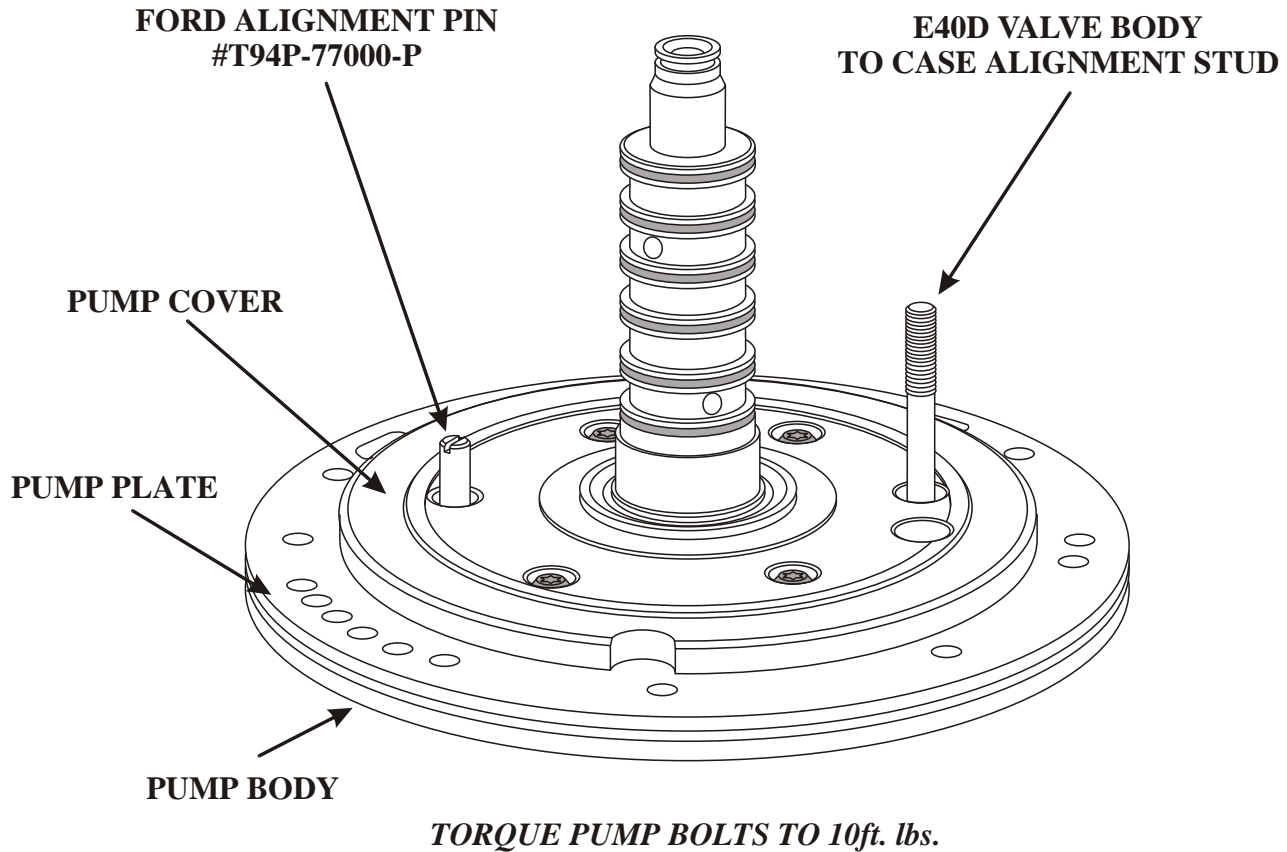
Figure 2

- C. A mis-aligned pump cover to pump body causing the drum to be off center.
- D. A worn Pressure Regulator Bore in the valve body, as shown in Figure 3, causing line pressure to be over the maximum amount which in turn causes convertor charge and cooler pressure to be minimal.

- C. Align the pump cover, plate and pump body with pump alignment pins to ensure perfect alignment. The Ford pins are part no. T94P-77000-P or use 2 E40D valve body to case alignment studs as shown in Figure 2.

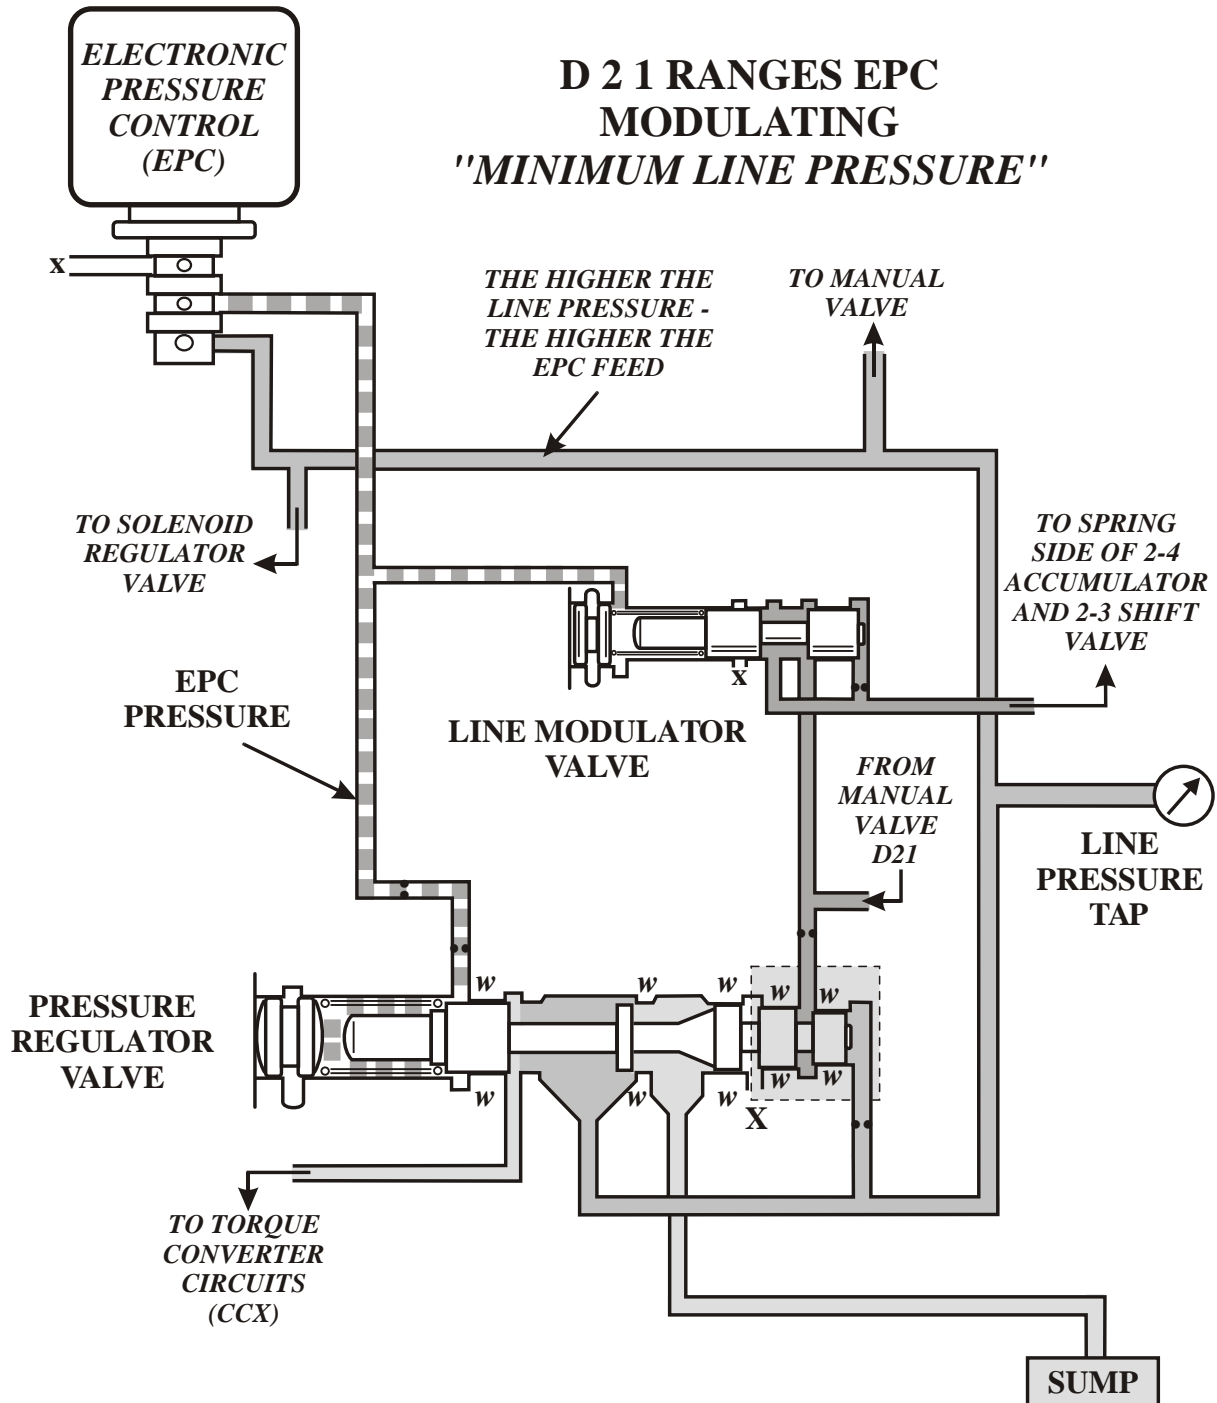
Figure 3

- A. A worn Pressure Regulator Bore in the valve body, as shown in Figure 3, causing line pressure to be in excess of 500psi. which in turn breaks parts!

- D. Refer to Figures 5 and 6 to check for bore wear. Remove the Pressure Regulator valve and inspect it for wear which normally shows up as brown lines. Re-install the Pressure Regulator valve back into its bore and check for wobble from side to side. Fill the cavity shown in Figure 6 with ATF. Place a suitable block over the passage shown in Figure 6 and torque the hold down bolt too 8ft. lbs. Apply 70psi. of air pressure to the hole in the block so the cavity is full and ensure there is no leakage between the block and the valve body. There should be no leakage between the first land of the Pressure Regulator Valve and the wall shown in Figure 6 for approximately 25-30 seconds. A new valve body will hold air pressure for 45-50 seconds. If the valve body in question leaks at 25 seconds or less, the bore is worn and the valve body will require replacement or Sonnax part no. 73840-RK regulating valve kit installed. **Note: requires reamer Sonnax part no. 73840-RTL.**

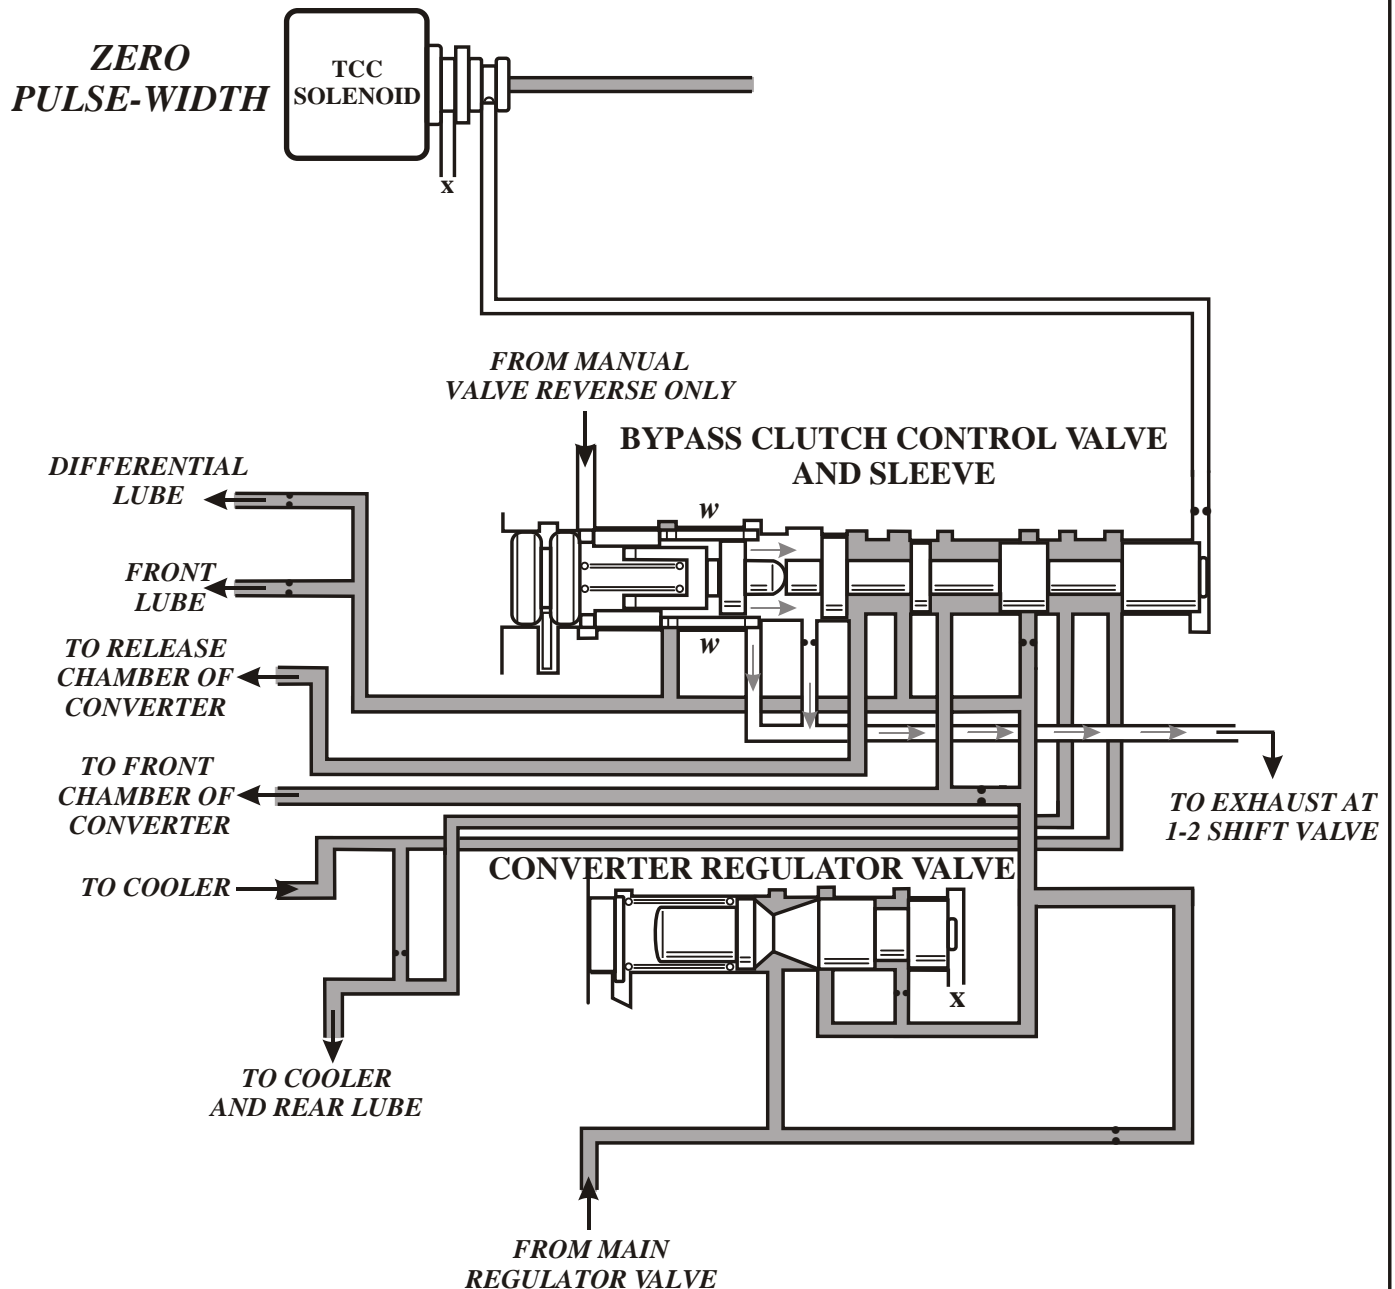
- E. A worn Bypass Clutch Control Valve sleeve, as shown in Figure 4, causing a loss of convertor regulator valve oil feeding front and differential lube.

*w = Wear areas in the sleeve bore*

*Wear in the areas of the sleeve can cause a loss of convertor regulator oil feeding front and differential lube*

- E. Remove and inspect the Bypass Clutch Control Valve Sleeve as shown in Figure 5. If the sleeve is worn the valve body will require replacement as the sleeve is not available from Ford separately, or Sonnax Part no. 73840-BK Bypass Clutch Control Valve Kit installed to renew the sleeve and valve bore. **Note: Requires Sonnax 73840-BTL reamer.**

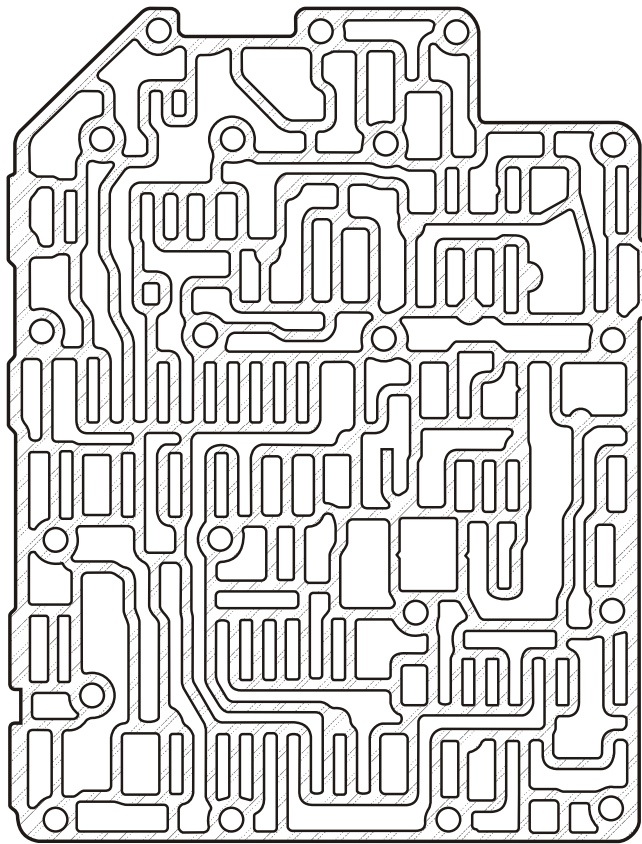
Figure 5

*CHECK THE INSIDE OF SLEEVE  
FOR SHINY AREAS*

*CHECK THE SIDES OF THE VALVE FOR  
BROWN LINES OR SHINY AREAS*

- A. Refer to Figures 5 and 6 to check for bore wear. Remove the Pressure Regulator valve and inspect it for wear which normally shows up as brown lines. Re-install the Pressure Regulator valve back into its bore and check for wobble from side to side. Fill the cavity shown in Figure 6 with ATF. Place a suitable block over the passage shown in Figure 6 and torque the hold down bolt too 8ft. lbs. Apply 70psi. of air pressure to the hole in the block so the cavity is full and ensure there is no leakage between the block and the valve body. There should be no leakage between the first land of the Pressure Regulator Valve and the wall shown in Figure 6 for approximately 25-30 seconds. A new valve body will hold air pressure for 45-50 seconds. If the valve body in question leaks at 25 seconds or less, the bore is worn and the valve body will require replacement or Sonnax part no. 73840-RK regulating valve kit installed. **Note: requires reamer Sonnax part no. 73840-RTL.**

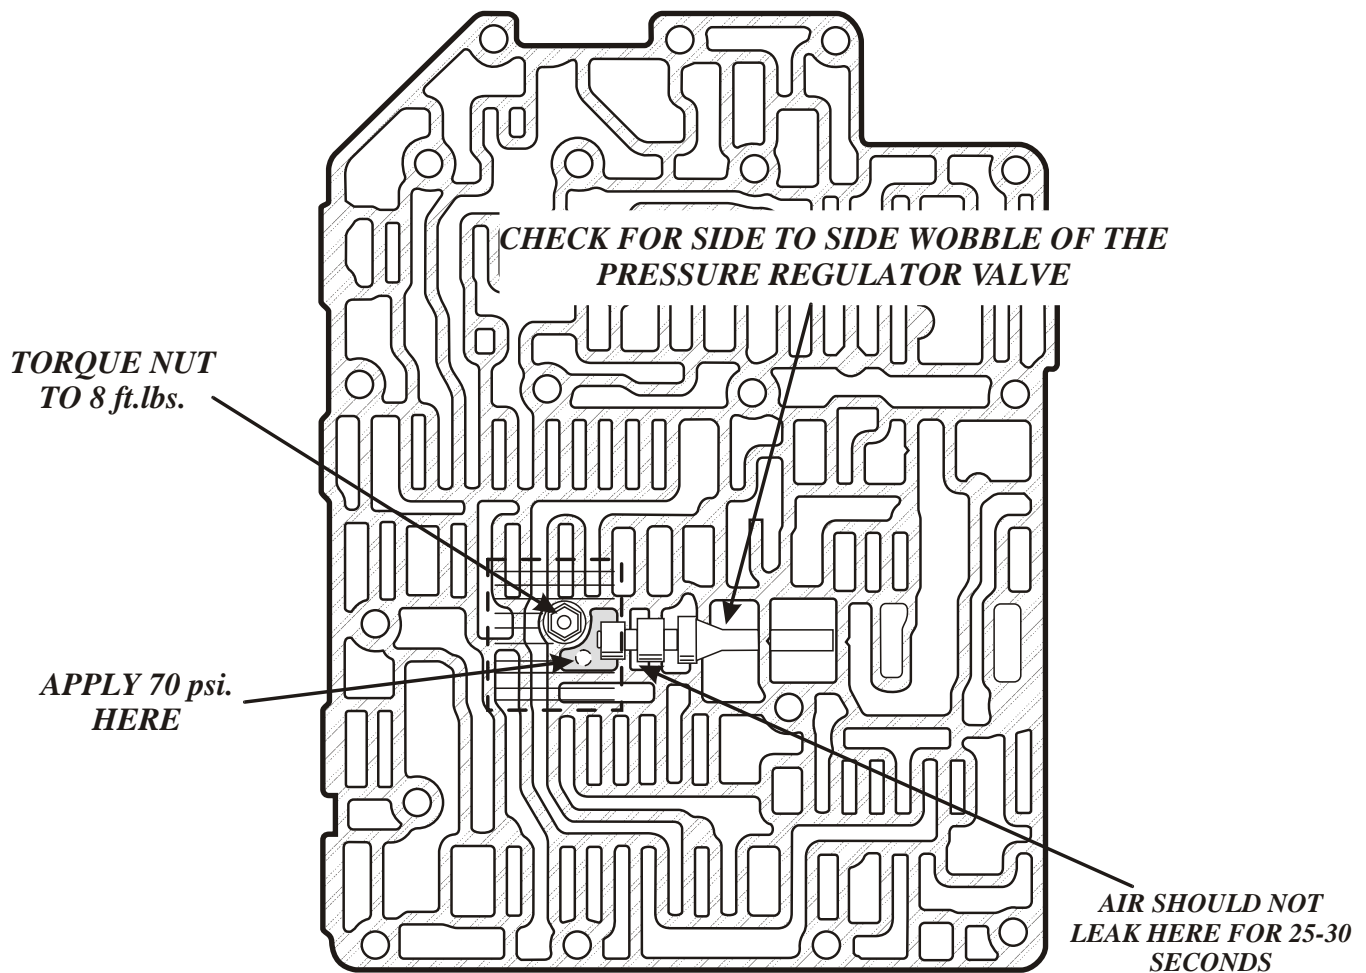
Figure 6

**FILL THE AREA HIGHLIGHTED IN GREY WITH ATF AND COVER WITH A SUITABLE PLATE AS OUTLINED WITH THE DOTTED LINE**

**APPLY 70 psi. OF AIR PRESSURE TO THE DOTTED HOLE IN THE PLATE. THE VALVE BODY BORE SHOULD HOLD THIS AIR PRESSURE FOR APPROXIMATELY 25-30 SECONDS OR THE BORE IS WORN.**
