Technical Service Information

THM 4T40-E TROUBLE CODE P1887 OR P0742

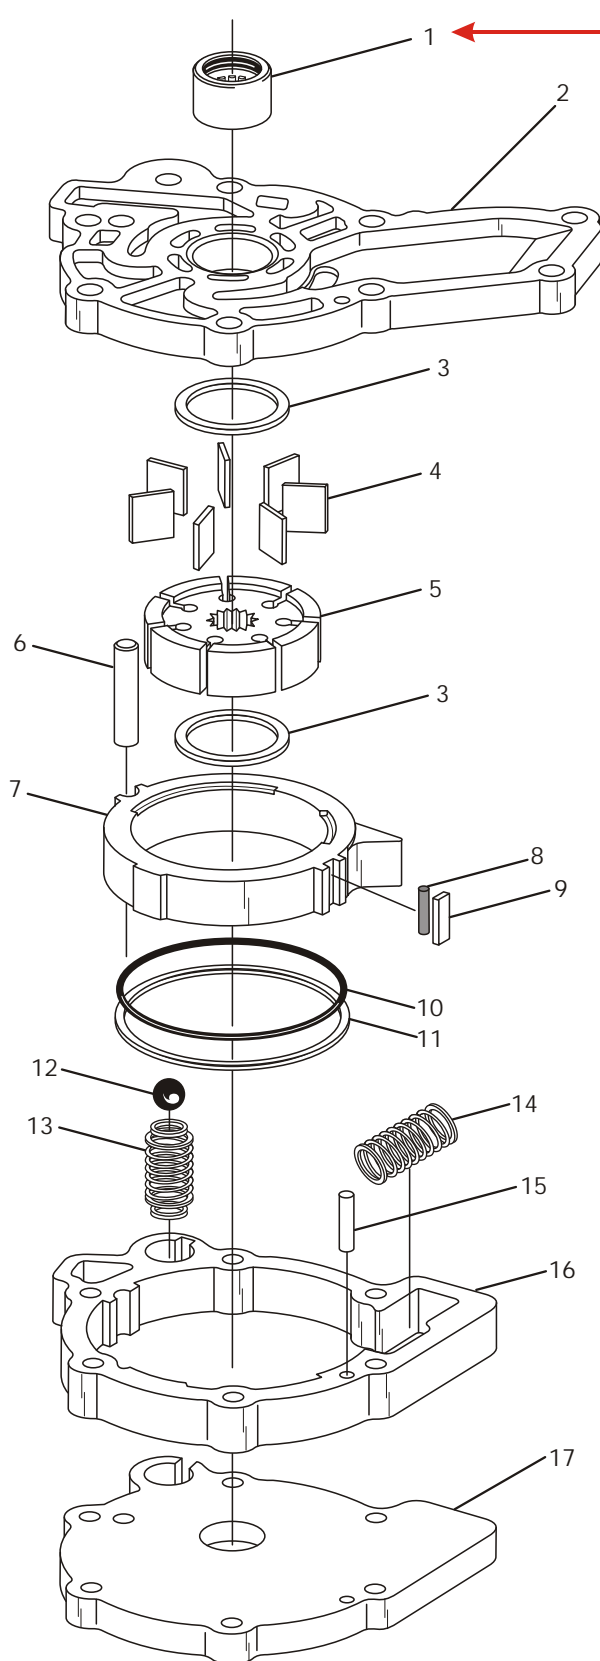
Figure 1

CAUSE: This is usually created by a leak of TCC release oil through the needle bearing and seal assembly located in the oil pump, as shown in Figure 1.

*This Needle Bearing And Seal Assembly
Is Now Available Under
TRANSTAR Part No. 67922B or
SONNAX® Part No. 33000-01*

CORRECTION: This needle bearing and seal assembly is now available under TranStar part number 67922B, which is a 2000 and later AX4N pump bearing and seal assembly. The AX4N bearing is not available from Ford Motor Co. The bearing is also available from Sonnax® under part number 33000-01. In some instances, because of the bearing failure, the entire pump assembly will have to be replaced and is available under OEM part number 24208987.
This Needle Bearing and Seal Assembly has been such a high failure item that ATSG recommends the needle bearing and seal assembly be replaced on every rebuild.
