# Technical Service Information

## **FORD AXOD-E CONVERTER TURBINE SPLINES CHANGE FROM 23 TEETH TO 25 TEETH**

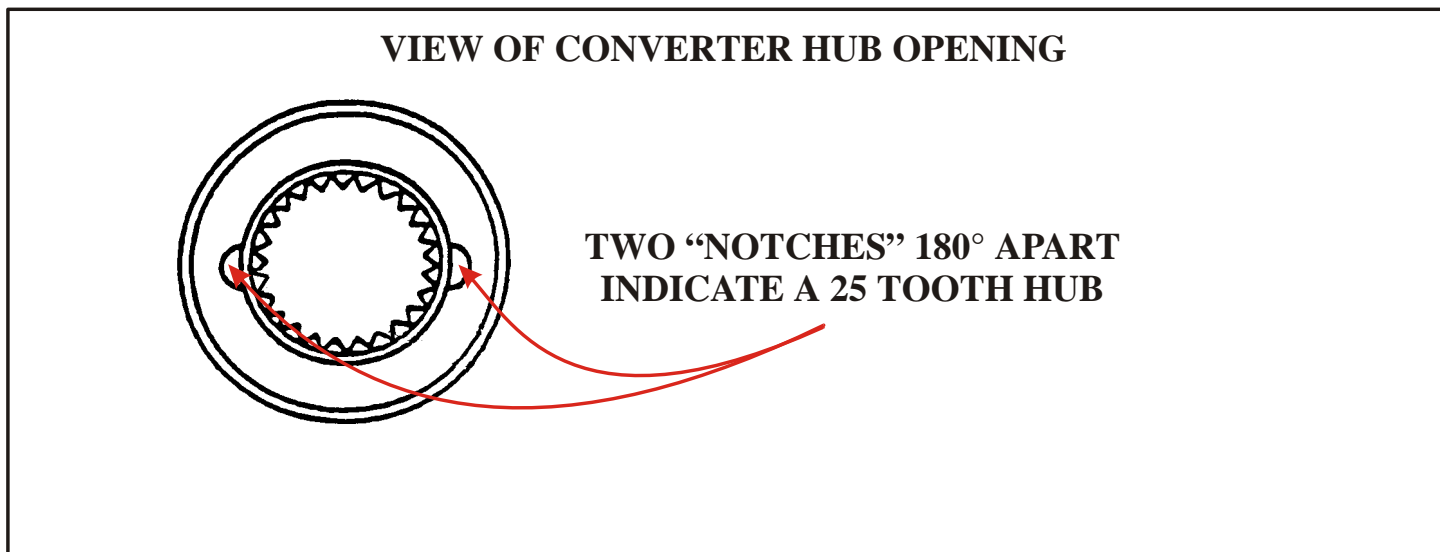
Figure 2

(1) **TORQUE CONVERTER** - Converter turbine hub splines changed from 23 teeth to 25 teeth. To identify this change the converter "Stamp Code" was changed. Refer to the Converter Stamp Code Chart in Figure 1. The 25 tooth converter can also be identified by looking down into the converter hub, as shown in Figure 2, and the converter hub will have two notches outside the spline area, and is very easy to see (See Figure 2).

If replacement of either the torque converter and/or turbine shaft is required, ensure that equal number of splines exist on the mating part.

***IT IS POSSIBLE TO INSTALL A 25 TOOTH CONVERTER ONTO A 23 TOOTH TURBINE SHAFT, IF THIS OCCURS, THE VEHICLE WILL HAVE NO FORWARD OR REVERSE MOVEMENT,***
