# Technical Service Information

## 3L30 (180C TRIMATIC)

### NO TCC APPLICATION

**COMPLAINT:** Diagnosing a “No TCC” condition on a 1989 to 1998 GEO Tracker or Suzuki Sidekick with a 1.6L engine and the 3L30 (180C) due to the complexity of the TCC control system.

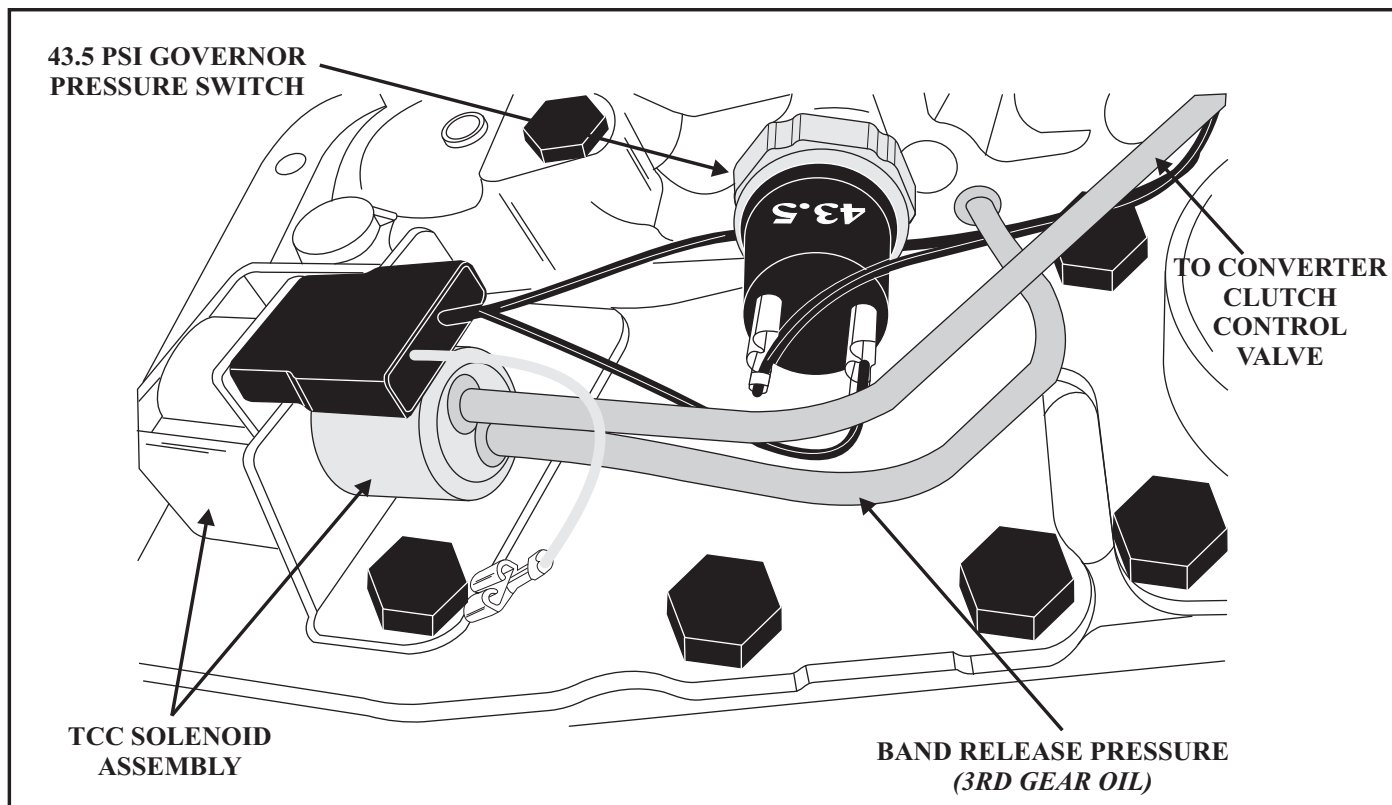
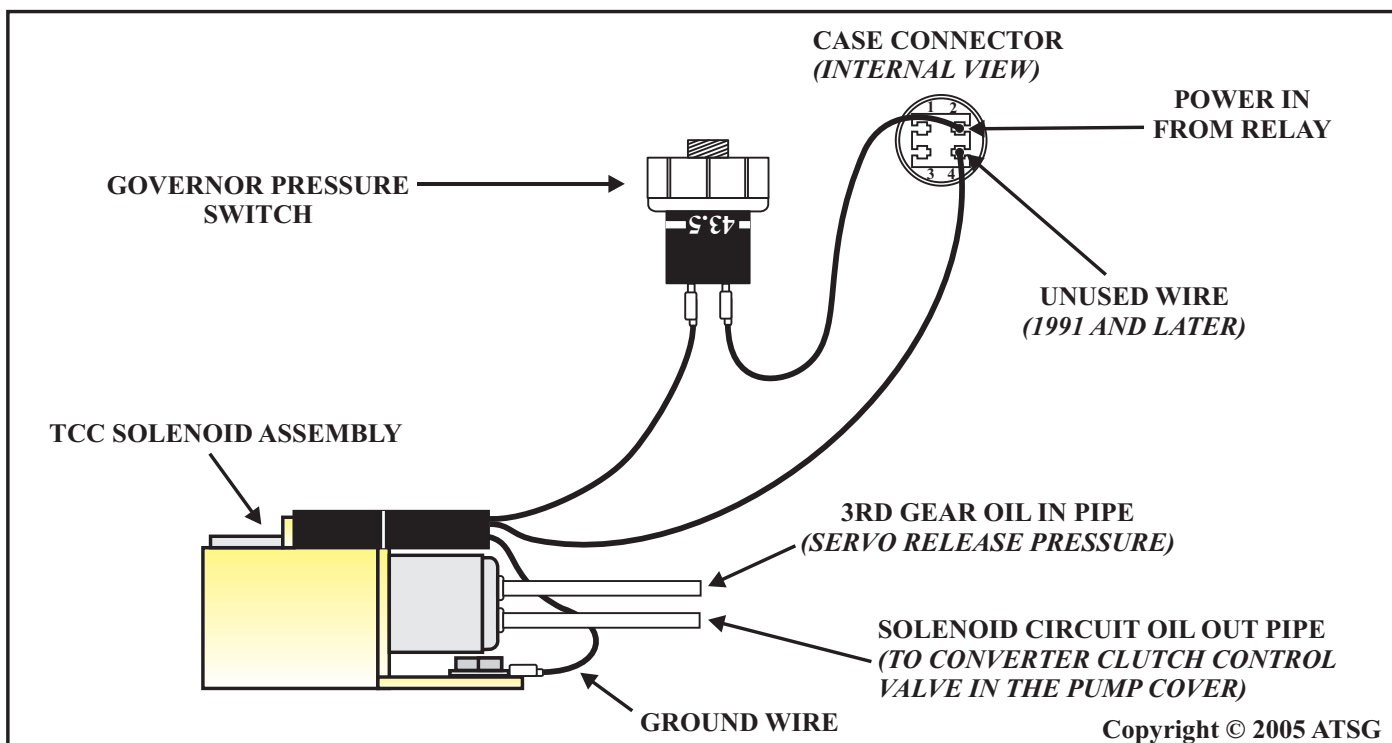
**CORRECTION:** The internal adaptation and description of the components used to control converter clutch apply can be seen in Figures 1 and 2. The bottom pipe coming from the valve body is band release pressure otherwise known as third gear oil. This ensures that the vehicle will never have TCC until 3rd gear. When the solenoid is energized this oil is routed through the upper pipe to the pump cover (Figure 3 and 4) where it strokes the converter clutch control valve into the lock up position.

In addition to the solenoid receiving 3rd gear oil, a governor pressure switch is utilized to time control (*via speed*) a voltage supply to the solenoid. In the example shown in Figures 1 and 2, it can be noticed that the pressure switch is rated to close at 43.5 psi. Also notice that the solenoid is permanently grounded. Putting this together with considering a properly operating system, 3rd gear is typically reached by approximately 35 miles per hour. This means the solenoid will have received 3rd gear oil before governor pressure is high enough to close the switch (*The idea is to prevent a converter clutch apply on top of the 2-3 shift*). Once governor pressure increases enough to close the switch (*40 mph or above*), voltage is supplied to the “already grounded” solenoid. Once energized, third gear oil is allowed to pass through the solenoid and stroke the converter clutch control valve in the pump (See the partial hydraulics in Figures 5 and 6).

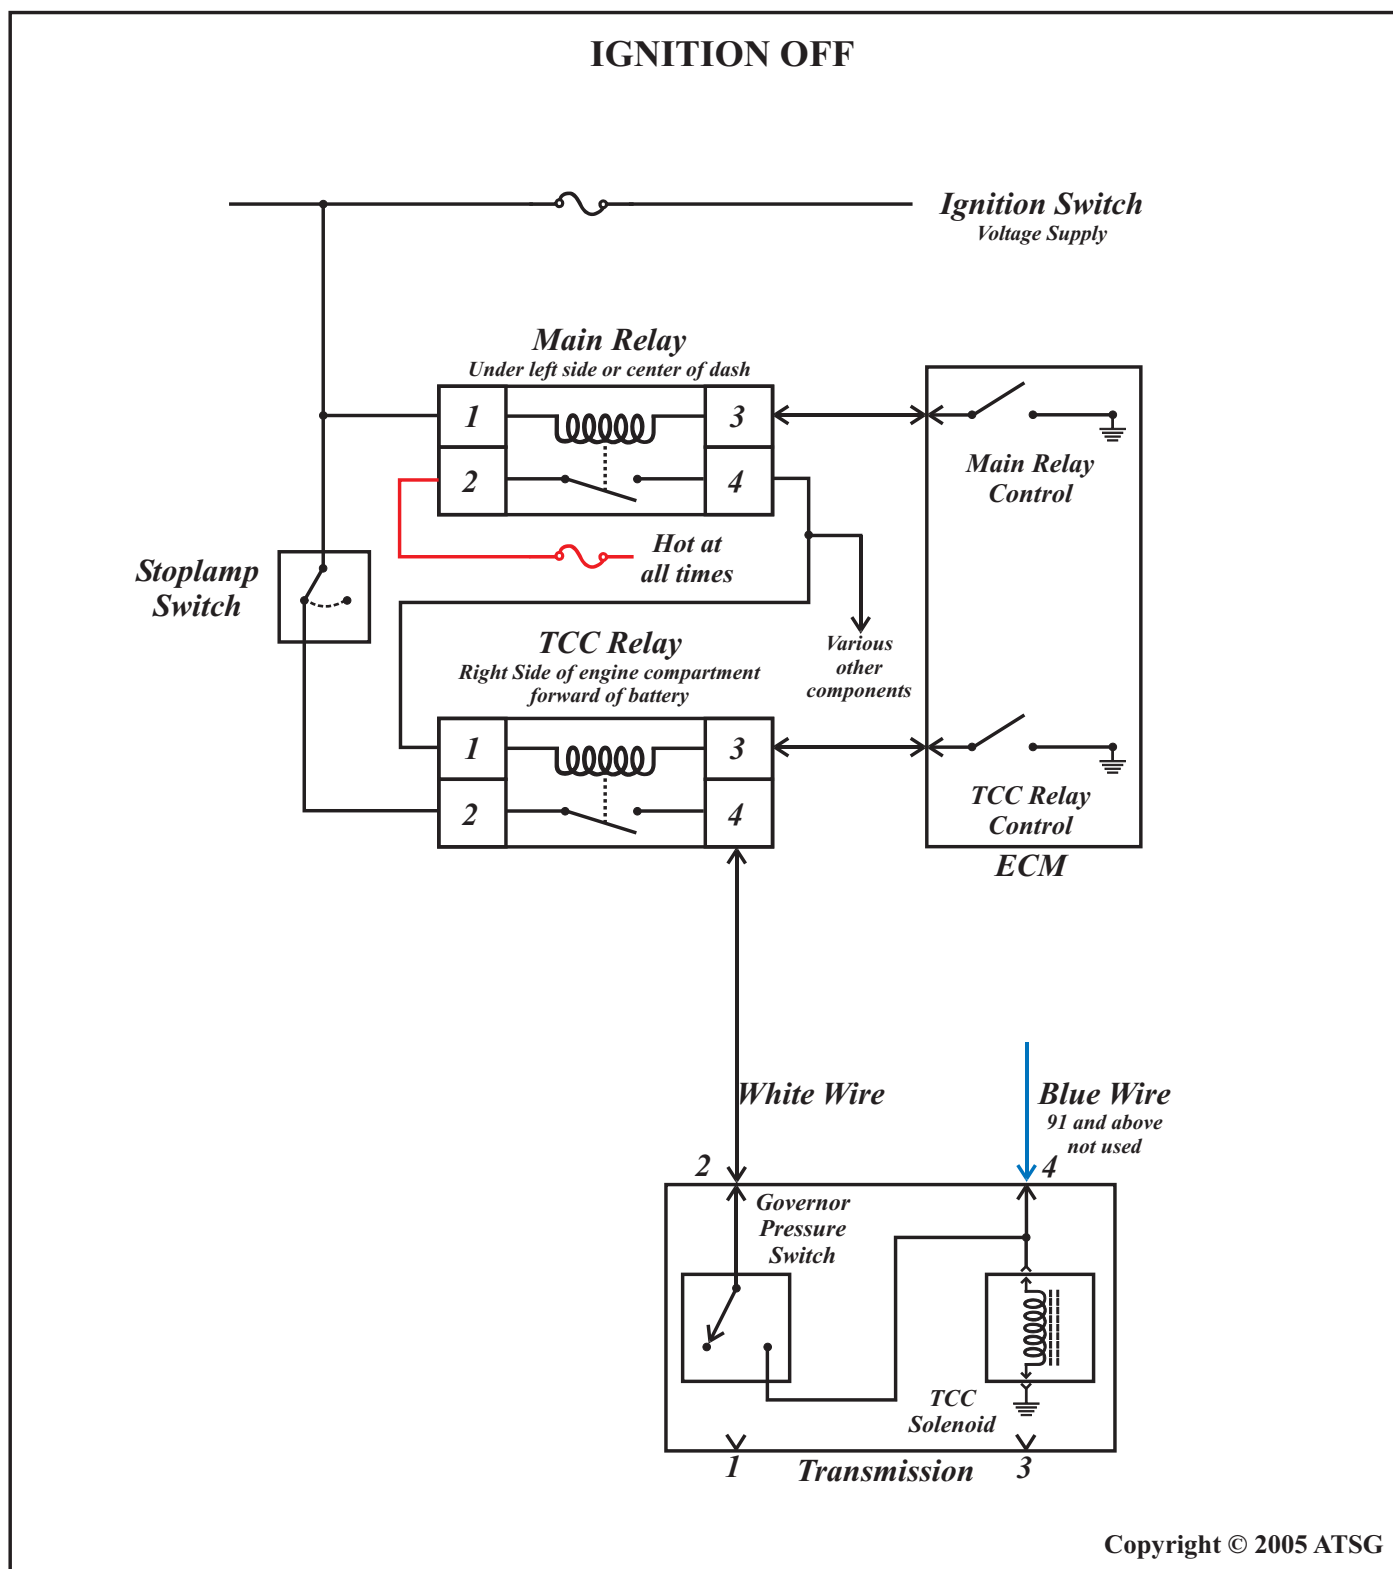
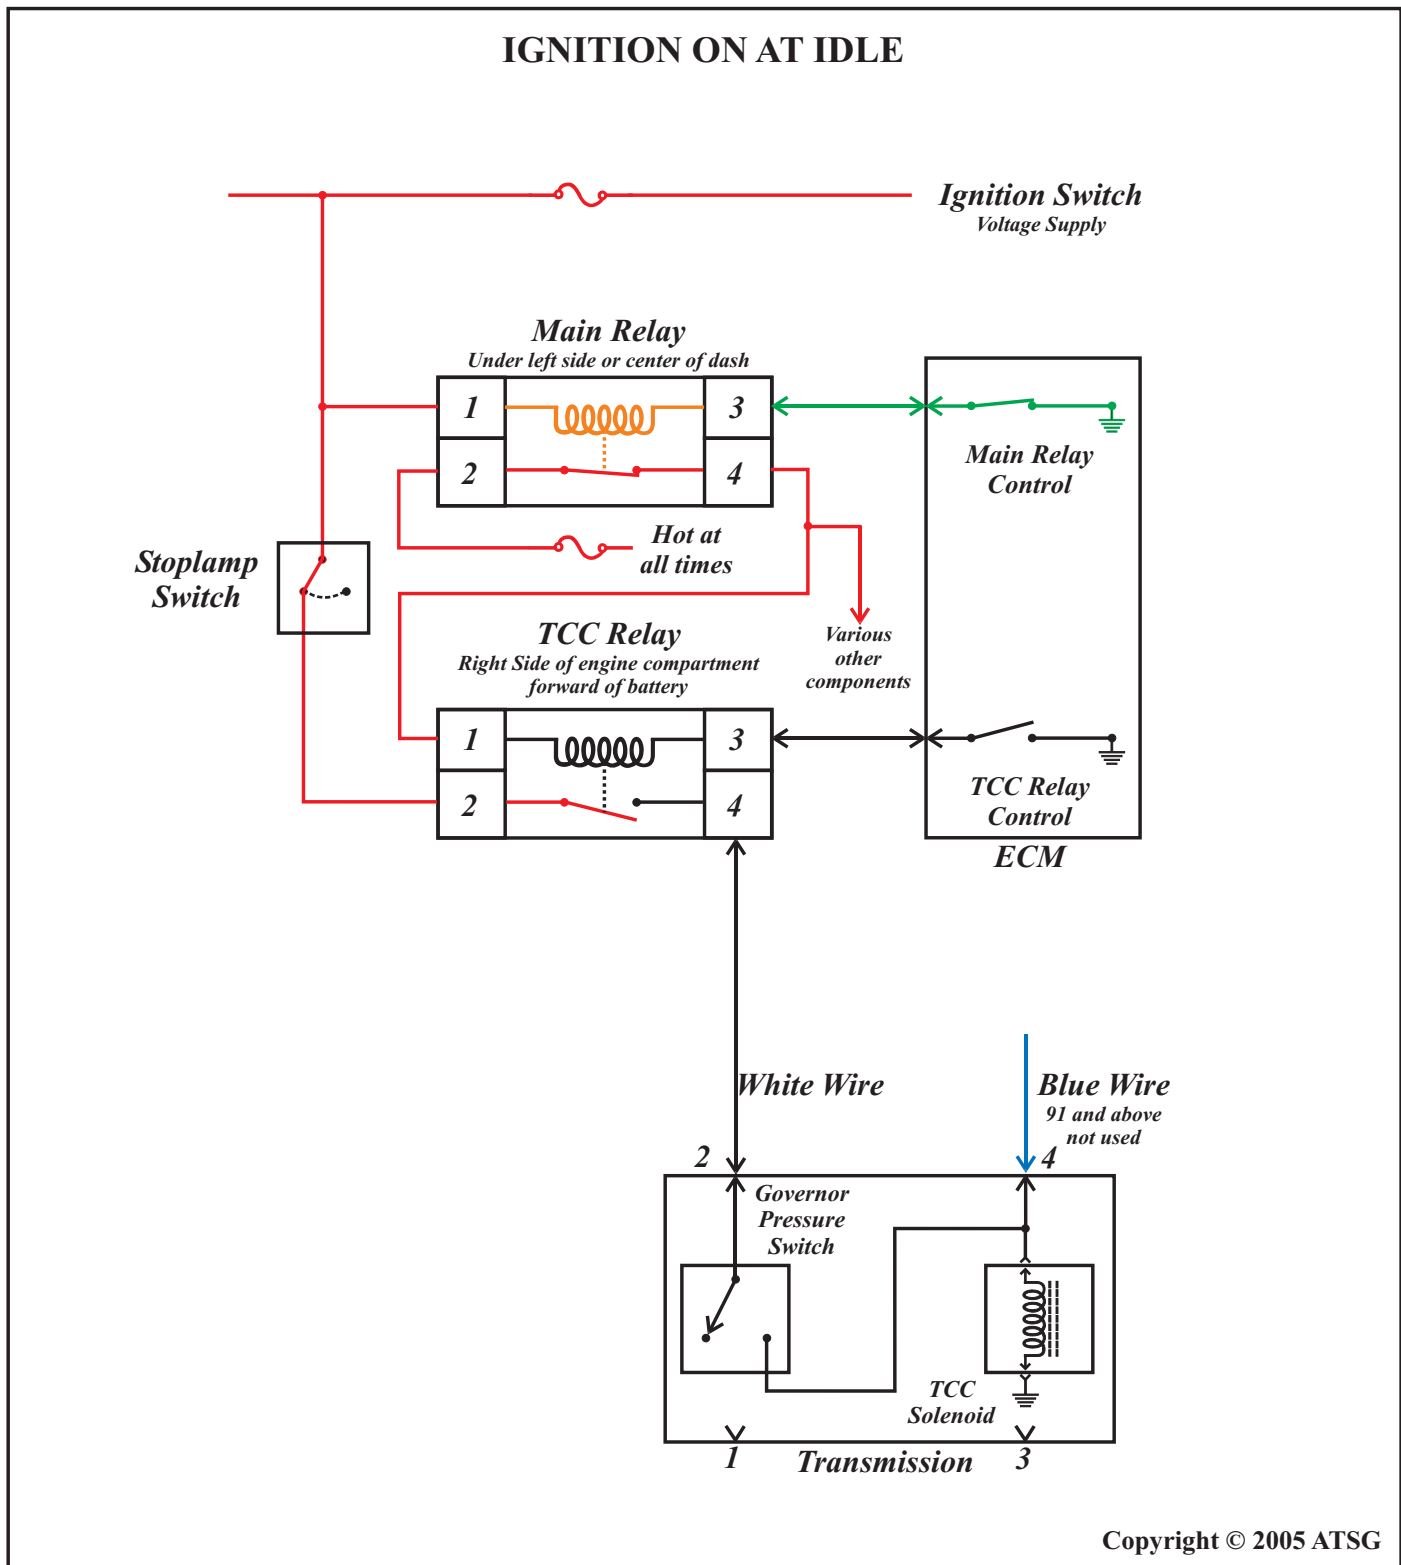
Figures 7 through 10 are typical wiring diagrams which reveal the external electronics controlling the voltage supply to the transmission. Using a 1995 Suzuki Sidekick as an example, the Main Relay can be located under the dash, while the Transmission Relay is located in the right side of the engine compartment forward of the battery as seen in Figure 11. These relay locations are very similar with the GEO Tracker as well as the ECM being located under the dash, high left of the steering column.

The wiring diagrams in Figures 7 through 10 indicate that the voltage supply to the Transmission Relay coil comes from the Main Relay. The ECM will ground the Transmission Relay after the vehicle is at operating temperature and the vehicle is moving. With the Transmission Relay coil energized, power from the Stop Lamp Switch is supplied to the transmission through a White Wire where it waits for the governor pressure switch to close at which time the solenoid becomes energized. It is noted in the wiring schematics that the Blue Wire is not used with 1991 and later vehicles.

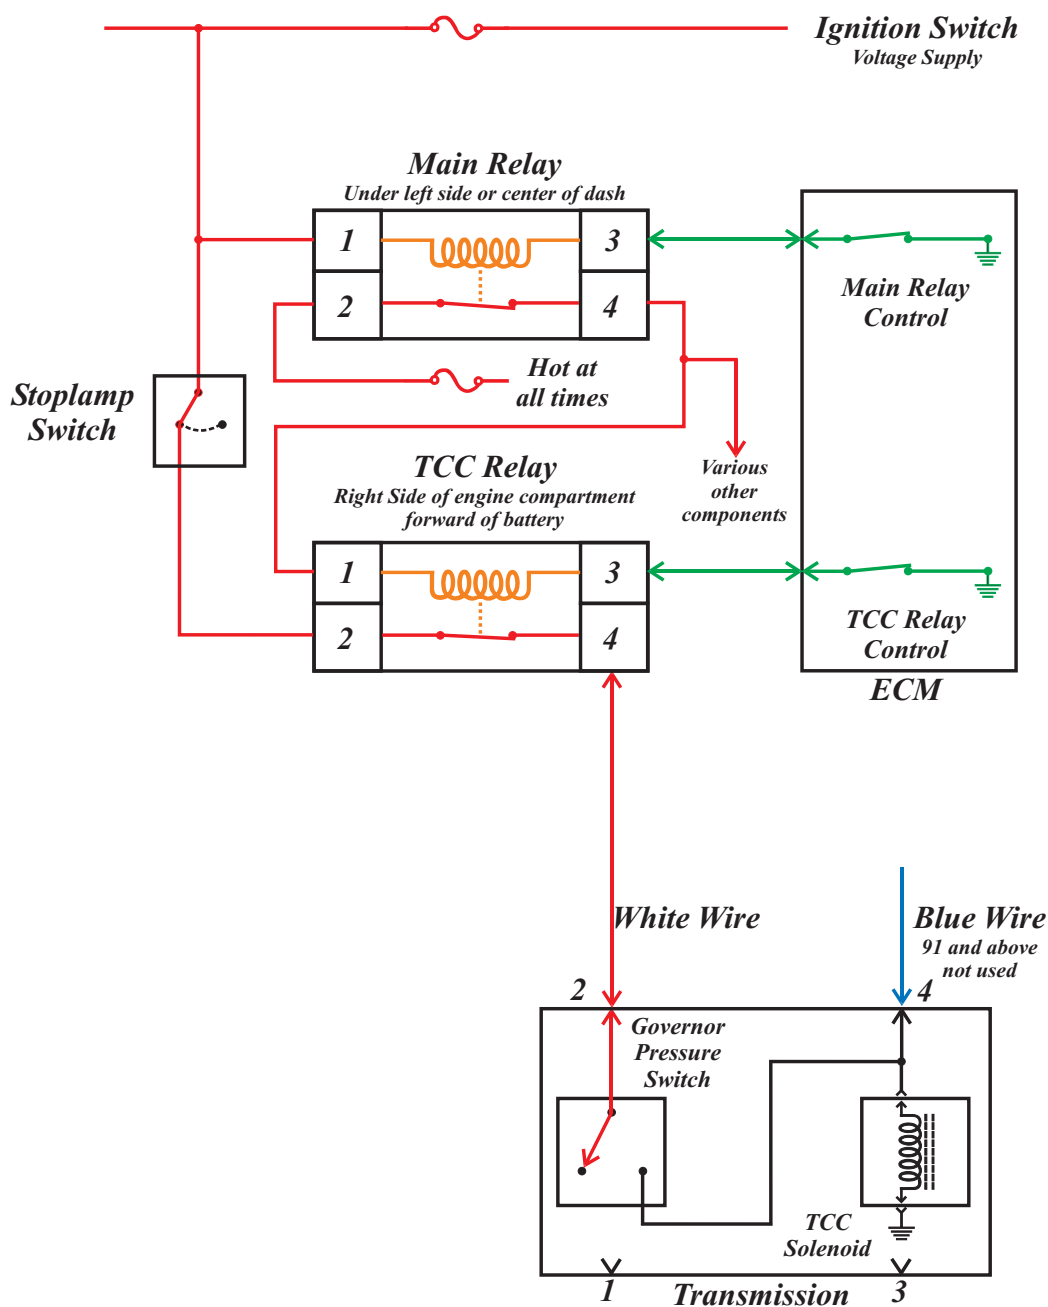
Figure 9

**VEHICLE AT OPERATING TEMPERATURE  
AT APPROXIMATELY 40 MPH OR MORE.**

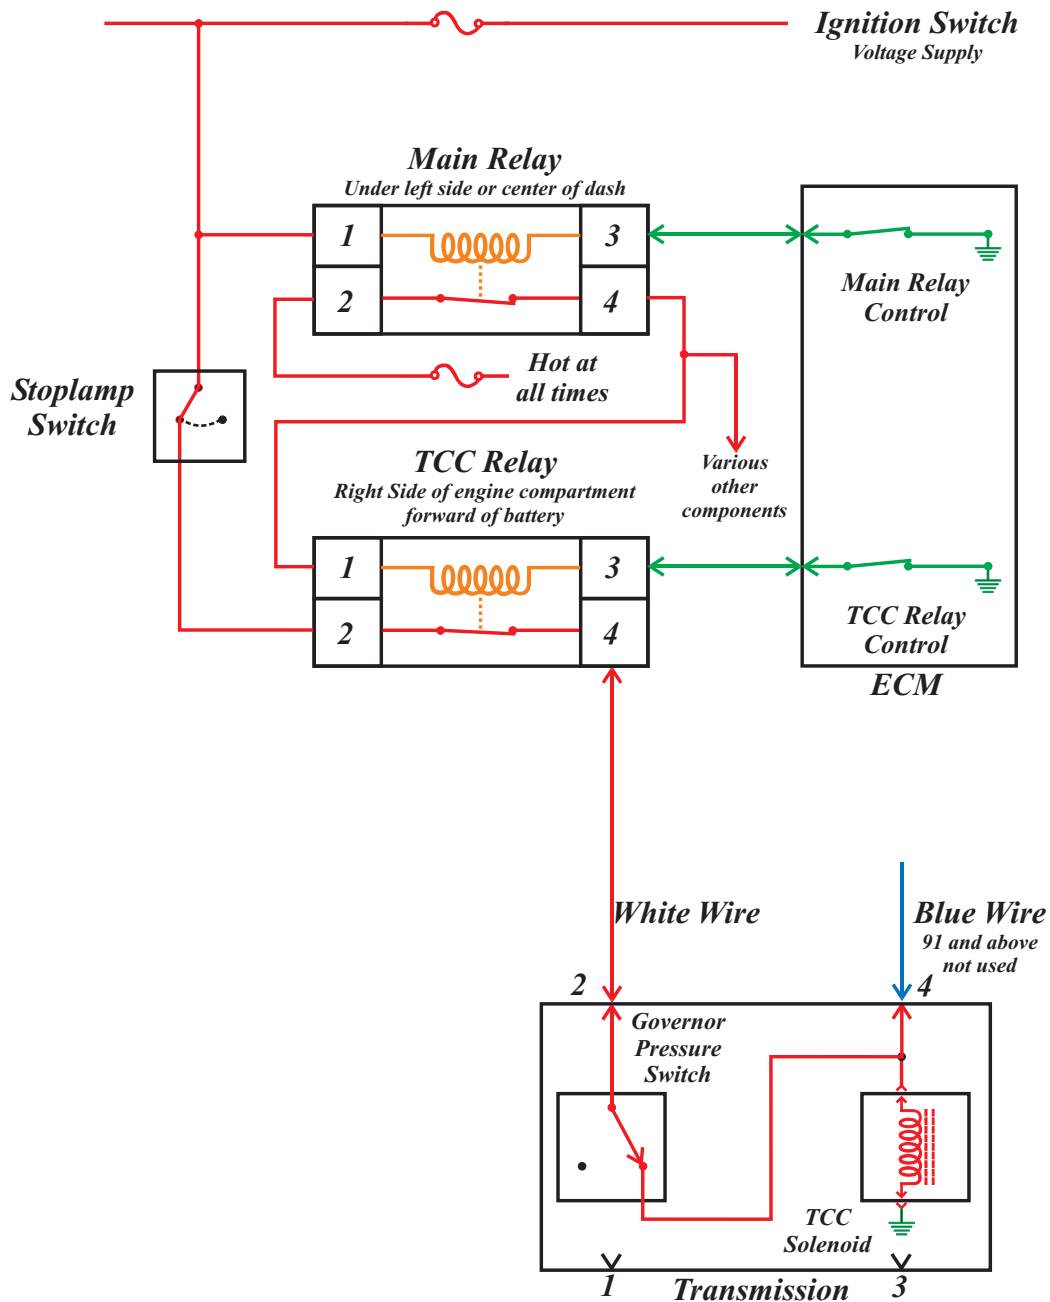
Figure 10

**VEHICLE AT PROPER OPERATING REQUIREMENTS  
AND THE GOVERNOR PRESSURE HAS CLOSED THE SWITCH.**

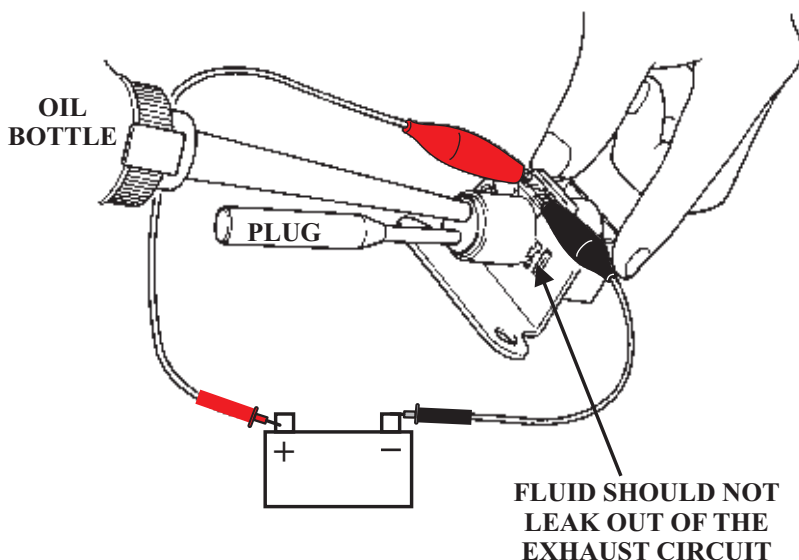
Figure 12

**WITH THE SOLENOID ENERGIZED, SQUEEZE FLUID INTO THE SOLENOID FLUID CHAMBER FROM AN OIL BOTTLE THROUGH THE UPPER PIPE HOLE WHILE THE LOWER PIPE HOLE IS BLOCKED**

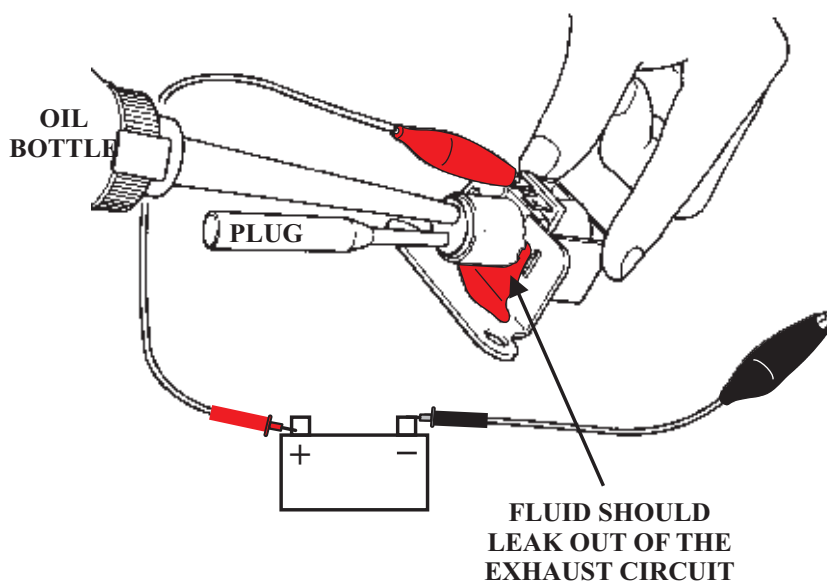
Figure 13

**WITH THE SOLENOID DE-ENERGIZED, SQUEEZE FLUID INTO THE SOLENOID FLUID CHAMBER FROM AN OIL BOTTLE THROUGH THE UPPER PIPE HOLE WHILE THE LOWER PIPE HOLE IS BLOCKED**
