# Technical Service Information

## THM 4L80-E NO LINE PRESSURE RISE

93-40  
Page 1 of 1

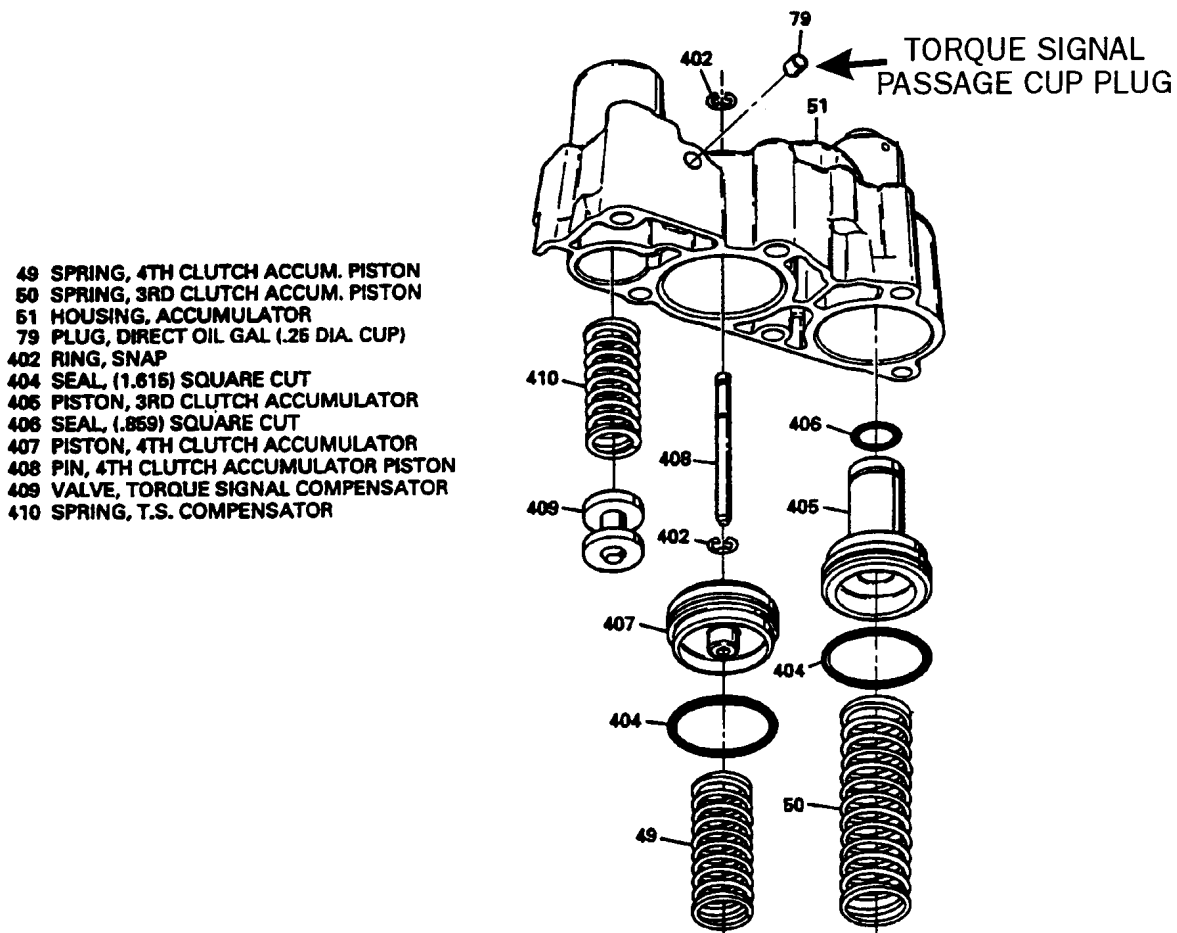
Figure 1

**COMPLAINT:** No line pressure rise when the throttle is opened. Line pressure remains at approximately 45 psi. and will produce soft mushy shifts. When the case connector is removed and/or the force motor voltage is removed, line pressure remains at minimum.

**CAUSE:** The cause may be that the cup plug has blown out of the torque signal passage in the accumulator body. See figure 1 for the location of the cup Plug

**CORRECTION:** Replace the cup plug and stake it in place to prevent it from coming out again.
