"2000" SEMINAR INFORMATION "FIXES TODAY FOR Y2K"

INDEX FORD & CHRYSLER

AUTOMATIC TRANSMISSION SERVICE GROUP

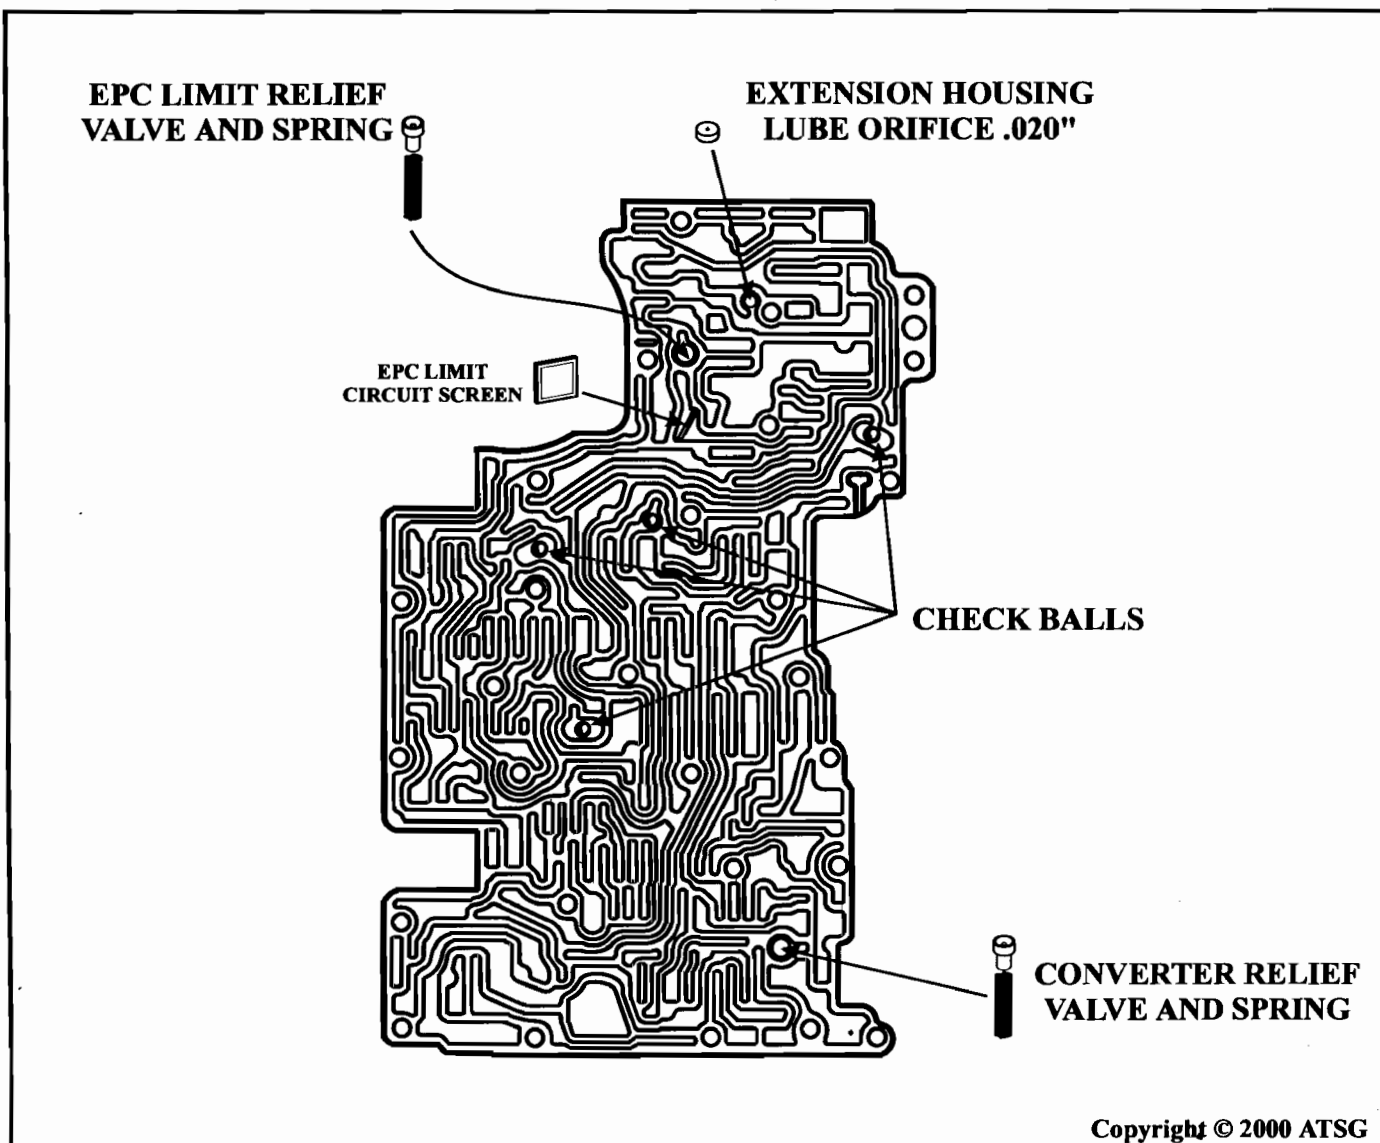
Figure 1

COMPLAINT: Some vehicles equipped with the 4R44E/4R55E may exhibit delayed engagements in forward & reverse and / or a slipping condition.

CAUSE: One cause may be, that the Extension Housing Lube Orifice may have been left out of the valve body causing a loss of line pressure.

NOTE: IN THE EVENT THE EXTENSION HOUSING LUBE ORIFICE IS LOST OR MISSING AND HAS TO BE REPLACED, THE ORIFICE SIZE IS .020".

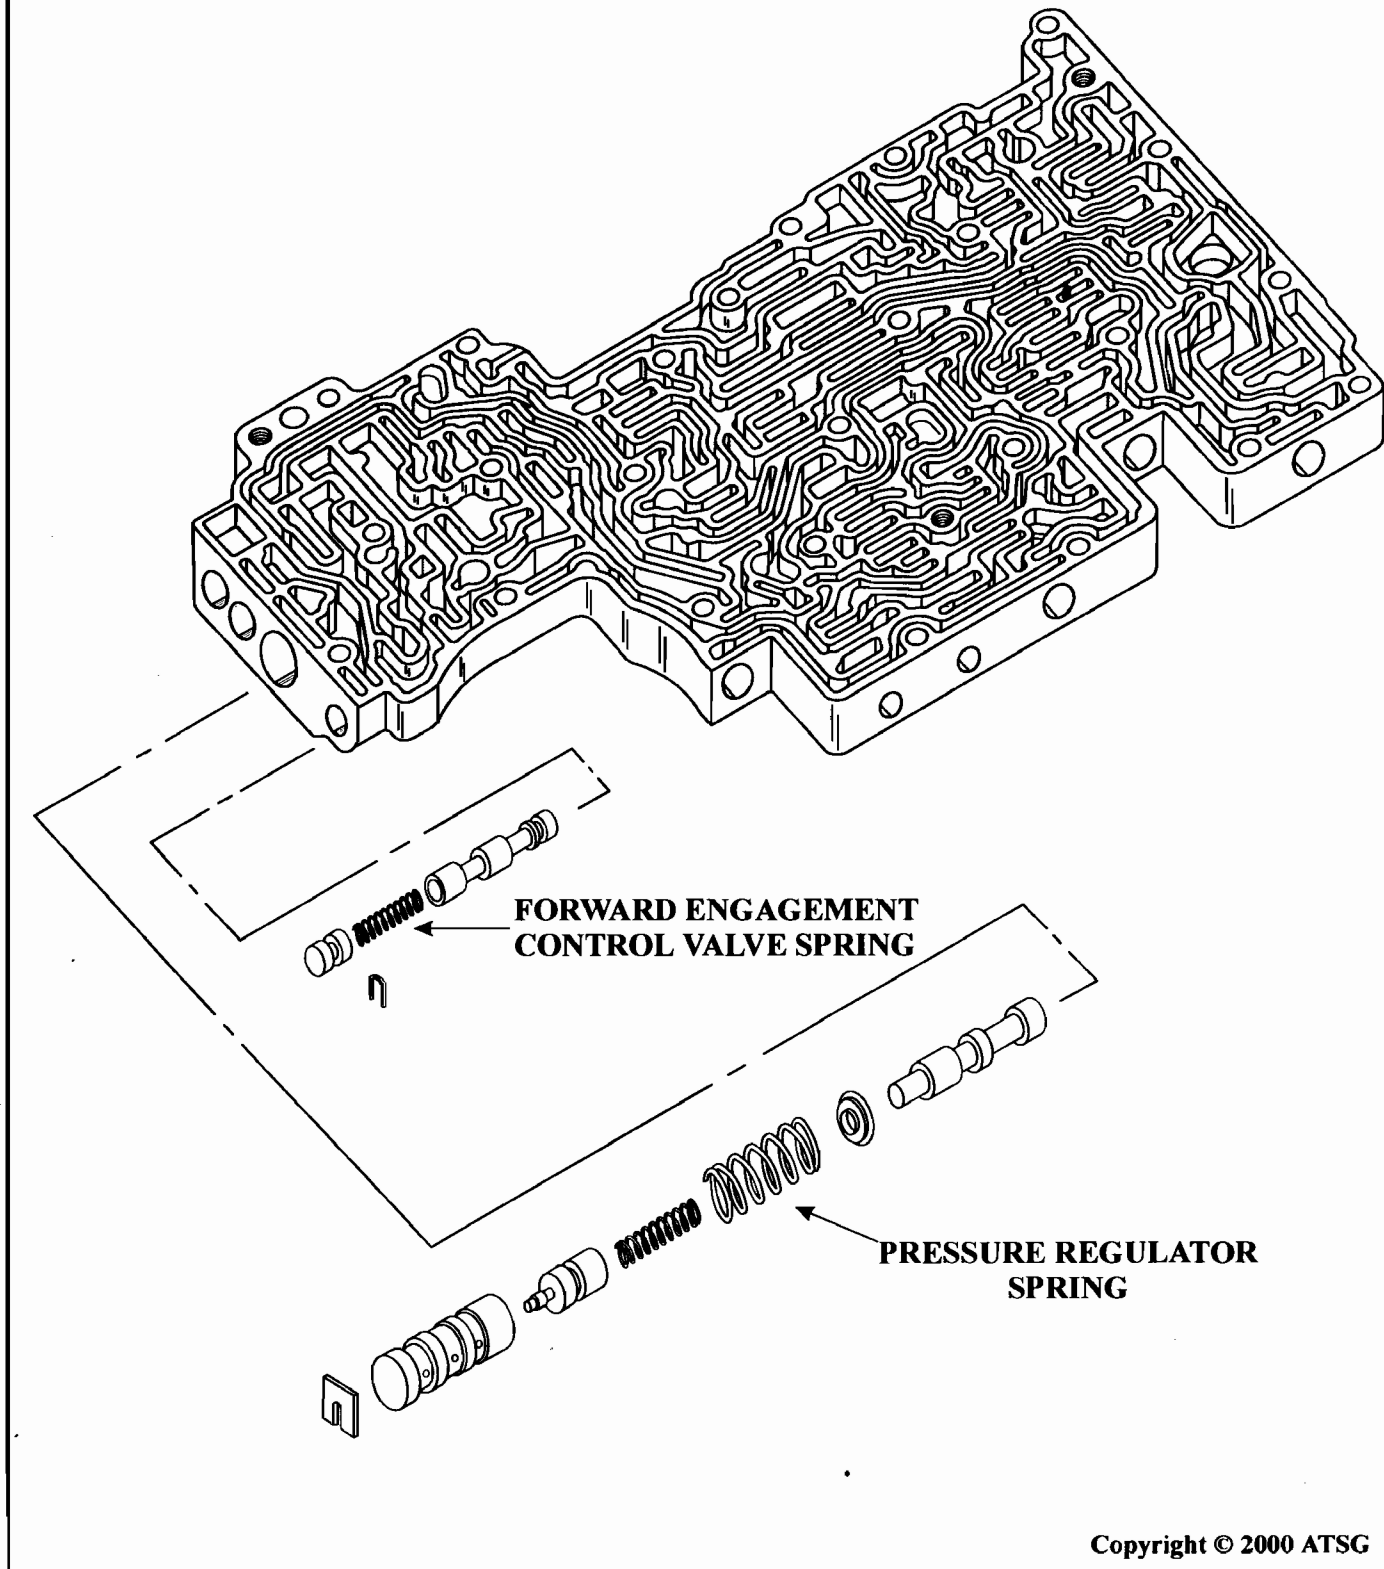
Figure 1
Automatic Transmission Service Group

COMPLAINT: Some vehicles equipped with the 4R44E/4R55E may exhibit a delayed forward engagement condition.

CAUSE: One cause may be, an insufficient volume of oil fed to the forward clutch circuit.

(2) Replace the pressure regulator spring with a yellow pressure regulator spring from the valve body of an A4LD transmission as shown in Figure 1.

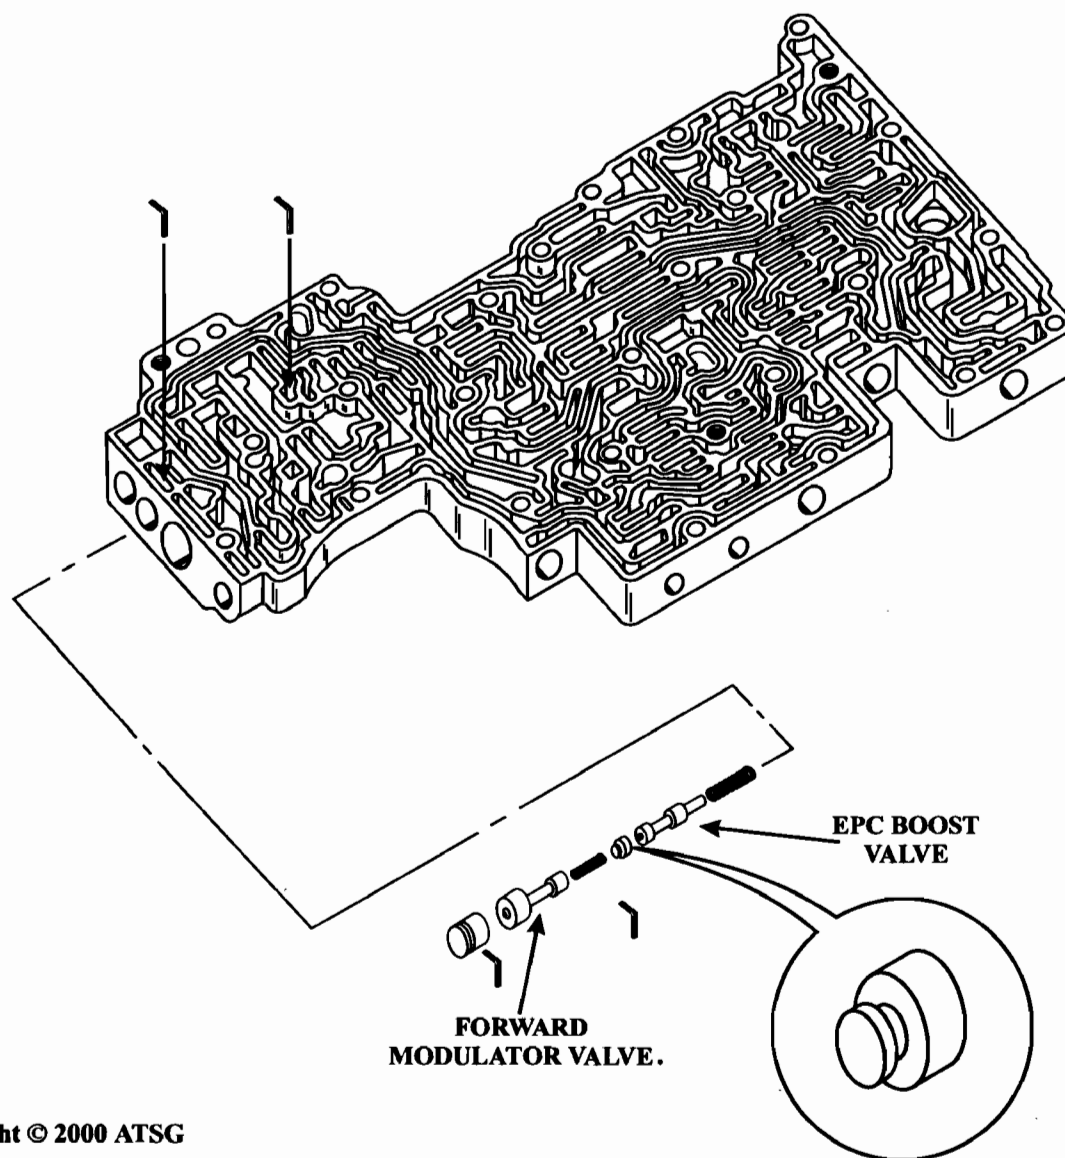
Figure 1
Automatic Transmission Service Group

FORD 4R44E/4R55E
NO FORWARD ENGAGEMENT IN THE
OVERDRIVE RANGE

COMPLAINT: Some Vehicles equipped with the 4R44E/4R55E, may exhibit a no forward engagement condition in the Overdrive range but will move in manual 2nd, Low, and Reverse,

CAUSE: One cause may be, that the bore plug that retains the Forward Modulator Valve, in the valve body, was installed backwards.

CORRECTION: Remove the valve body and inspect the Forward Modulator Control Valve line up and ensure the retaining plug between the Forward Modulator Control Valve spring and the EPC boost valve is installed correctly as shown in Figure 1.

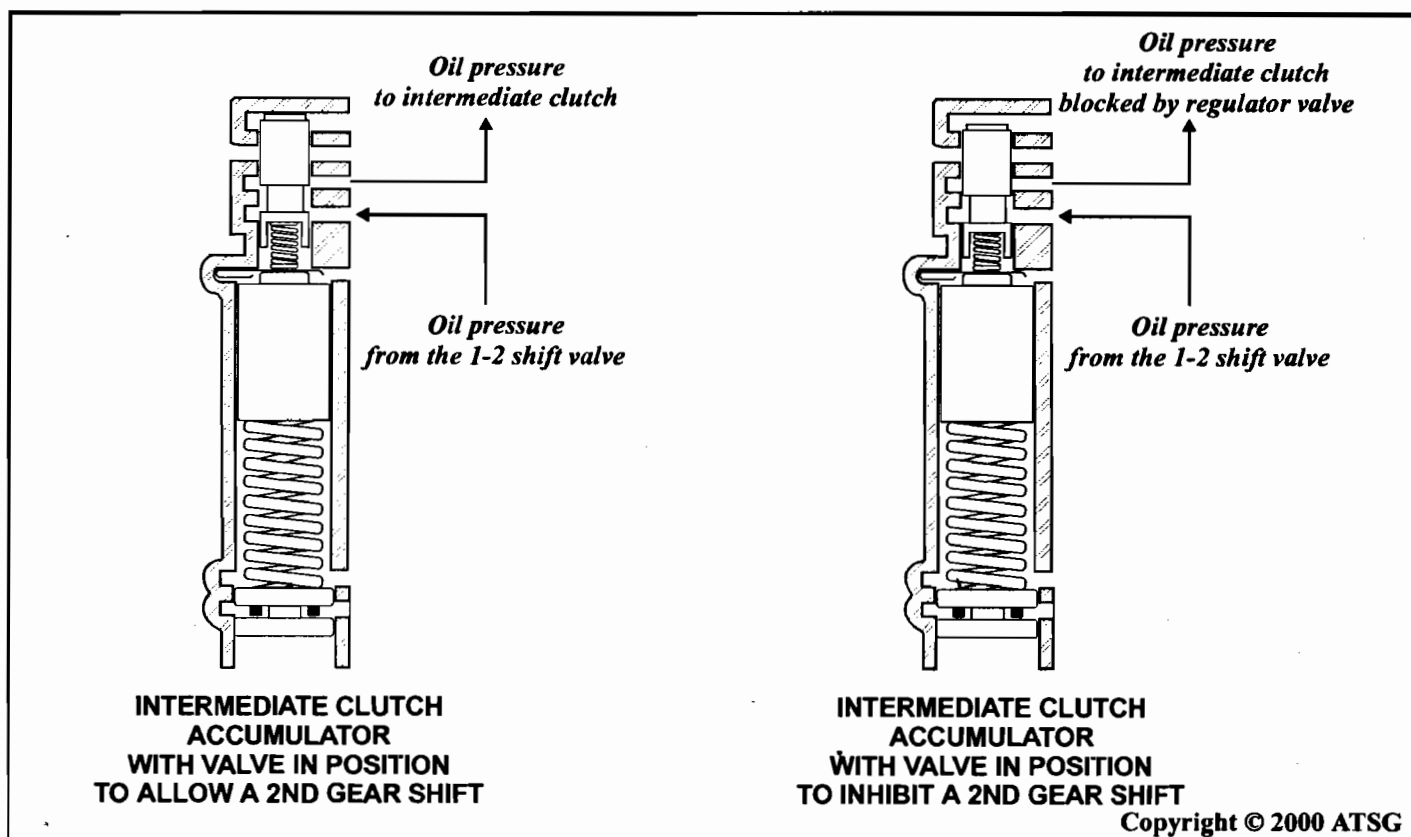
COMPLAINT: After rebuild, any vehicle equipped with the E4OD transmission may exhibit a condition of "missed shifts" on 2nd, 3rd and/or 4th gears. The scanner reveals "No Codes Present", and when manually shifting with an aftermarket shift box, the same condition exists.

CAUSE: The cause may be, one or more of the accumulator regulator valves sticking, all of which are located in the accumulator valve body. Refer to Figures 2 and 3. The hydraulic diagrams in Figure 1 will illustrate the hydraulic effect of a sticking accumulator regulator valve.

CORRECTION: Remove the accumulator valve body and inspect the accumulator regulator valve for the particular shift that you are concerned with. If the 1-2 shift was missing, and you have a 1991 model or later, ensure that the spring loaded screen is in the case under the main spacer plate. If none of the accumulator valves seem to be sticking it may be necessary to replace the complete accumulator valve body. Ensure that you install the proper accumulator valve body for the model that you are working on, as they will not interchange. The 1989-1994 models are identified with "E9" or "F4" in the casting number and 1995-1997 models are identified with "F5" in the casting number. Refer to Figures 2 and 3.

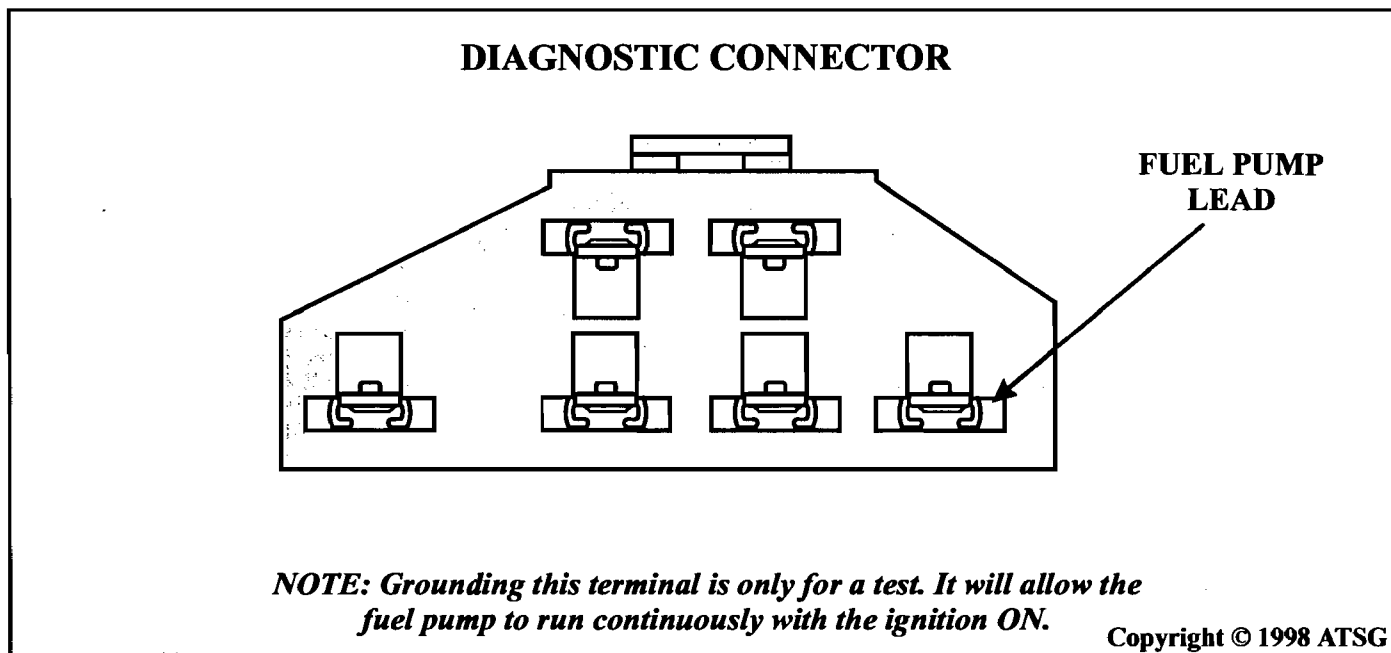
CAUSE: The cause may be, a faulty Programmable Speedometer Odometer Module, indicating the vehicle is traveling at speeds in excess of 100 mph in Reverse. When the Powertrain Control Module recognizes this, it may go into an **Overspeed Protection Program**. When in this program, the Powertrain Control Module may remove the ground signal applied to the Fuel Pump Relay resulting in fuel shut-off.

CORRECTION: Disconnect the Rear ABS sensor from the differential to disable speedometer operation completely. If the problem still persists and the speedometer is still showing high vehicle speed, ground the terminal shown in the diagnostic connector shown in Figure 1 as a test, to ensure that the fuel pump is not being shut off. If the stalling condition is cured, replace the Programmable Speedometer Odometer Module (Complete Speedometer Head). If the stalling condition still persists it may be a plugged transmission oil cooler, partially open TCC solenoid, or pump halves that have not been torqued properly or they are cross-leaking. Repair and/or replace as necessary.

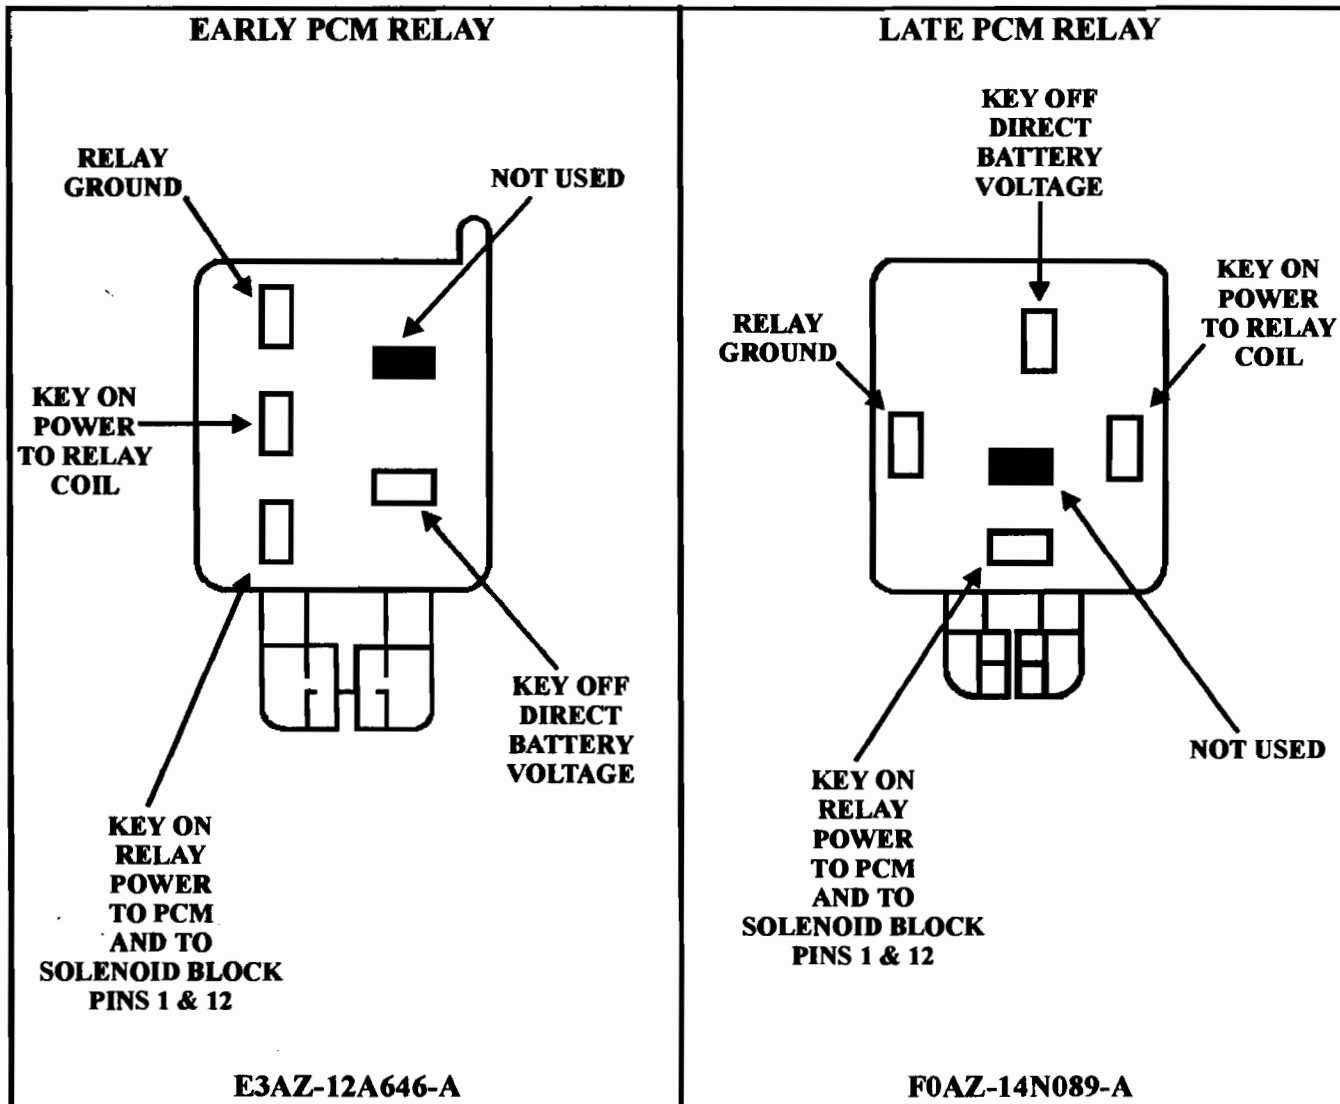
Figure 1

CAUSE: The above complaints can be caused by a faulty PCM Power Relay, formally called an EEC Power Relay for gas applications and a TECA Relay for diesel applications, which is either stuck off or stuck on.

**STUCK IN FOURTH GEAR, HIGH LINE PRESSURE, NO CODES STORED,
SELF-TESTS CANNOT RUN AND BATTERY(S) MAY RUN DOWN**

CORRECTION: Diagnose the relay circuits by using the illustration in figure 1 and then replace the relay if necessary. Use the illustrations in figures 2 thru 7 to locate the PCM Power Relay.

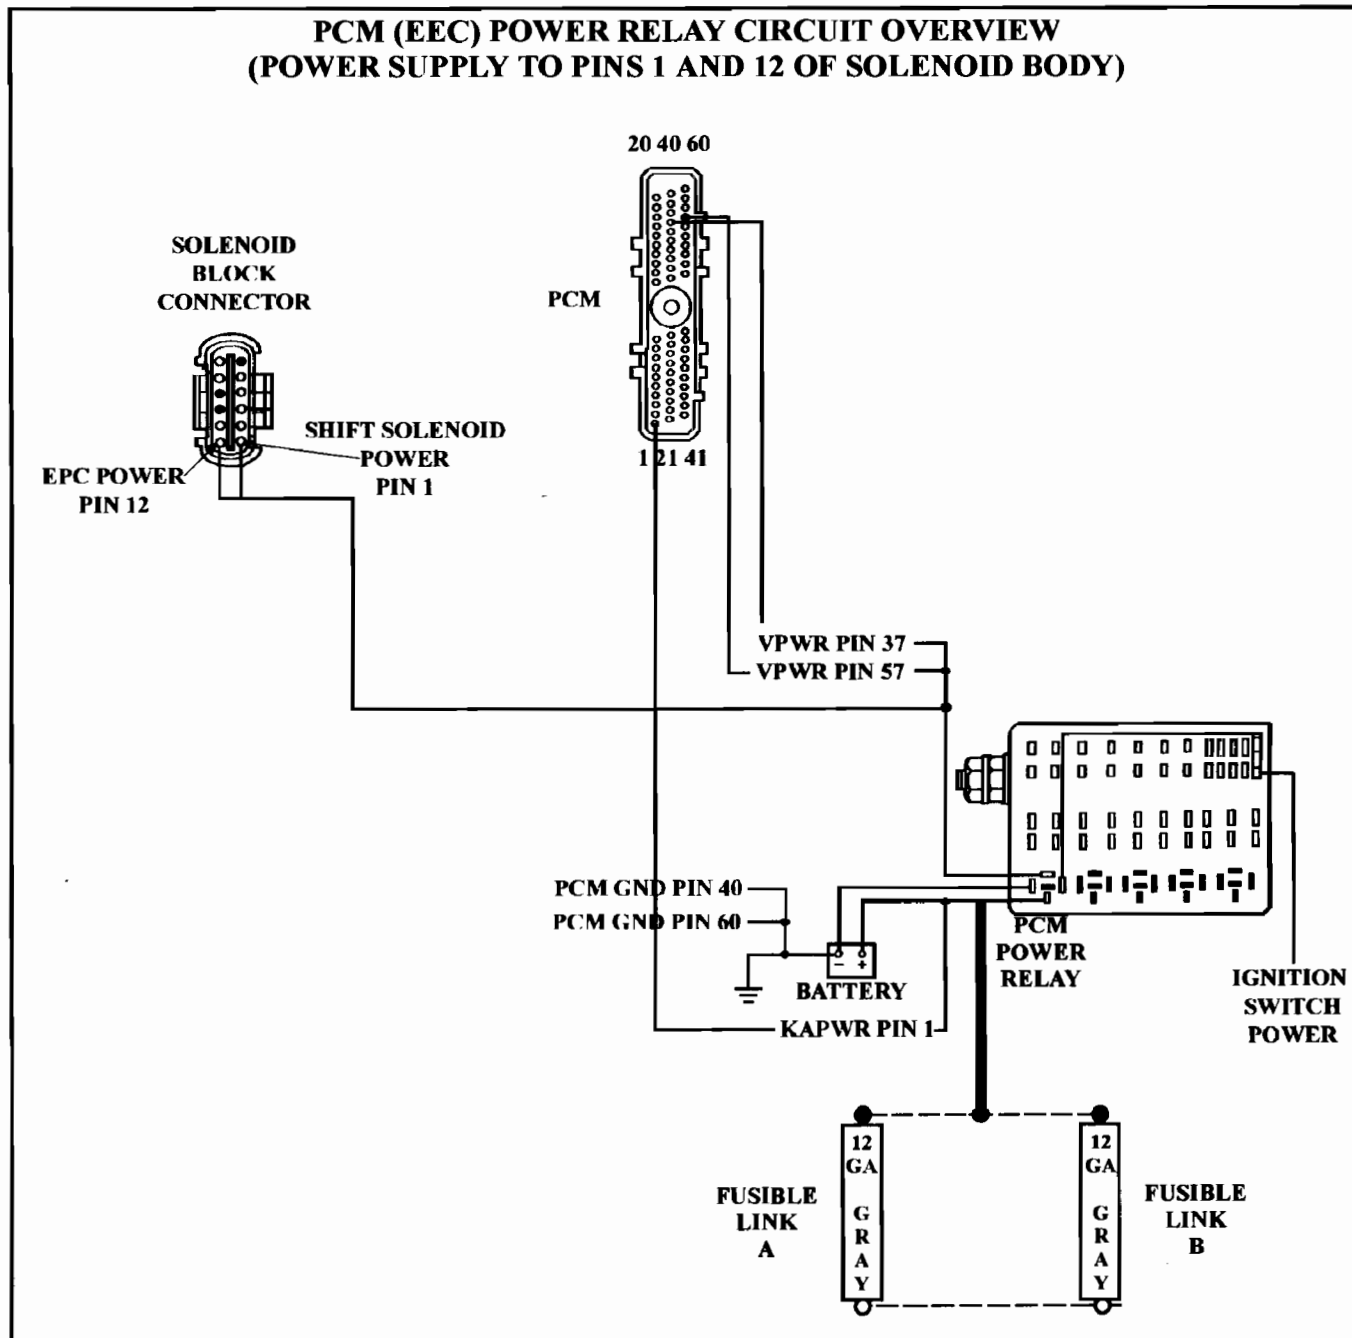
Figure 8

**STUCK IN FOURTH GEAR, HIGH LINE PRESSURE, NO CODES STORED,
SELF-TESTS CANNOT RUN AND BATTERY(S) MAY RUN DOWN**

NOTE: If the PCM Power Relay has no power to the direct battery feed terminal, check the condition of fusible link "A" and "B" coming off the positive battery cable as shown in the wiring diagrams in figures 8 and 9.

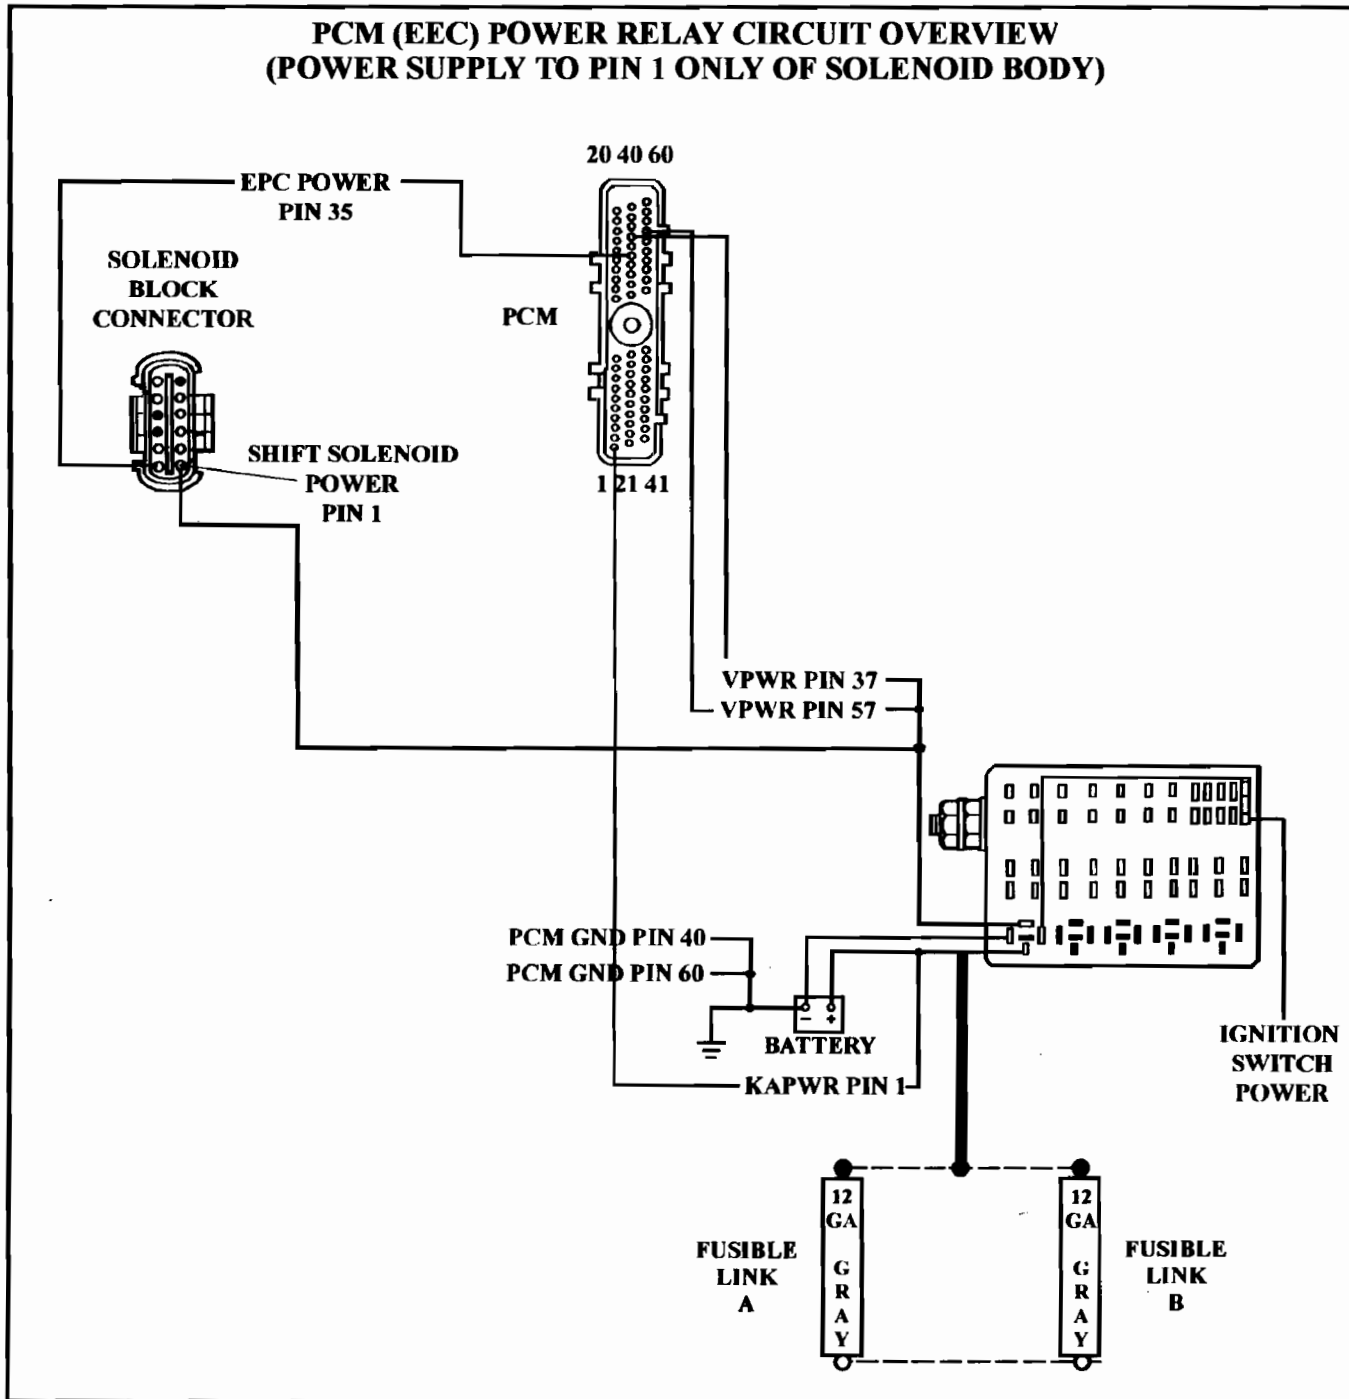
Figure 9

**STUCK IN FOURTH GEAR, HIGH LINE PRESSURE, NO CODES STORED,
SELF-TESTS CANNOT RUN AND BATTERY(S) MAY RUN DOWN**

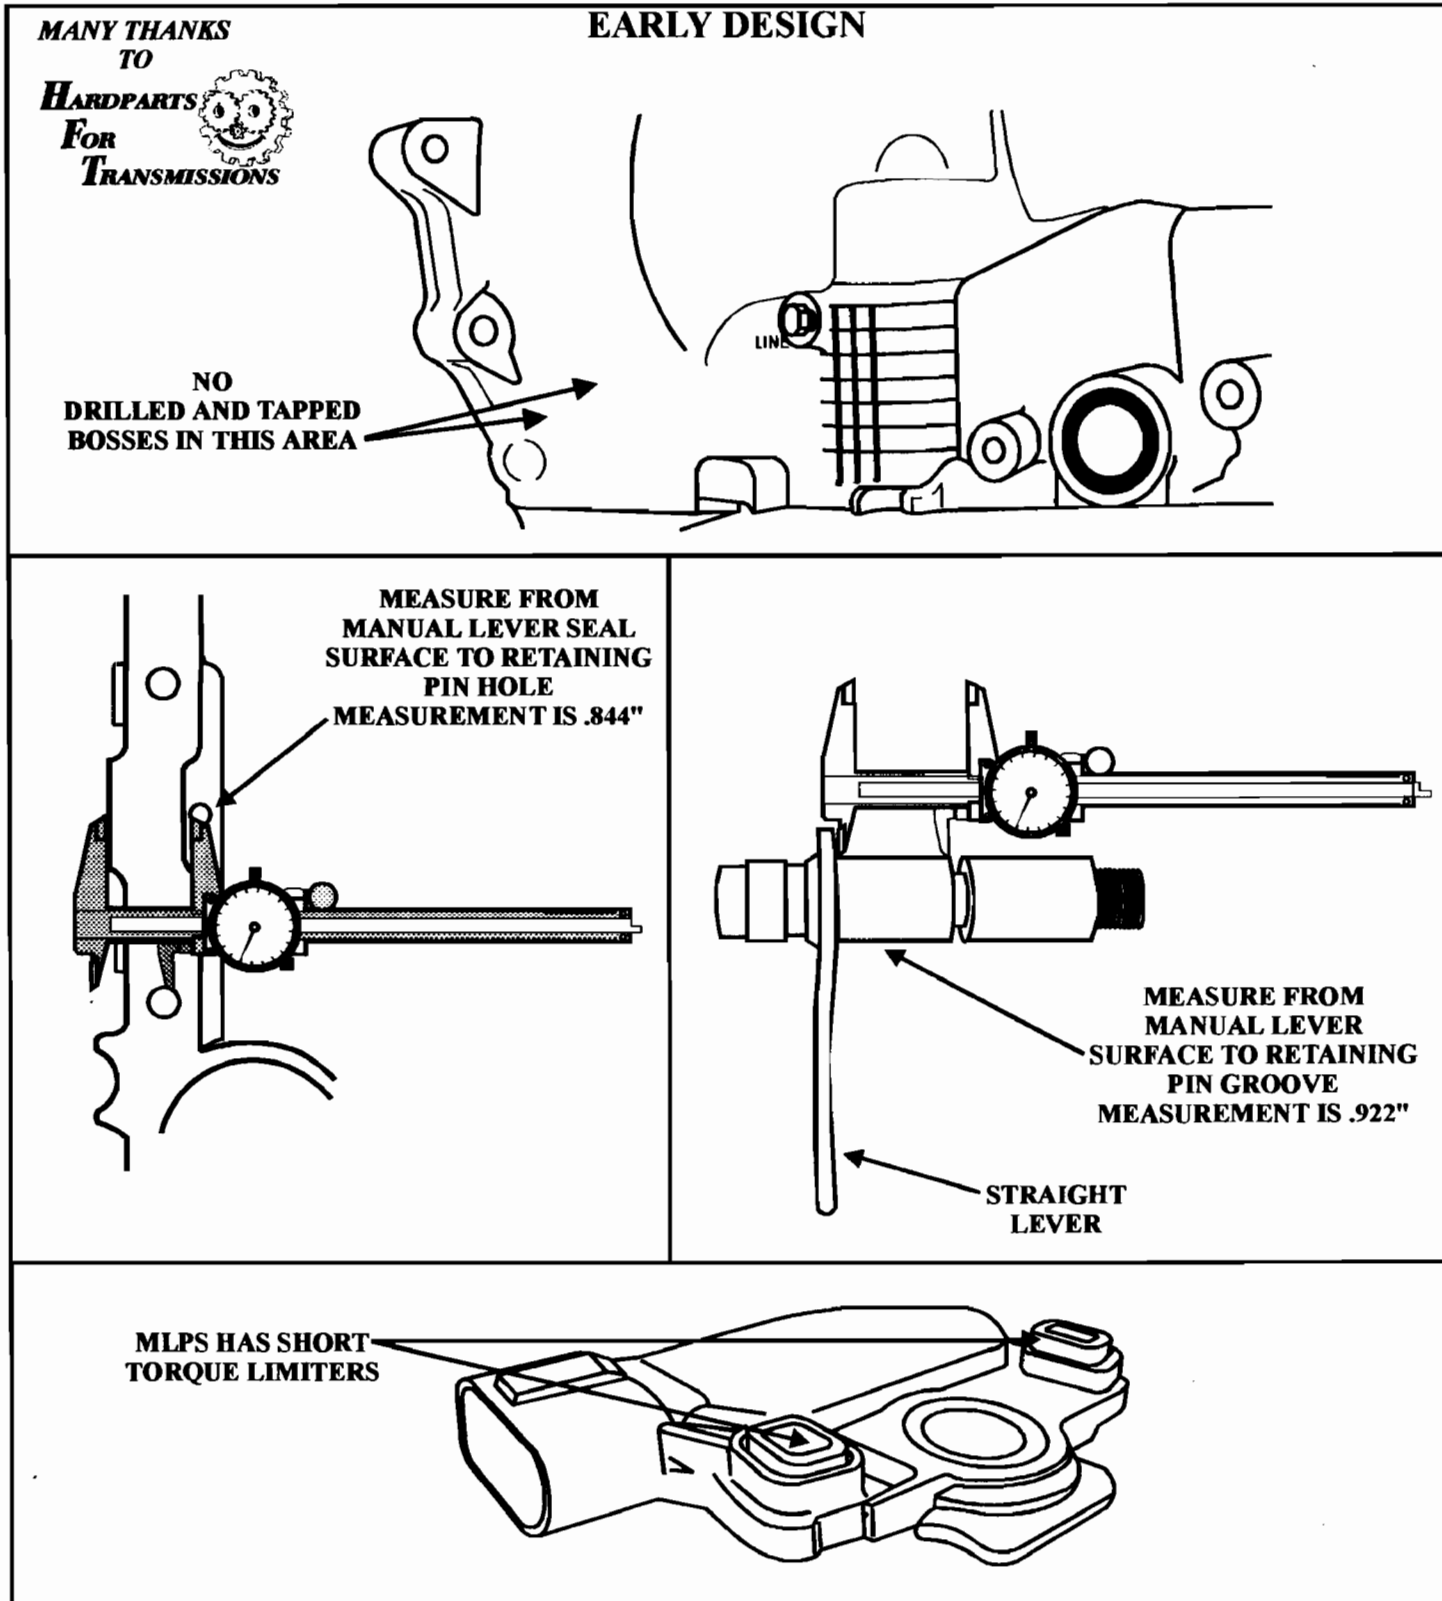
Figure 1

CAUSE: AODE cases are different in thickness in the pan rail area from the manual lever seal surface to the manual lever retaining pin hole.
These case differences also require different length manual selector levers and different height manual lever position sensors.
These cases, manual selector levers and manual lever position sensors are NOT interchangeable!
This may go unnoticed until the transmission is completely assembled or even after it is installed in the vehicle.

FORD AODE/4R70W
CASE INTERCHANGEABILITY

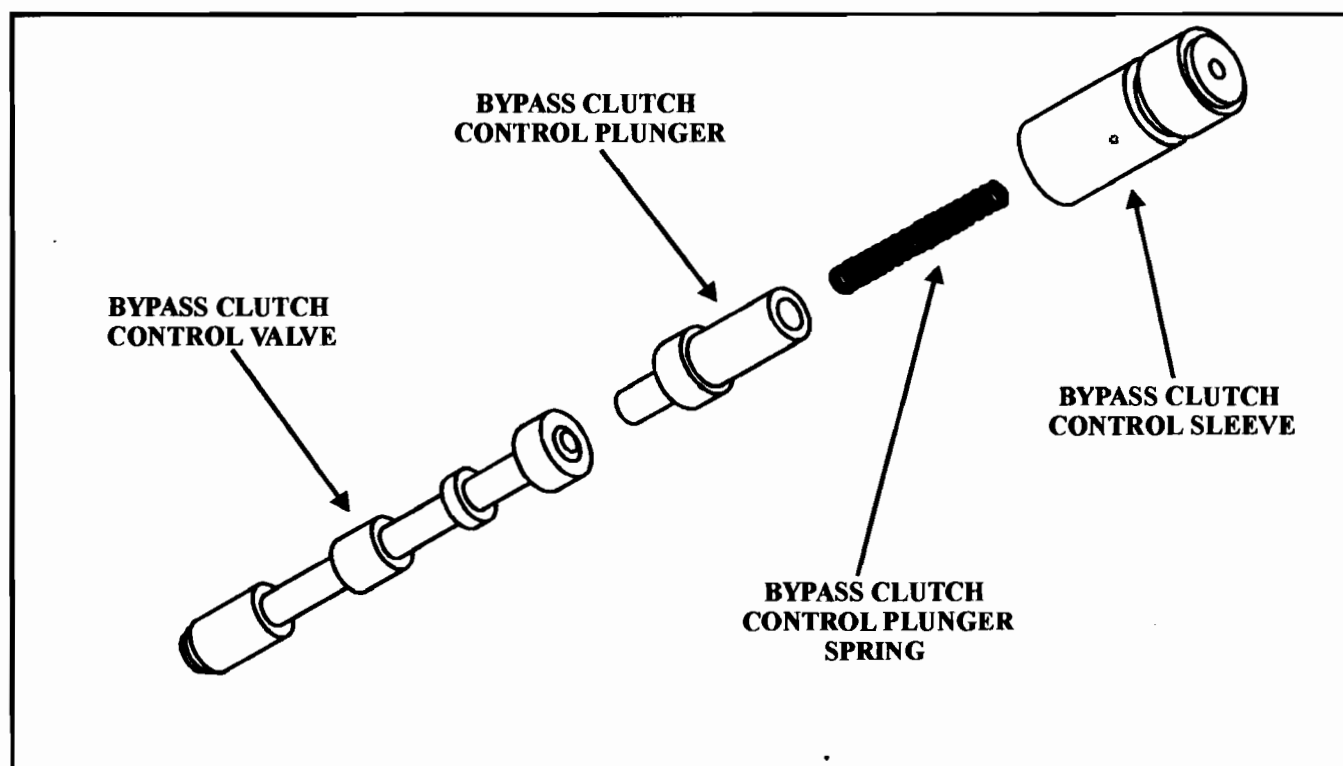
Figure 1

FORD AX4N STALLS ENGINE IN GEAR

COMPLAINT: After overhaul, the engine stalls as soon as the manual shift lever is pulled into any position except park and neutral.

CAUSE: The *Bypass Clutch Control Plunger*, located in the bypass clutch control valve line up shown in figure 1, is shown backwards in most service manuals. When the spring and plunger are installed backwards, the plunger blocks the feed hole in the plunger sleeve, which now causes the balance of the valve to be lost. This causes the bypass clutch control valve to stroke to a position that will allow all converter clutch release oil to be exhausted, allowing the converter clutch to apply. This in turn will cause the engine to stall as soon as the manual shift lever is moved out of park or neutral as seen in figure 2.

NOTE: The Bypass Clutch Control Sleeve should *always* be checked for wear during overhaul, as it is a high wear item, and can cause TCC apply and lube circuit problems.

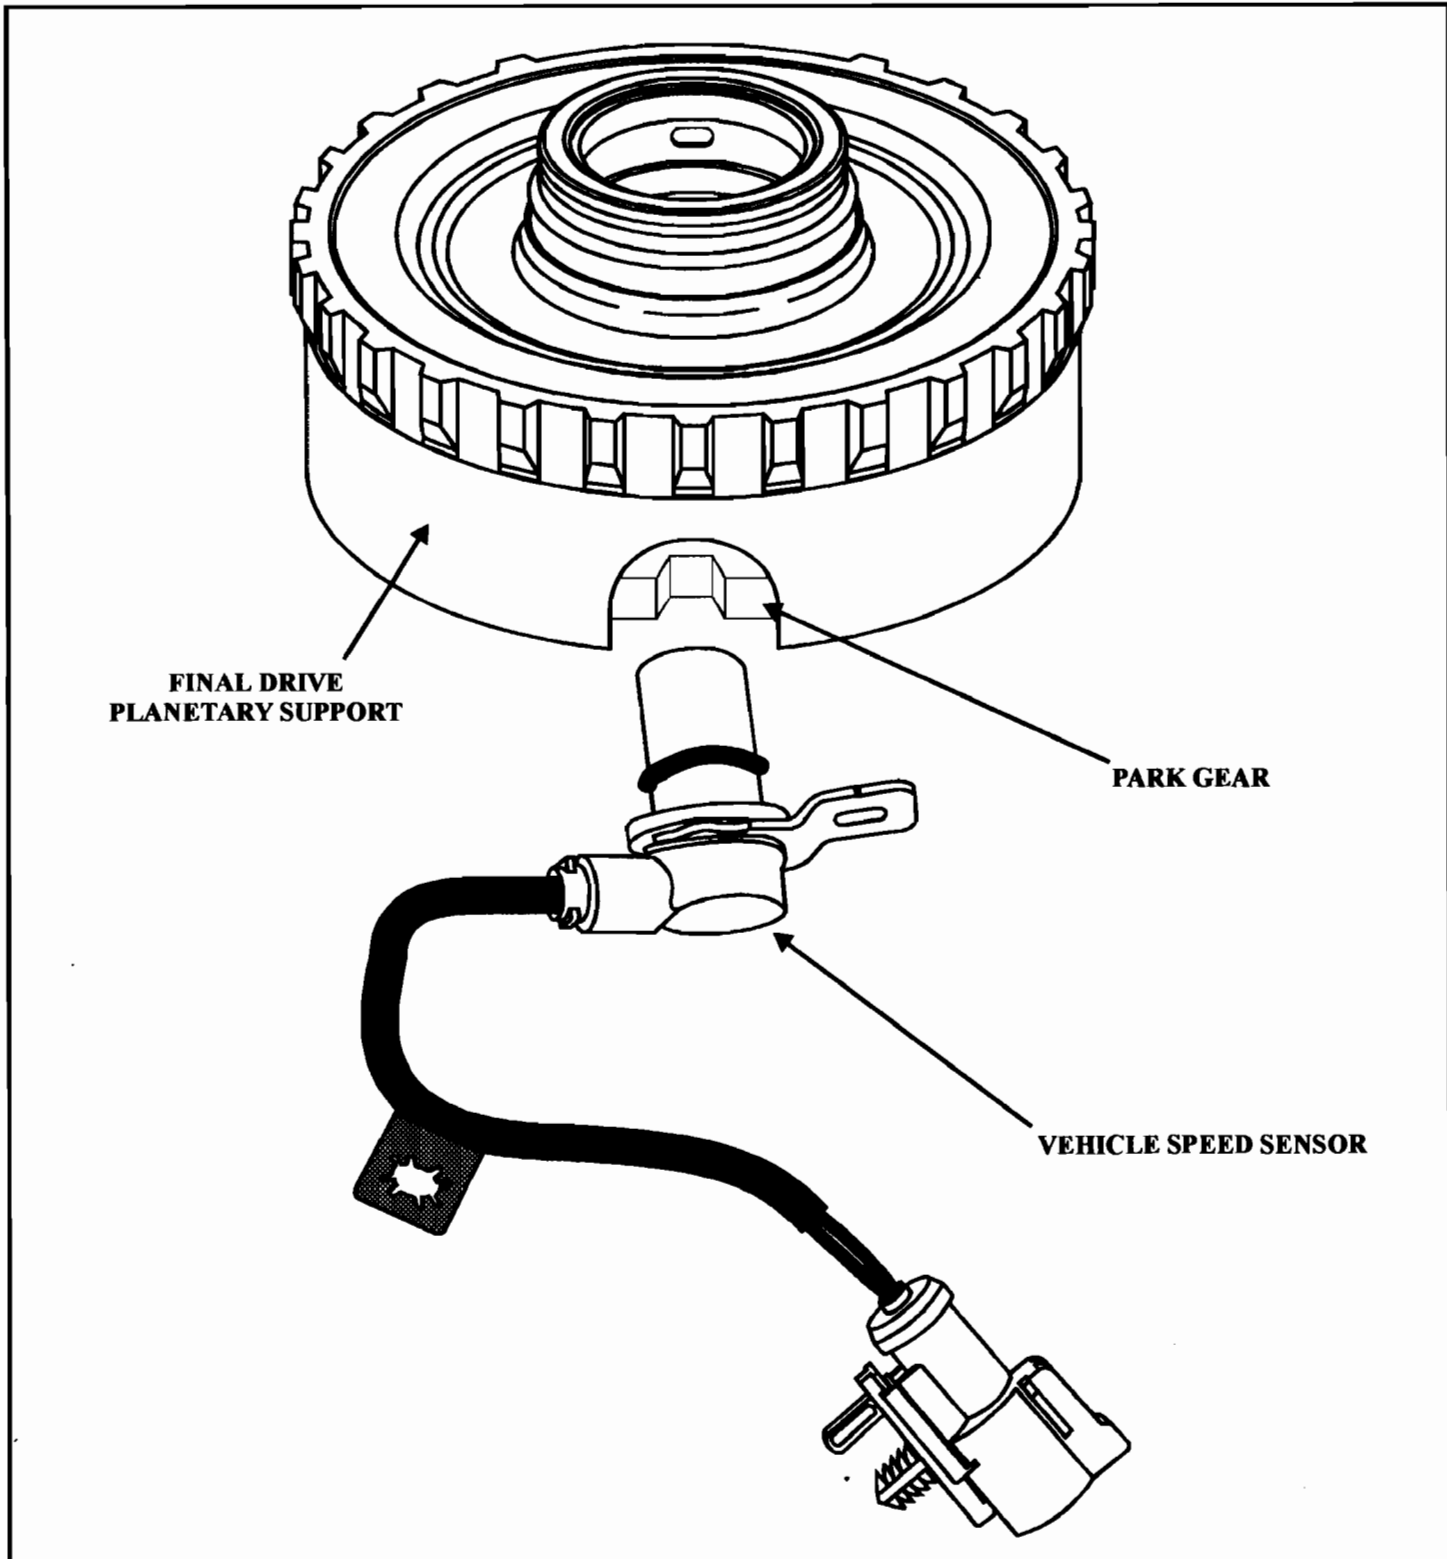
Figure 1

CHANGE: The gear driven vehicle speed sensor that has been in use in the AX4S and the AX4N since their inception will be replaced, as a running change during the 1999 model year beginning with the AX4S and at the start of production for the 2000 model year for the AX4N, with a permanent magnet speed sensor. The PM Generator will be mounted in the barrel of the case and will be using the park gear teeth as an exciter wheel.

REASON: The possibility of the VSS drive or driven gear "apple coring" will be eliminated as well as the intermittent loss of vehicle speed signal due to the speed sensor sub harness damage that would occur as a result of exhaust system heat transferral.

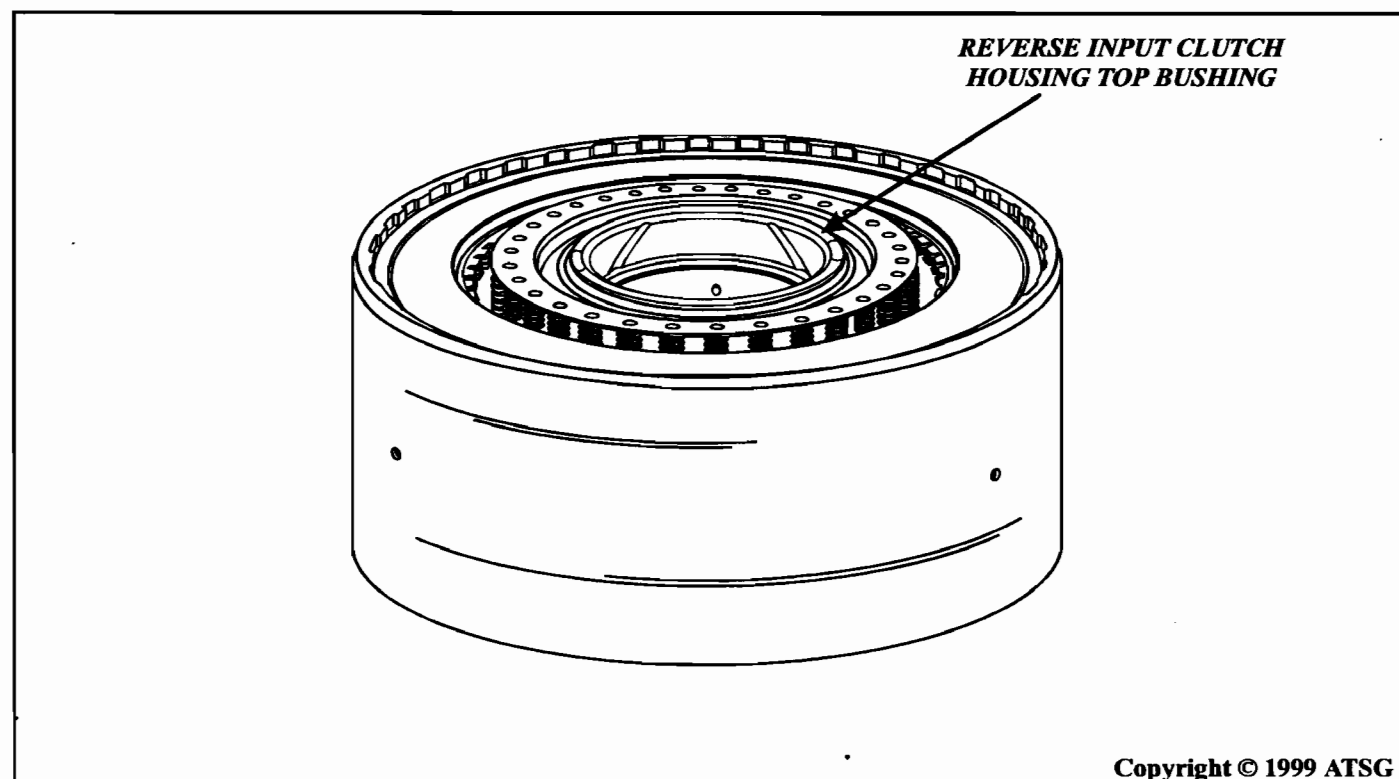
Figure 1

**FORD CD4E
PREMATURE REVERSE DRUM
BUSHING FAILURE**

COMPLAINT: After overhaul, a vehicle equipped with a CD4E transaxle exhibits premature failure of the top bushing in the reverse input housing (See Figure 1), and apparently due to lack of lubrication. Because of the bushing failure, the ring area in the reverse input housing may be grooved, and the sealing rings on the forward/coast/direct housing may be worn.

CORRECTION: Identify and locate the slots in the reverse input clutch hub and ensure that the slots are aligned with the lubrication holes in the splines of the forward/coast/direct clutch drum during the assembly process. Refer to Figure 2 for correct assembly.

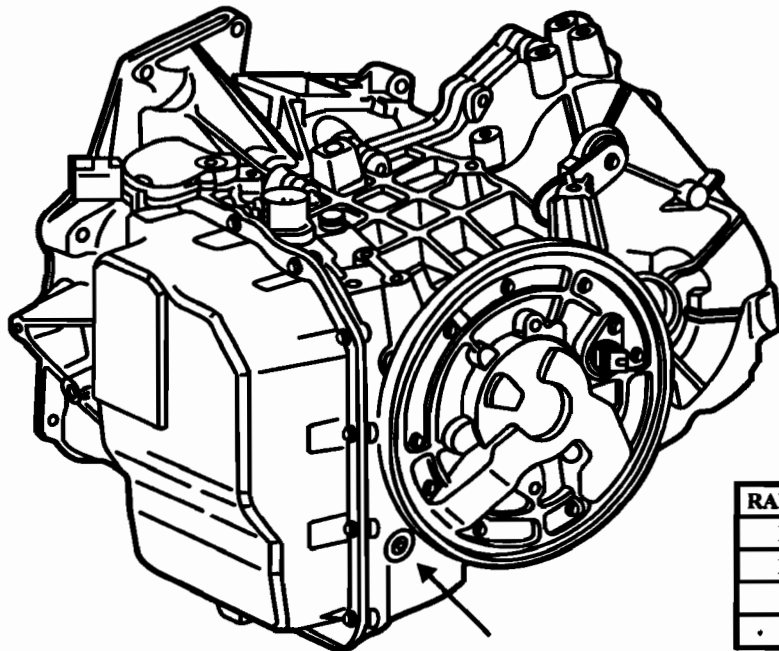
LINE PRESSURE
SERVICE PORT

RANGE	TAP	PSI AT IDLE	PSI AT STALL
R	Line	64-76	259-294
D	Line	45-63	168-184
2	Line	45-63	168-184
1	Line	45-63	168-184

CORRECTION: First scan the computer for gear ratio error or slip codes such as a code 645. Next verify line pressure using the information in figure 1. Next check the condition of the forward one-way clutch for wear as indicated in figure 2. It is actually a good practice to replace this sprag as they are notorious for looking good but being bad. Finally check the condition of the forward clutch. Remember that the forward clutch drum is also notorious for cracking which can cause forward clutch failure as well as direct clutch failure. (Refer to figure 3)
