"2000" SEMINAR INFORMATION "FIXES TODAY FOR Y2K"

INDEX FORD & CHRYSLER

AUTOMATIC TRANSMISSION SERVICE GROUP

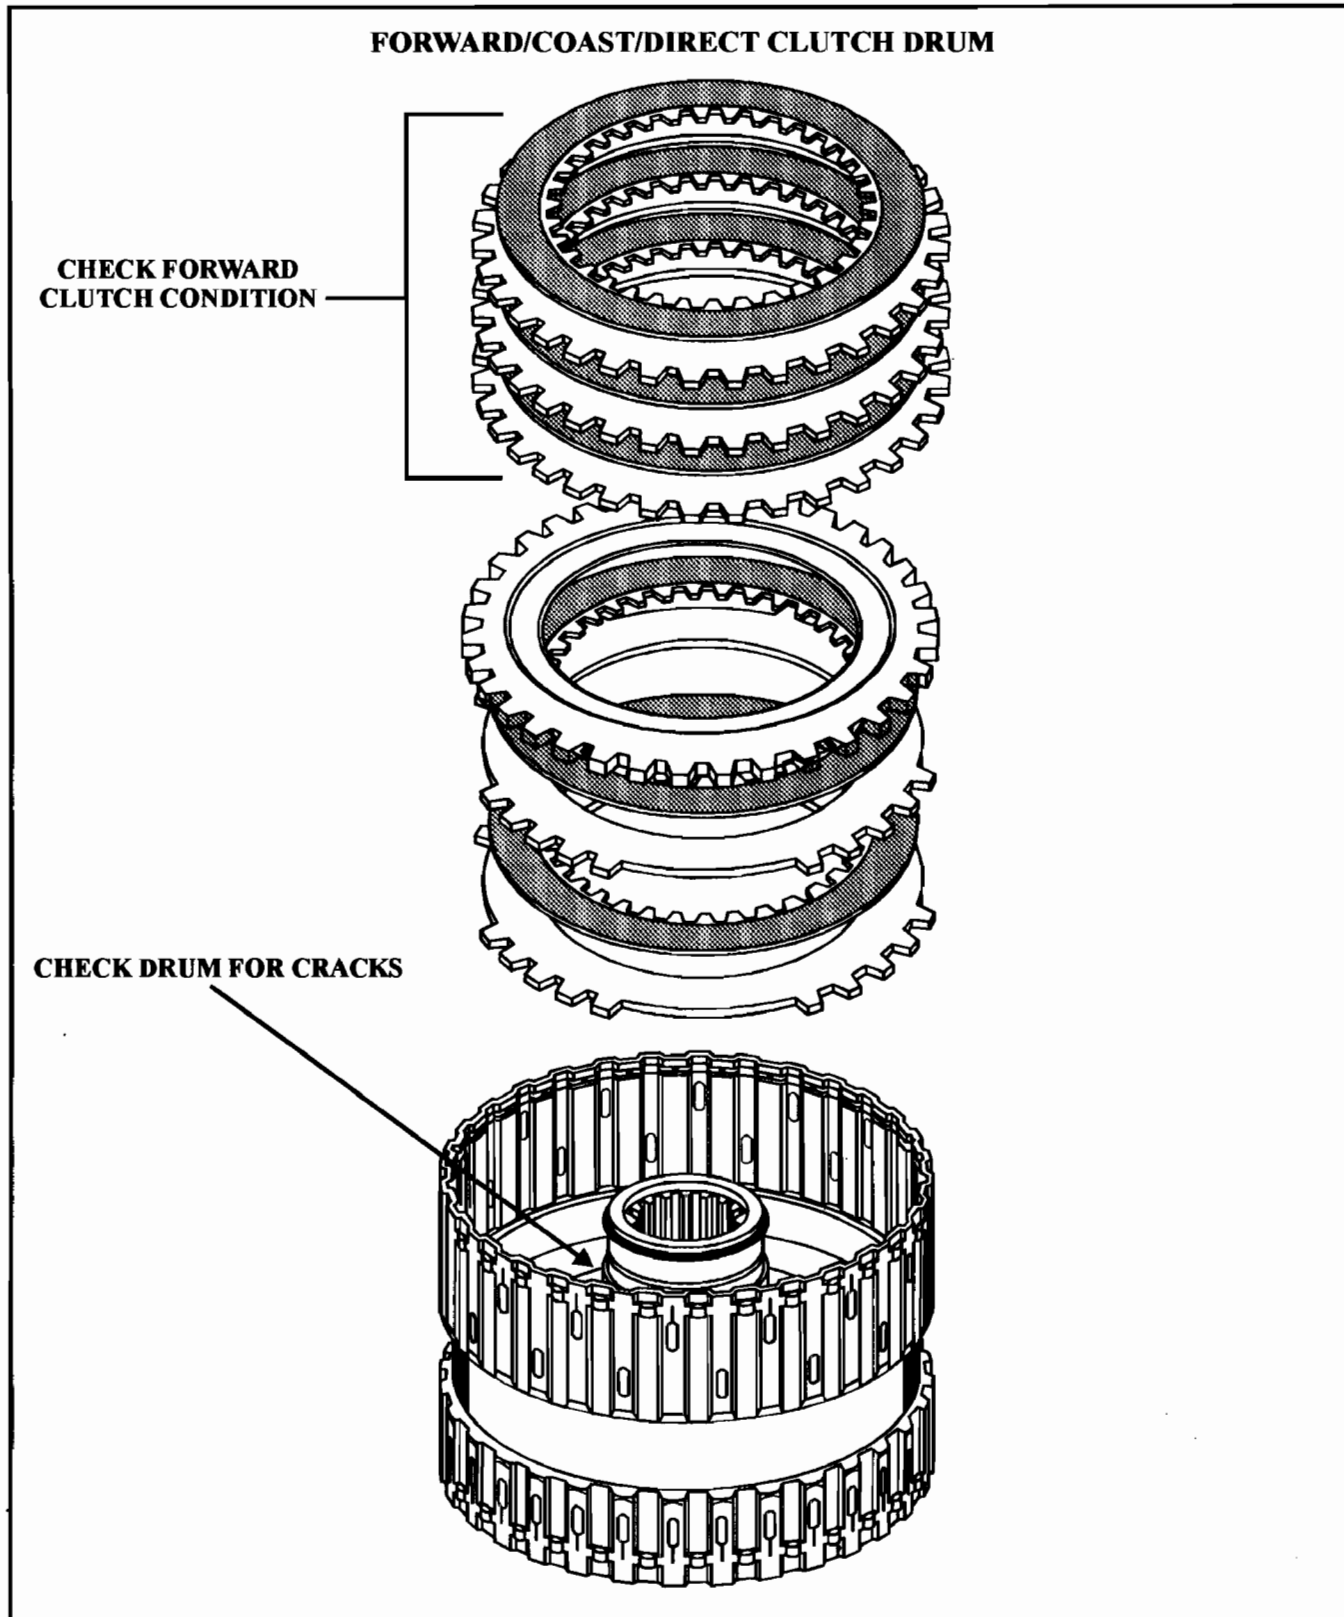
Figure 3

FORD CD4E/MAZDA LA4A-EL
HIGH LINE PRESSURE

CORRECTION: First scan the computer for gear ratio error or slip codes such as a code 645. Next verify line pressure using the information in figure 1. Next check the condition of the forward one-way clutch for wear as indicated in figure 2. It is actually a good practice to replace this sprag as they are notorious for looking good but being bad. Finally check the condition of the forward clutch. Remember that the forward clutch drum is also notorious for cracking which can cause forward clutch failure as well as direct clutch failure. (Refer to figure 3)
