Technical Service Information

FORD AXOD/AXOD-E

NO MOVEMENT OR NO CONVERTER CLUTCH

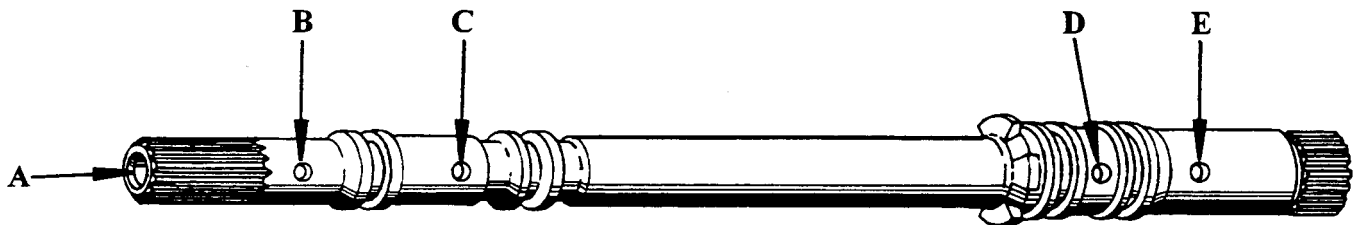
1. The converter feed passage in the Oil Pump Drive Shaft blocked with debris or was not machined properly to allow converter feed oil to enter the converter.
2. The Oil Pump Drive Shaft leaking or not machined properly, allowing converter feed passage and converter release passage to be connected

NOTE: THERE ARE ADJOINING HOLES ON THE OPPOSITE SIDE OF THE OIL PUMP DRIVE SHAFT THAT ARE NOT ILLUSTRATED.

CORRECTION: Refer to Figure 1 to check the Oil Pump Drive Shaft, and clean or replace as necessary. **NOTE:** We have seen some replacement shafts, both reman and new that were leaking between the converter apply and release passages.

APPLY AIR PRESSURE INTO HOLE "D" AND ENSURE THAT AIR PRESSURE ESCAPES THROUGH HOLE "C" ONLY.

APPLY AIR PRESSURE INTO HOLE "A" AND ENSURE THAT AIR PRESSURE ESCAPES THROUGH HOLES "B"&"E" ONLY.
