Technical Service Information

MERCEDES 722.3 /.4 HARSH ENGAGEMENT INTO REVERSE AND DRIVE

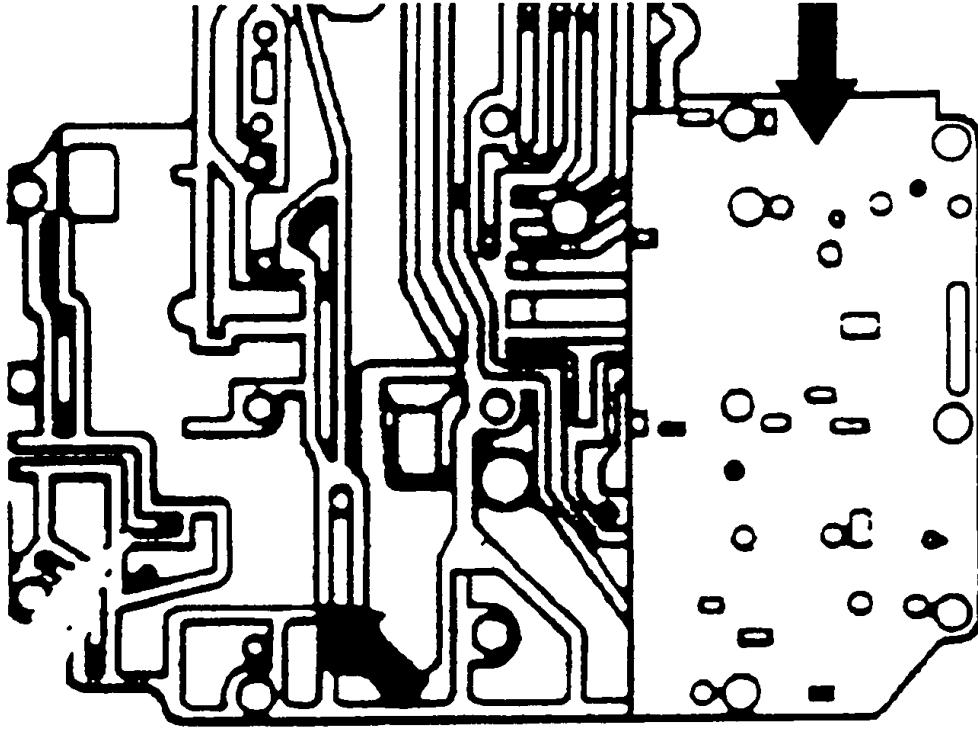
Figure 1

- a. Transmission fluid has milky discoloration,
- b. Transmission fluid foams heavily when drained,
- c. The gasket on the large intermediate plate shows severe swelling or a green slimy coating (upper right arrow in Figure 1).
- d. The intermediate plate shows signs of corrosion under the gasket (lower left arrow in Figure 1).

- a. (See note) If coolant is detected in the transmission fluid, replace radiator and all friction linings in the automatic transmission.
- b. For vehicles with transmission 722.4 already equipped with a brass radiator, or if no coolant can be detected in the transmission, install nitrated outer steel plates LB3 to resolve the complaint.
