Technical Service Information

THM 440-T4 LOCK-UP ON TOP OF 2ND GEAR

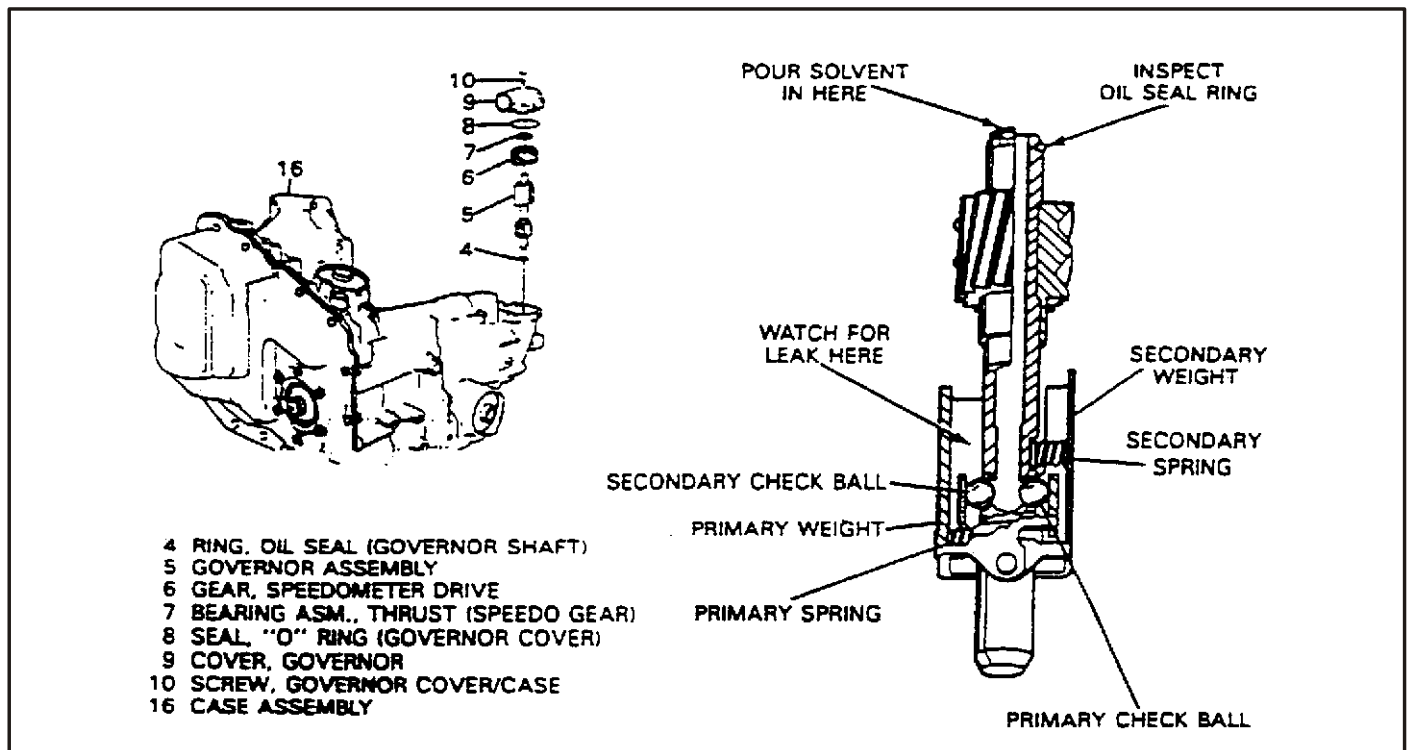
Figure 1

Erratic shifts or no upshift in a THM 440-T4 transaxle may be caused by particles of hardened imprex (TM) material lodging in the governor pressure channel. (Imprex (TM) is an "Impregnation Plastic" used in the manufacturing of cases to help seal the case and minimize porosity.)

1. Remove governor assembly (5) from transaxle and clean with solvent.
2. Inspect governor for binding weights and/or mispositioned springs. To verify operation, turn governor upside down and pour solvent into the governor shaft. Check for leakage past the checkballs. If leakage is noted, replace the governor assembly.
3. Reinstall governor cover (9) without the governor assembly.
4. Start the engine and move the selector lever to drive (D) position. Allow the engine to run for 15-20 seconds.
5. Apply brake, move the selector lever to park (P), and stop the engine.
6. Reinstall the governor assembly (5) into the transaxle and road test the vehicle to verify transaxle operation.
