Technical Service Information

THM 440-T4 HARSH REVERSE ENGAGEMENT

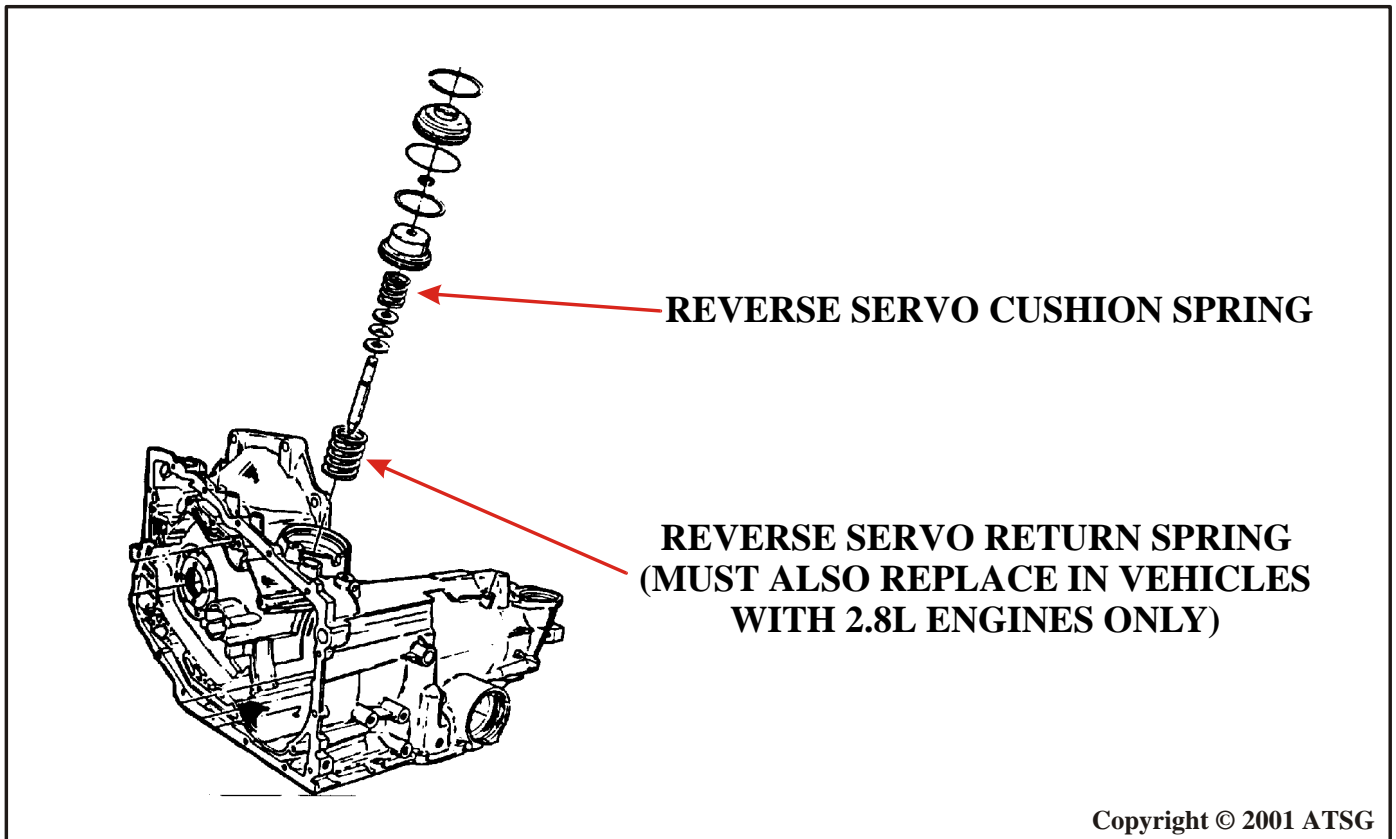
Figure 1

COMPLAINT: Harsh Garage Shift From Park/Neutral To Reverse.

CAUSE: The cause may be:

1. Low vacuum supply to the vacuum modulator.
2. Stuck modulator valve in case.
3. No. 9 checkball missing or off location.

CORRECTION: AFTER ALL OF THE ABOVE ARE ELIMINATED:
There is now available a new Reverse Servo Cushion Spring, and a new Reverse Servo Return Spring. Replacing these springs should correct the harsh reverse condition. The reverse servo return spring should only be replaced on the 2.8L engines.

Spring, Reverse Servo Cushion (All).....	8668121
Spring, Reverse Servo Return (2.8L Only).....	8668127
