Technical Service Information

MITSUBISHI F4A40/50 SERIES SHUDDERING ENGAGEMENTS OR HARSH SHIFTS

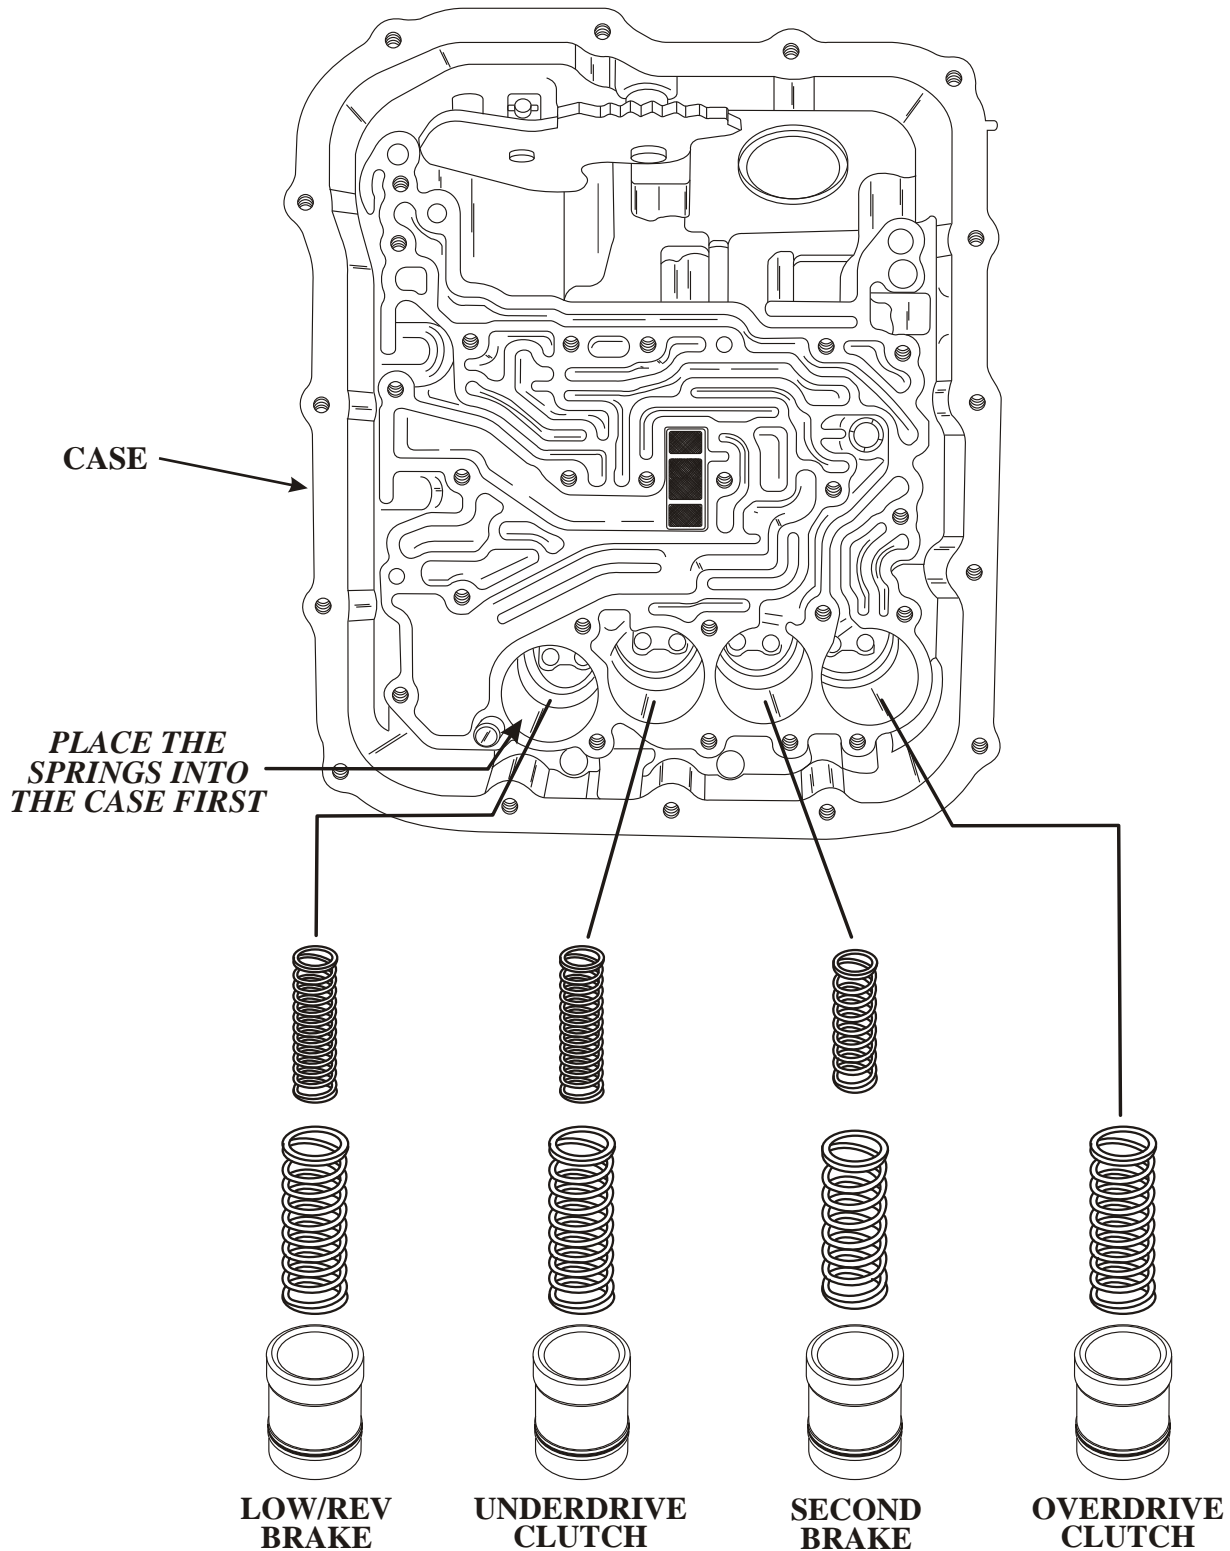
COMPLAINT: After overhaul, vehicles equipped with the F4A40/50 series transaxles may exhibit Shuddering engagements into gear or Harsh upshifts.

CAUSE: The cause may be, during overhaul, the Accumulator Pistons and springs were installed backwards into the case or the springs were mis-assembled in the Accumulator Pistons.

ACCUMULATOR PISTON AND SPRING PLACEMENT IN THE CASE

CORRECTION: Refer to Figure 1 for the spring dimensions for each Accumulator piston, and to Figure 2 for the correct accumulator identification and placement.

NOTE: *Ensure that each Accumulator line-up is placed into the case springs first.*
