Technical Service Information

THM 4L60 (700-R4) BIND-UP IN REVERSE

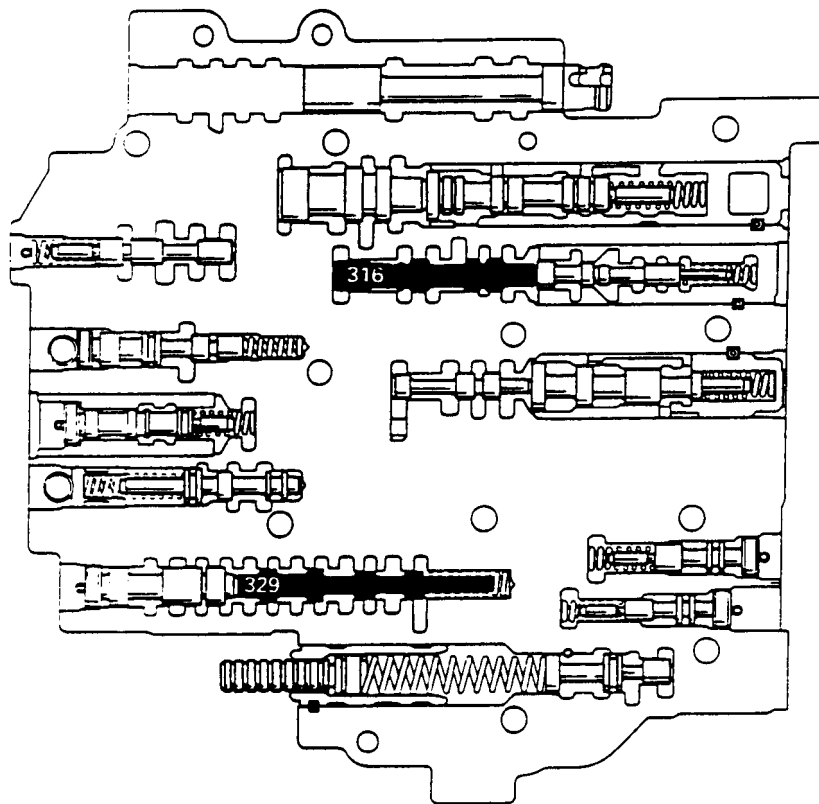
- COMPLAINT:** Binding or "Tie-up" when selector lever is placed in the averse position.
- CAUSE:** This condition may be caused by the 4-3 sequence valve or the 2-3 shift valve, stuck in the upshifted position, because of burrs or contamination.
- CORRESTION:** Clean the contamination or remove burrs from the problem valves. Refer to Figure 1 for valve location.
