Technical Service Information

SATURN ERRATIC SHIFT PATTERN, AFTER REBUILD OR AFTER REPROGRAMING PCM

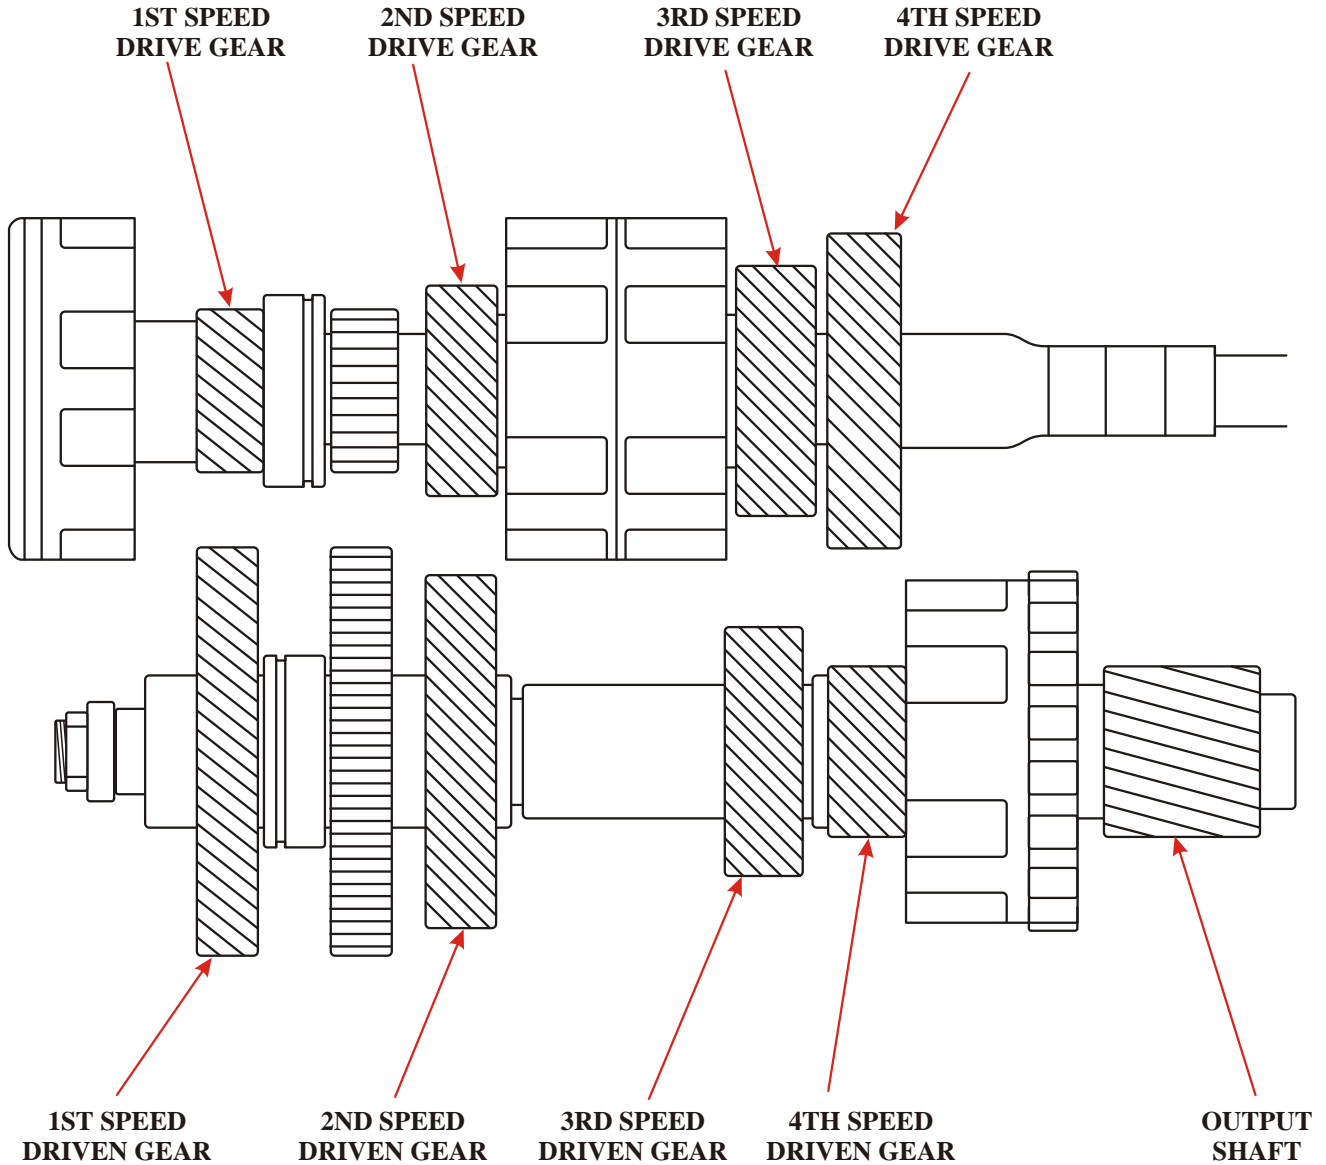
Figure 2

CAUSE: The cause may be, a mis-match of gear train parts (Drive and Driven Gears), between the 1st design "MP6" Base Transaxle, and the 2nd design "MP6" Base Transaxle, or the "MP7" Performance Transaxle.

INDIVIDUAL DRIVE AND DRIVEN GEAR IDENTIFICATION

CORRECTION: When rebuilding a Saturn transaxle, and gear train replacement is necessary, ***ensure*** that the replacement gears have the ***exact*** same tooth counts as the originals. Refer to the charts in Figures 1 and 2 for the proper gear tooth counts for the model that you are rebuilding.

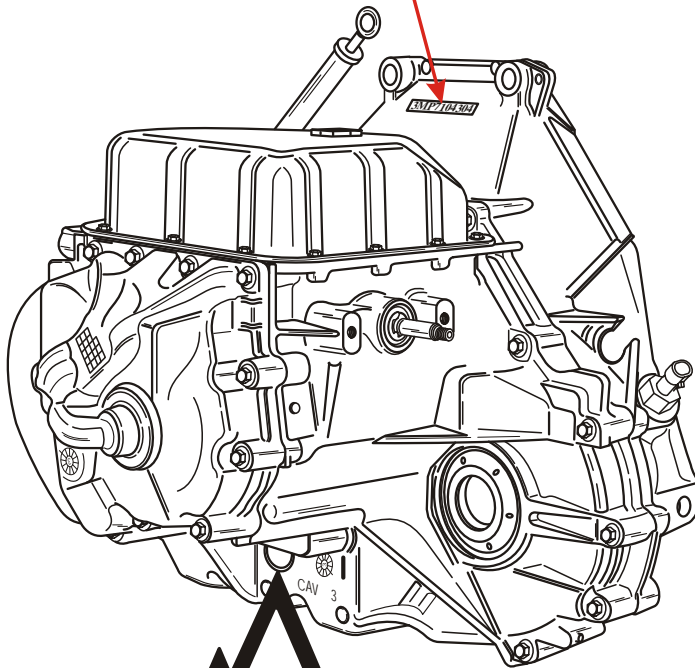
Important Note: Refer to Figure 3 to identify the transaxle design level and type of transaxle. They are as follows: ***"MP6" Base = 1st Design***

"MP6" Base (With "SV") = 2nd Design

"MP7" = Performance Version

**STAMPED IDENTIFICATION CODE
CAN BE FOUND IN THIS AREA**

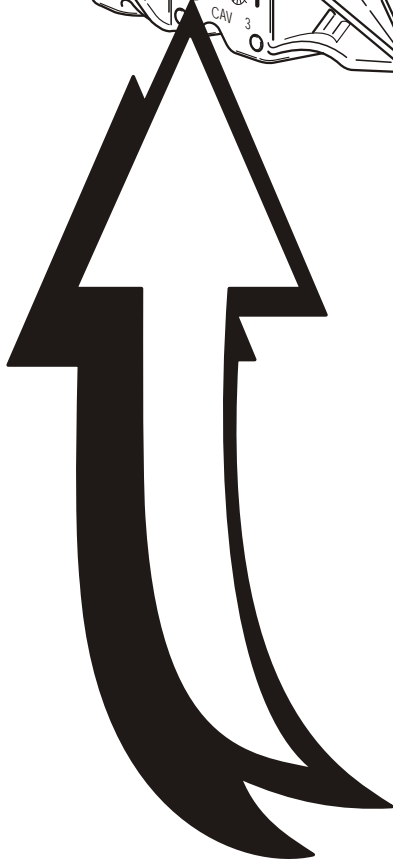
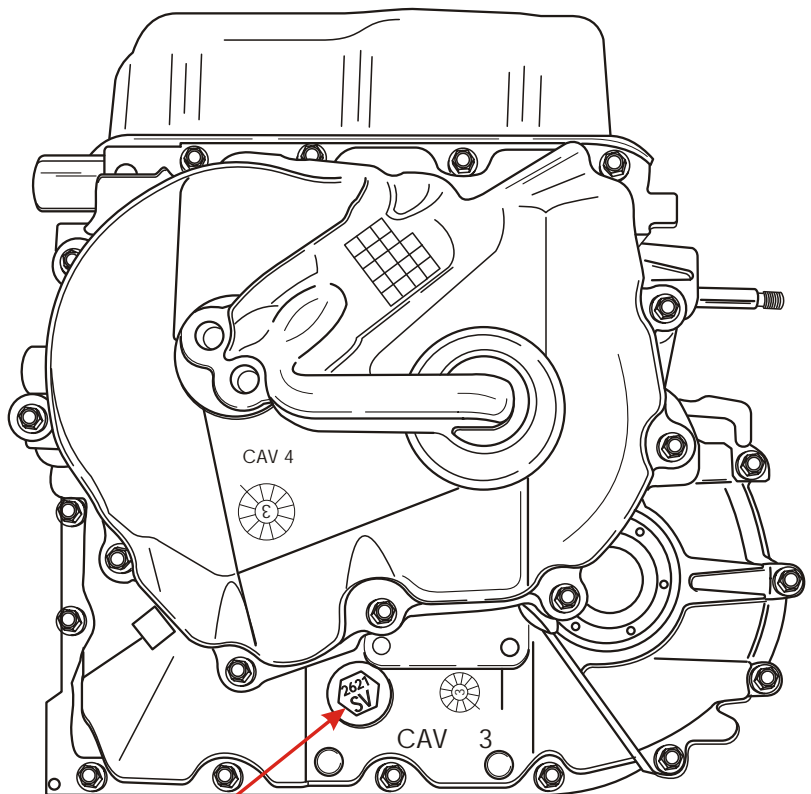
Figure 3

Identification "SV" here is 2nd design level
