## **"2008" SEMINAR INFORMATION INDEX**

### ***Ford, Chrysler & Imports***

## ***AUTOMATIC TRANSMISSION SERVICE GROUP***

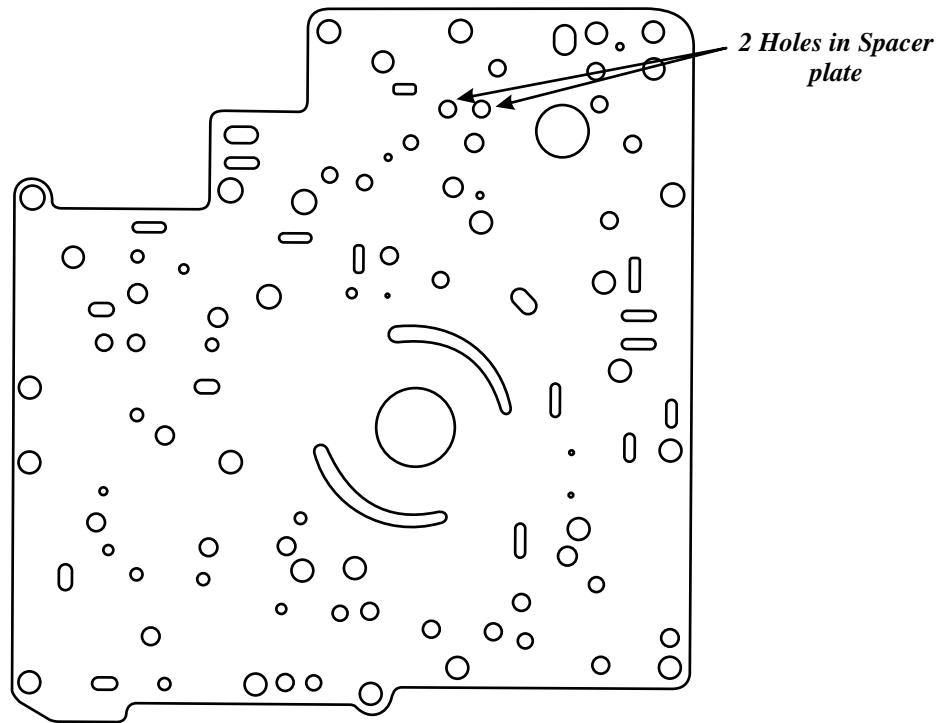
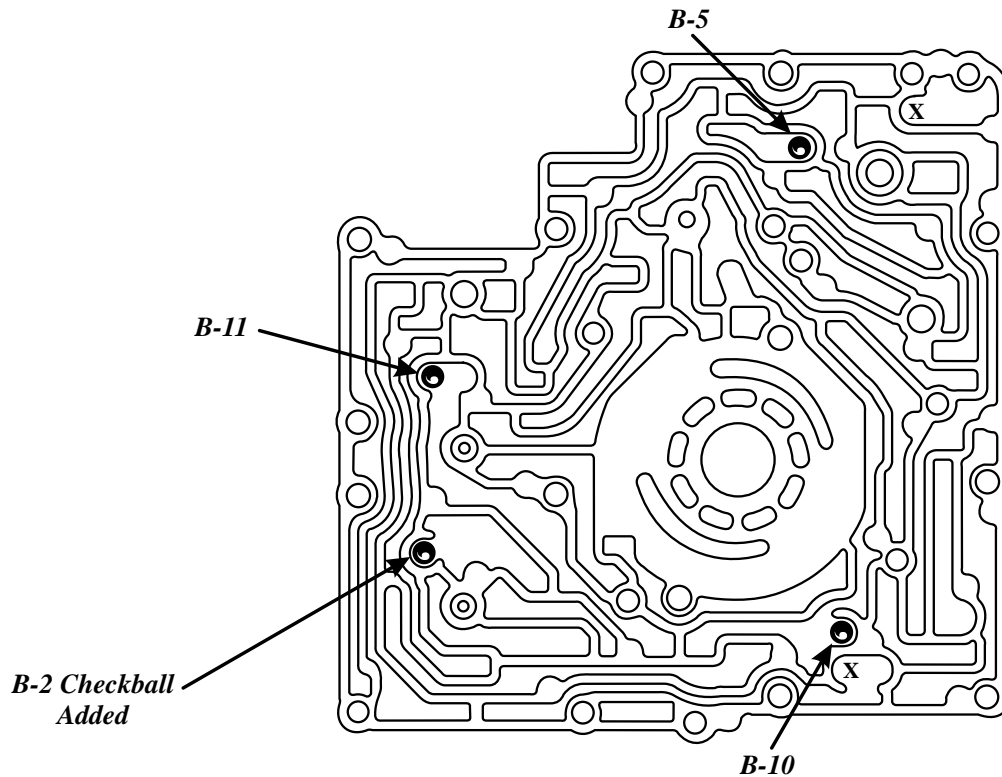
**COMPLAINT:** 1999 and Up Ford vehicles equipped with the AX4S transaxle may exhibit a 1-2 neutral condition after overhaul. Upon valve body inspection, the 1-2 Capacity Modulator Valve is not sticking.

**CAUSE:** The cause may be, during overhaul, the pump had to be replaced, because of typical pump shaft bearing and rotor failure, and a replacement pump body with a 98 and earlier spacer plate was used. The 1999 and up pump plate requires 3 check balls, and when the B5 check ball is left out when using the previous design spacer plate, L12 pressure will be lost at the manual valve, thru the Reverse circuit.

**CORRECTION:** Refer to Figure 1 to identify the previous design Pump body and Pump spacer plate, and Refer to Figure 2 to identify the 1999 and Up design Pump body and Pump Spacer plate and ensure that the correct plate and checkball locations are used.

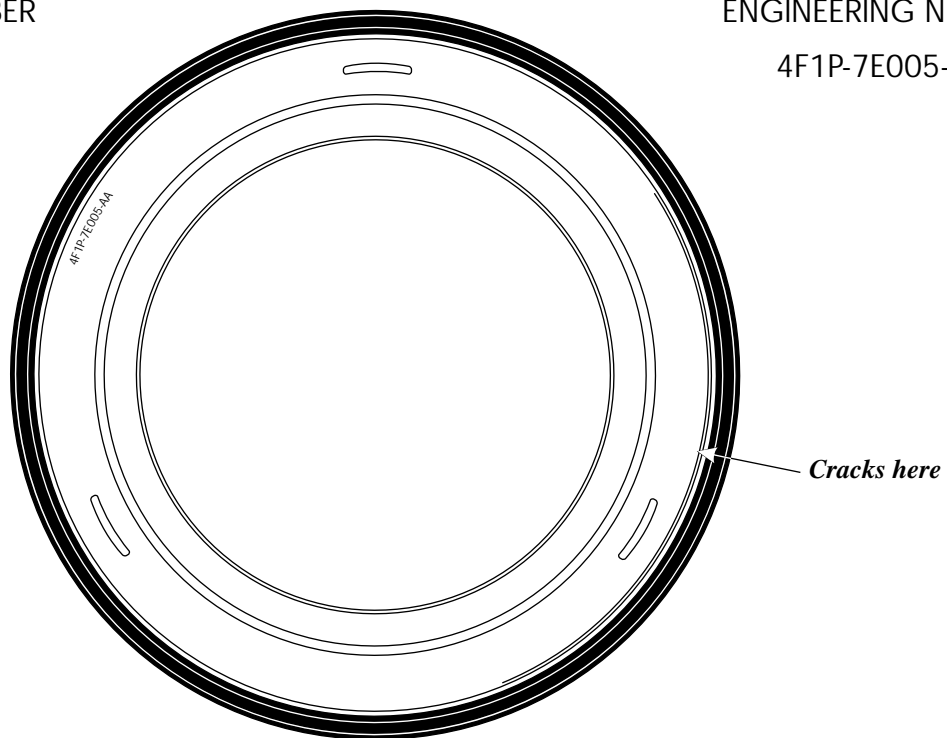
Figure 3

**CAUSE:** The cause may be, a cracked Intermediate Piston, as shown in Figure 3, or a weak 1-2 Capacity Modulator Valve Spring. Note: 2004 and Up 4F50N are equipped with the 1-2 Capacity Modulator Valve that controls the rate of application of the Intermediate Clutch, like the previous 1-2 Capacity Modulator Valve on the AXOD/AX4S. See Figure 4.

PREVIOUS DESIGN  
ENGINEERING NUMBER  
F88P-7E005-AA

NEW DESIGN  
ENGINEERING NUMBER  
4F1P-7E005-AA

**CORRECTION:** To correct this condition, replace the Intermediate piston with an updated piston from Ford or from your parts distributor as some distributors sell the O.E. pistons. Install a heavier spring into the 1-2 Capacity Modulator valve line-up. Note: the 2-3 Capacity Modulator Valve spring is the same as the 1-2 , if a firmer 2-3 upshift is desired , a firmer spring can be used there also. See Service information for available aftermarket replacement springs. *Note: the 1-2 and 2-3 Capacity Modulator Valve springs are identical so 2 aftermarket springs can be used, to cover 2nd and 3rd gear shift feel, per transmission overhaul.*

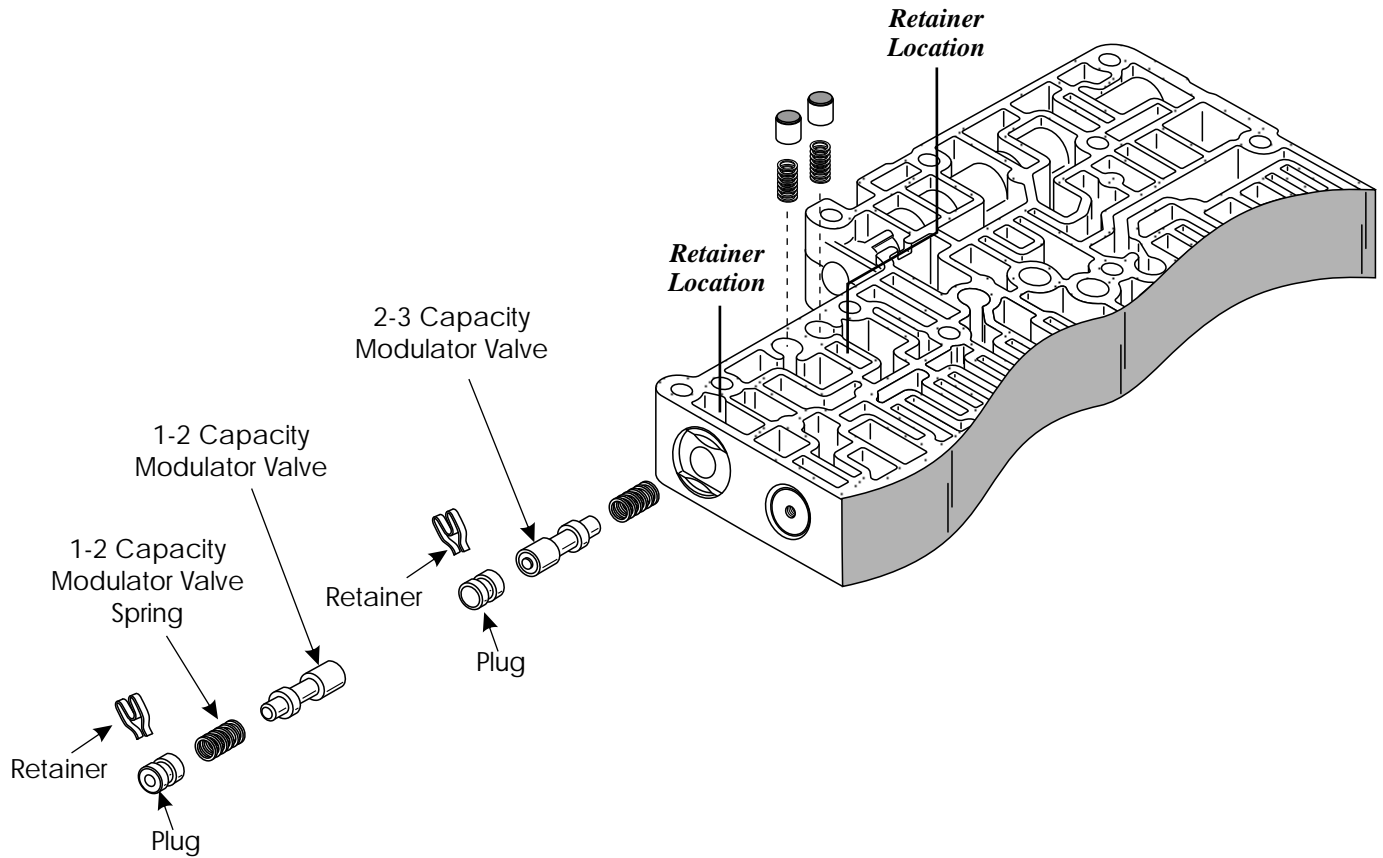
## 2004 AND UP 4F50N 1-2 CAPACITY MODULATOR VALVE SPRING LOCATION

*Note: The 1-2 and 2-3 Capacity Modulator valve springs are the same*

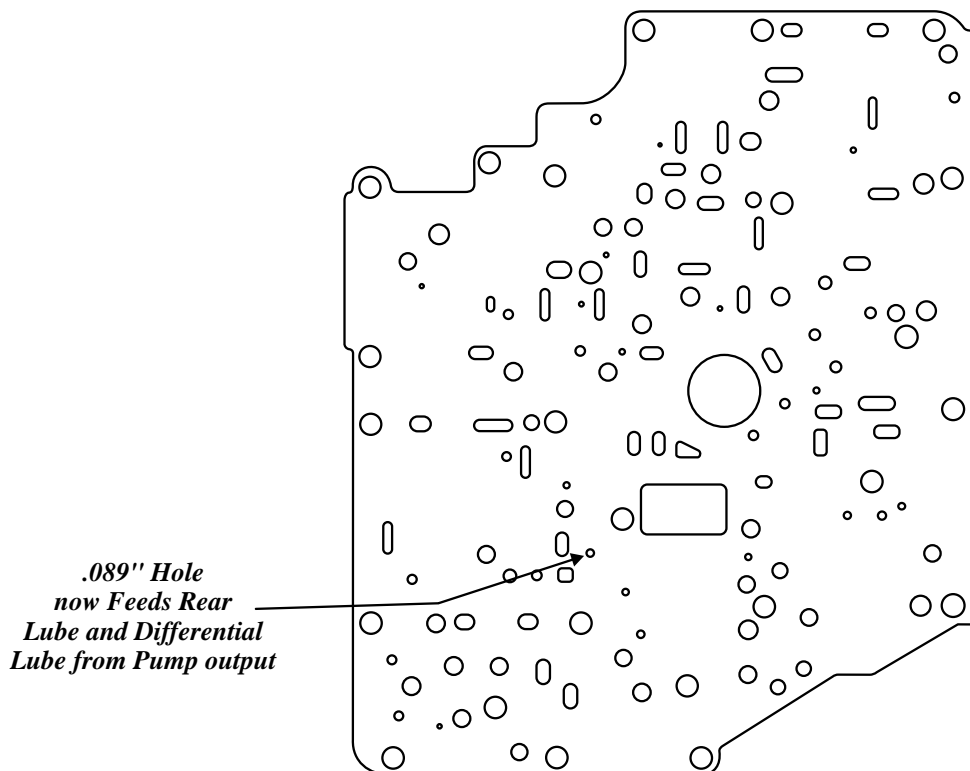
Figure 5

**CAUSE:** The cause may be, a leak in the lube circuit, which is now fed directly from pump output, through an .089" orifice in the main spacer plate, as shown in Figure 5. This leak may be from a broken o-ring on the lube pipe where it fits in the case or a crack in the braised area where it feeds the support, or a damaged "orange" lube seal in the support (see Figures 6 and 7). A leak in the lube circuit may cause a low overall line pressure condition, when the PCM notices that forward has not been engaged, it will elevate line pressure causing the bang when forward is finally engaged.

**CORRECTION:** To correct this condition, ensure that the lube pipe o-ring and the braised area of the pipe are in good condition, also make sure that the "orange" seal in the support is in good condition.

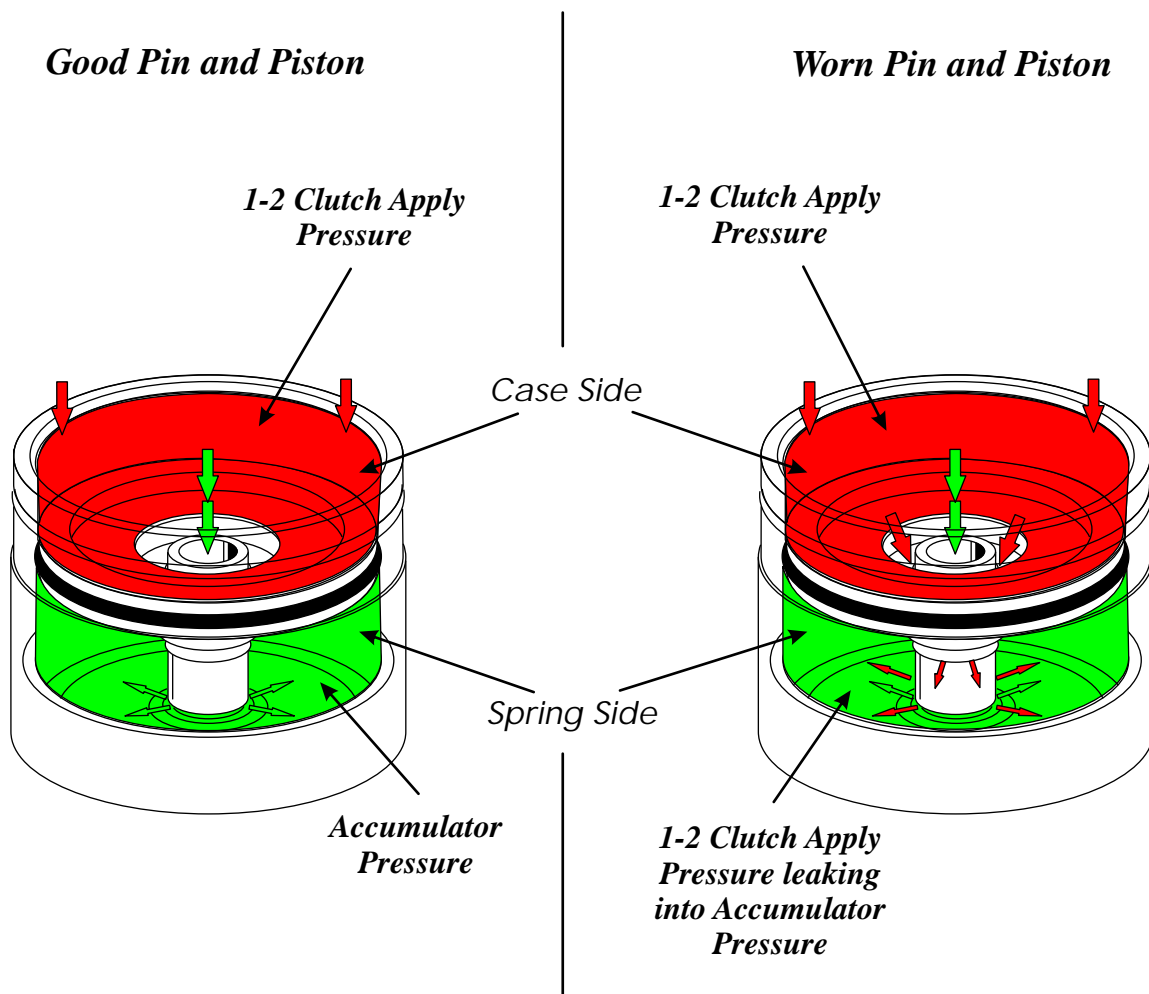
## N-D / 1-2 CLUTCH ACCUMULATOR ASSEMBLY

**CAUSE:** The cause may be, a worn 1-2 Clutch Accumulator pin and piston causing a slow engagement into Drive. This slow engagement will cause the PCM to elevate line pressure which causes the harsh / bang on engagement. Refer to Figure 8 for the identification of the 1-2 Accumulator pin and piston. Refer to Figure 9 for a cross-sectional view of the 1-2 Clutch Accumulator hydraulic circuit.

*Note: Accumulator Pressure is fed thru the pin to the spring side of the Accumulator Piston, when the Pin wears it will allow 1-2 Clutch Apply pressure to leak into the Accumulator Circuit causing a slow engagement of the 1-2 Clutch.*

**CORRECTION:** To correct this condition, ensure that the Accumulator pin and piston have a snug fit, replace as necessary.

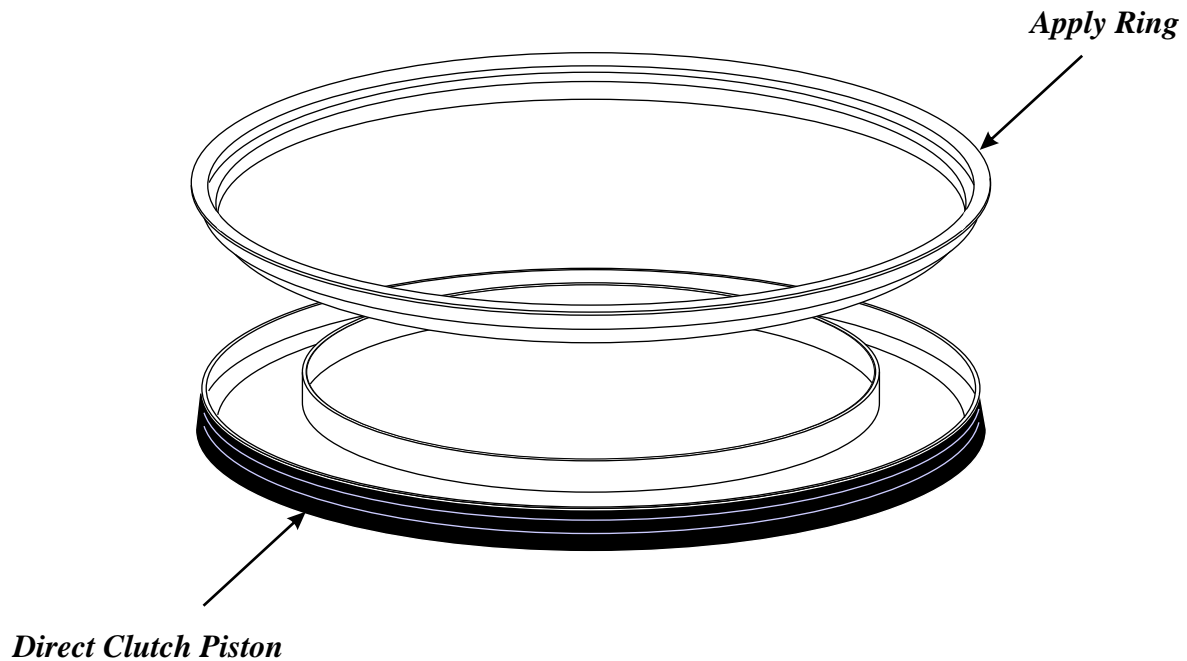
Figure 11

**CAUSE:** The cause may be that during overhaul, the direct clutch bonded piston was replaced and the apply ring was not transferred to the new piston. Refer to the cross-sectional view in Figure 10 which shows that when the apply ring is left off, the Direct clutch piston will not contact the Direct clutch bottom steel.

**CORRECTION:** To correct this condition ensure the apply ring is assembled onto the Direct Clutch Piston as shown in Figure 11.

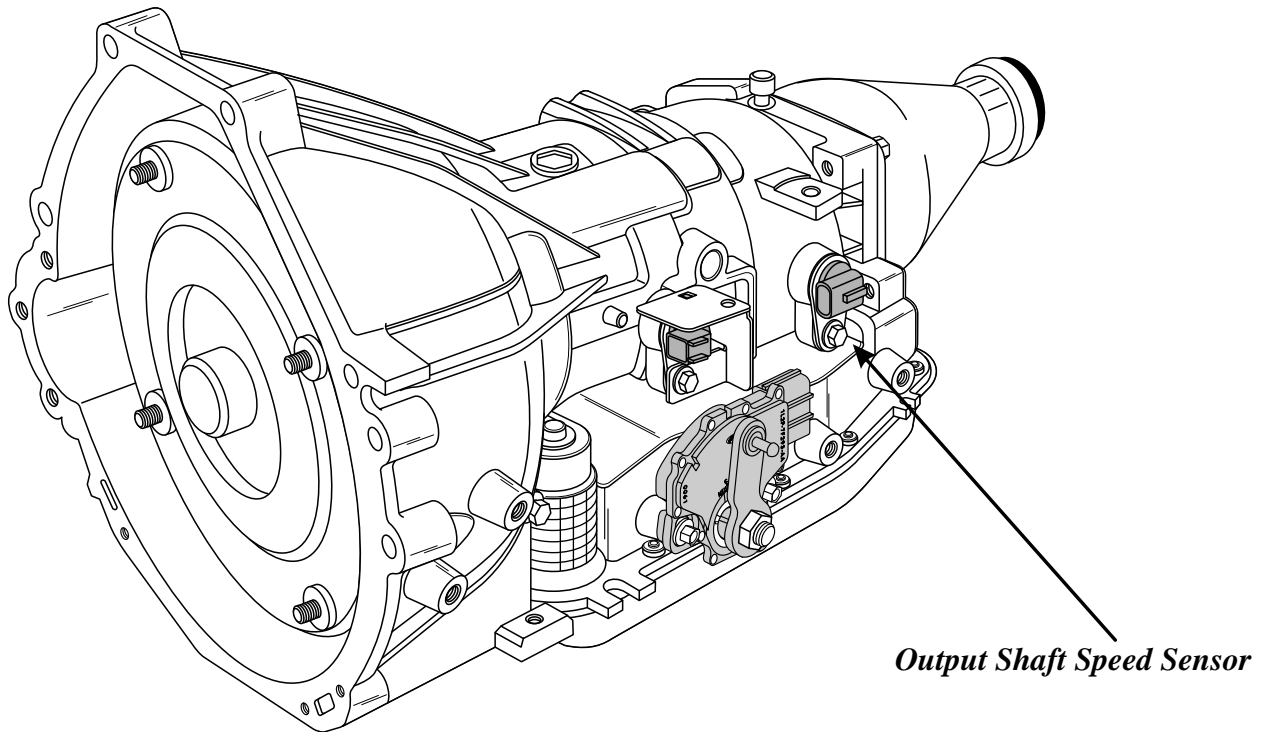
Figure 1

**CAUSE:** Beginning at the start of production for the 2004 model year, this family of transmissions is manufactured with extended parking lugs on the ring gear to trigger the output speed sensor, instead of the previous design with holes in the ring gear, which also required a strategy change in the PCM. If either a transmission earlier than 2004, or the use of 2003 or earlier ring gear is installed in a 2004-up vehicle, the PCM will not be able to correctly calculate vehicle speed, and will result in either no speedometer reading, or a slow speedometer reading. DTC's P0720-P0722 may be set. The 2004-up Rear Ring that has the extended park lugs utilizes the Output Shaft Speed Sensor with the white body, and a black connector (See Figure 5). The 2003-earlier units had the Rear ring gear with the holes, and utilizes the all black Output Shaft Speed Sensor, which is .083 inches longer than the 2004-up Output Shaft Speed Sensor (See Figure 4).

OUTPUT SPEED SENSOR, 2001-2003 (Square Connector) .....1L3Z-7H103-AB  
OUTPUT SPEED SENSOR, 2004 Models (.083" Shorter) .....3L3Z-7H103-AA

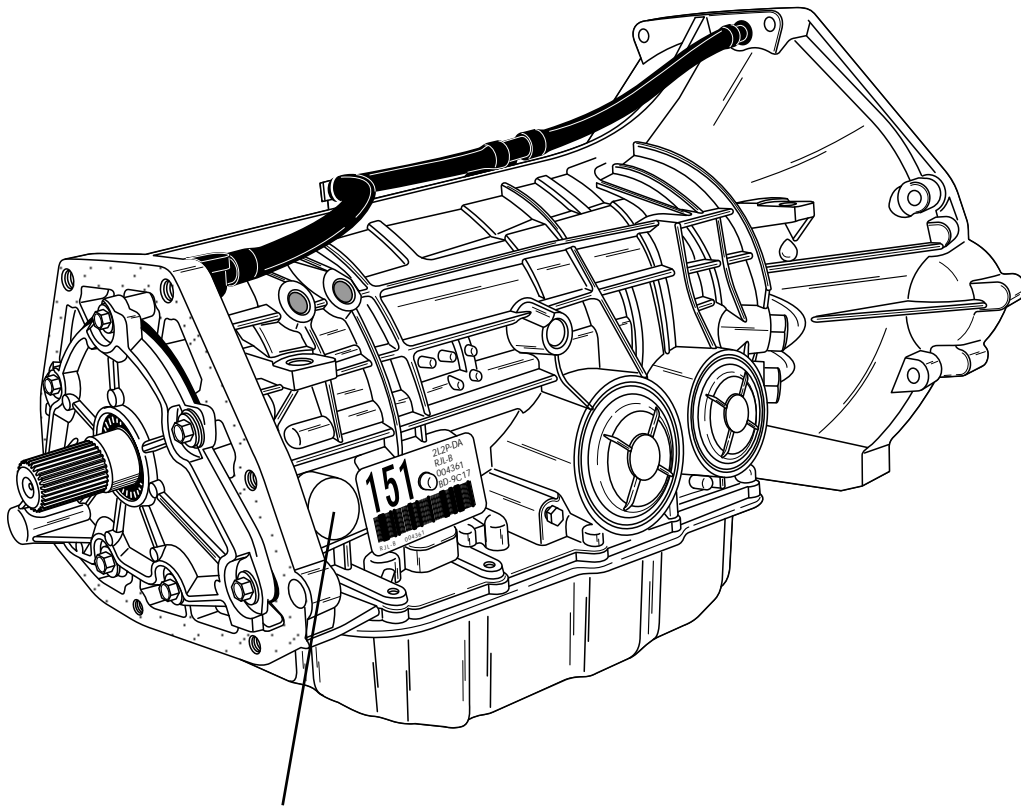
Figure 1

- CAUSE:** Beginning in 2003, Ford eliminated the fill plug that is located on the passenger side rear of the transmission. The boss in the case where the plug was located is still there, however, the plug is not.

PREVIOUS FILL PLUG LOCATION  
NOTE; BOSS STILL EXISTS, HOWEVER  
FILL PLUG IS NOT THERE.

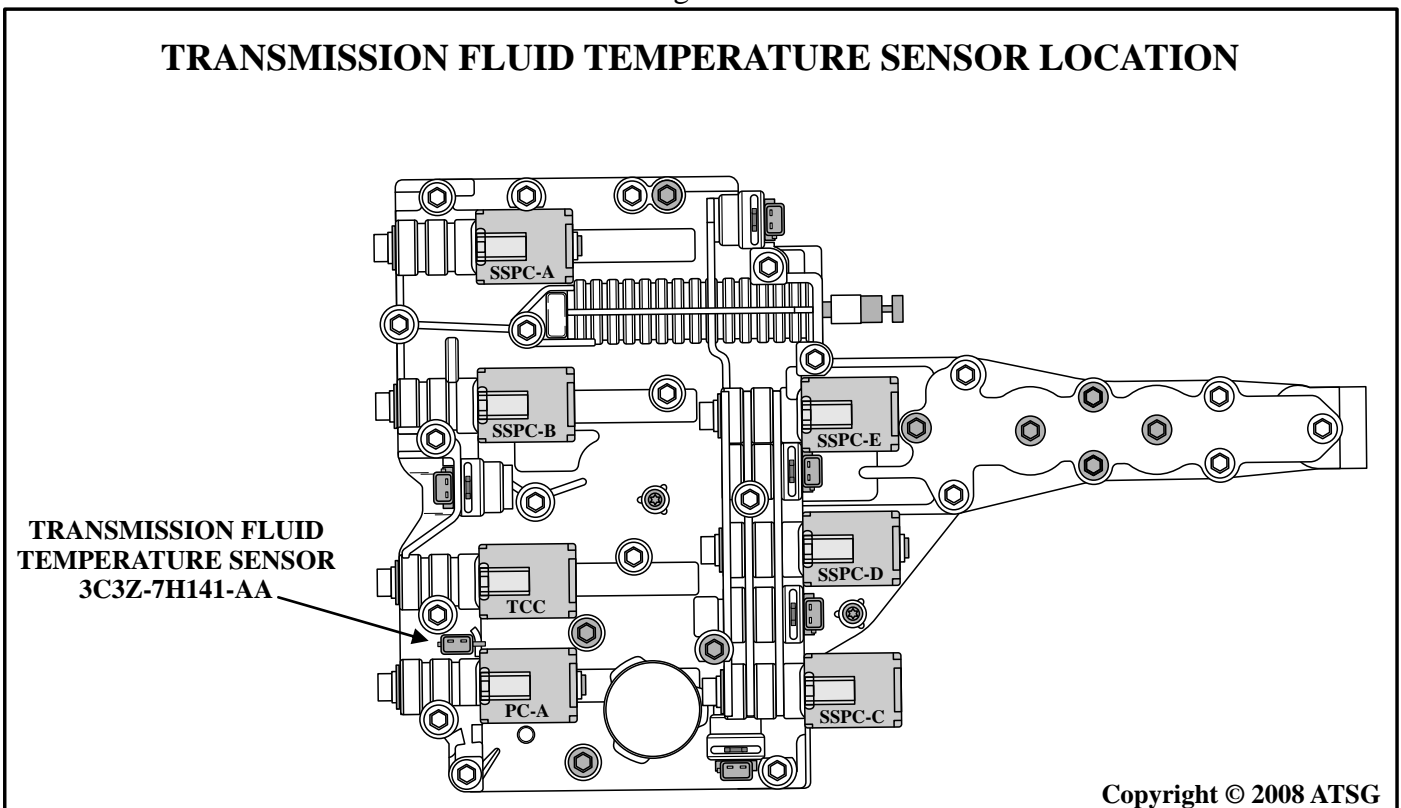
Figure 2

**CAUSE:** Either the TFT sensor is faulty (Figure 2) or the internal wiring harness is faulty (Figure 3). The transmission fluid temperature (TFT) sensor twist-locks into the solenoid body and is a temperature sensitive device called a thermistor (Figure 2). As the fluid temperature increases, the TFT resistance decreases, as shown in the chart in Figure 4. The PCM uses the TFT signal as an input to determine cold and hot temperature shift scheduling and for TCC apply and release scheduling. When the transmission is in cold mode operation, below -15°C (5°F), as determined by the TFT sensor, the transmission shifts 1st gear, 2nd gear, 3rd gear, 4th gear (ratio 1.09), 6th gear. When in hot mode the transmission will shift 1st gear, 2nd gear, 3rd gear, 5th gear (ratio 1.00), 6th gear. Either way it is still a five speed unit with six forward gear ratios available, dependant upon cold mode or hot mode operation.

*Note: Plug in the trans harness connector and the same voltage and ground tests can be performed with the trans pan removed at the 2 terminal connector when unplugged from the TFT sensor as seen in figure 2. This will confirm the complete circuit integrity to the sensor. If this test fails, the internal harness is faulty.*

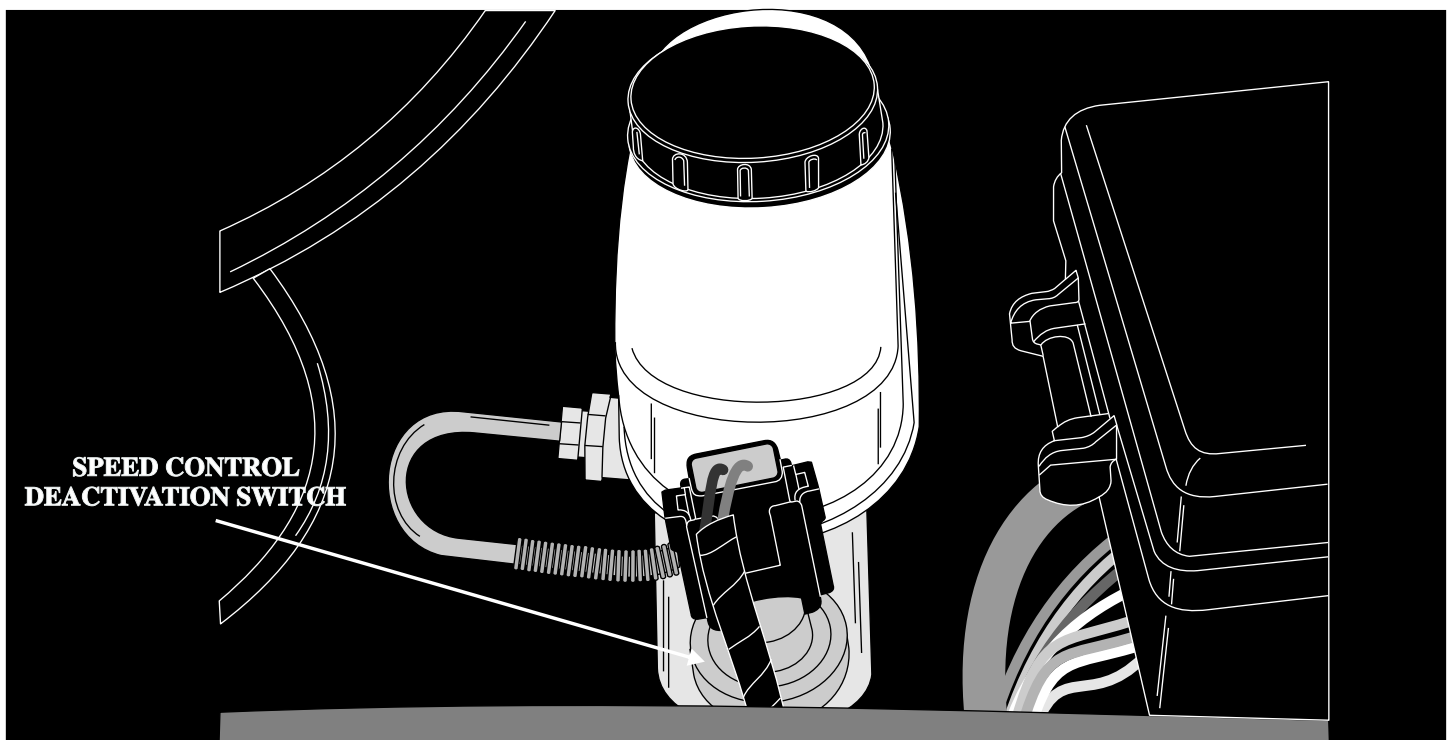
Figure 3

**CAUSE:** A leaking Speed Control Deactivation Switch. When the Speed Control Deactivation Switch develops a leak, the brake fluid drips on to the Speed Control Amplifier connector which carries system voltage even when the vehicle is turned off.  
The brake fluid begins to smolder and eventually ignites, the fire then spreads to whatever will burn, the end result could be catastrophic if this process occurs in the middle of the night.

The repair consists of replacing the deactivation switch (Refer to Figure 3) and installing a fused sub-harness which routes the connector out from under the brake master cylinder, (Refer to Figure 4).

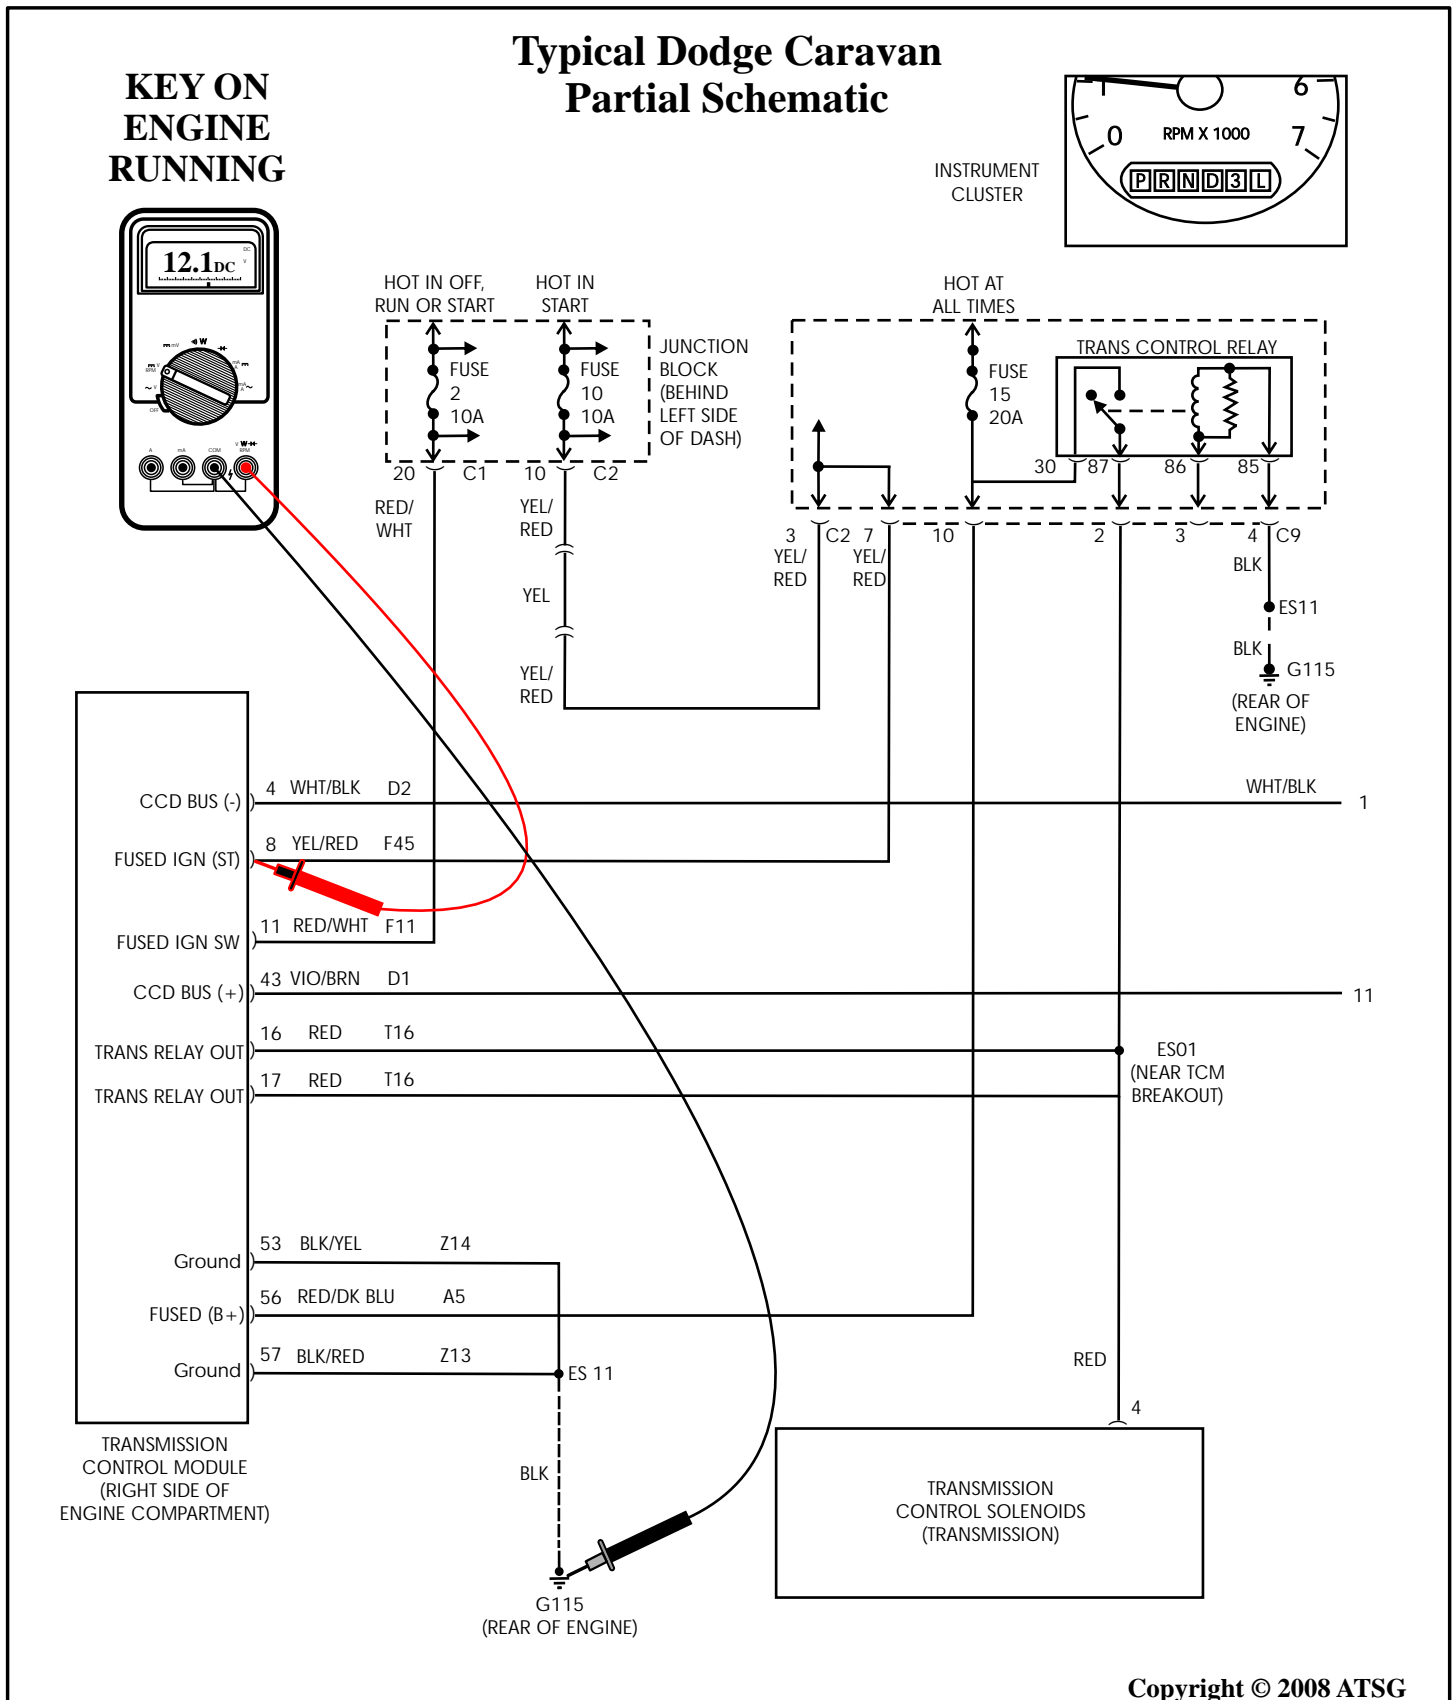
Figure 1

**CAUSE:** Malfunctioning ignition switch causing a continuous 12 volts present on pin 8 of the TCM while the engine is running (shown in figure 1). Battery voltage on pin 8 should only be present with the ignition switch in the crank position. Voltage should drop to zero when ignition key is released back to the run position (figure 2). Some models vehicle start when the key is turned to the "On" position, such as the 2000 Dodge Intrepid with the type of starting circuit as seen in figure 3.

**CORRECTION:** Replace ignition switch or fix possible short to power.

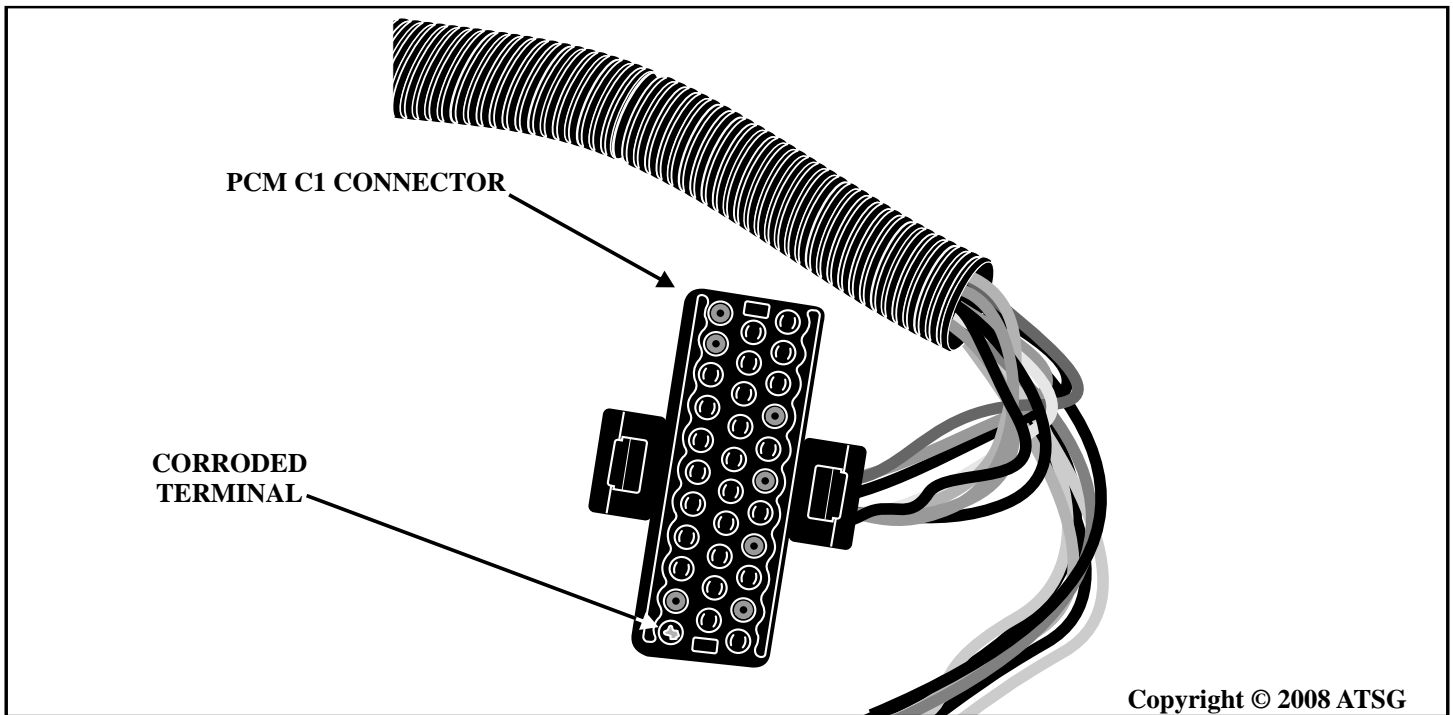
Figure 1

After pulling the connector apart, it was obvious what was causing the above complaints. The terminal end (Refer to Figure 1) was severely corroded. The reason for the corrosion is shown in Figure 2, the PCM connectors are located next to the air conditioning receiver/dryer. The condensation created by the receiver/dryer compromised the C1 connector which lead to the severe corrosion condition.

**CORRECTION:** Replace the damaged terminals with wire end repair kit (Figure 6) using figures 3 through 6 to guide through the wire replacement procedure and then protect them from A/C condensation.

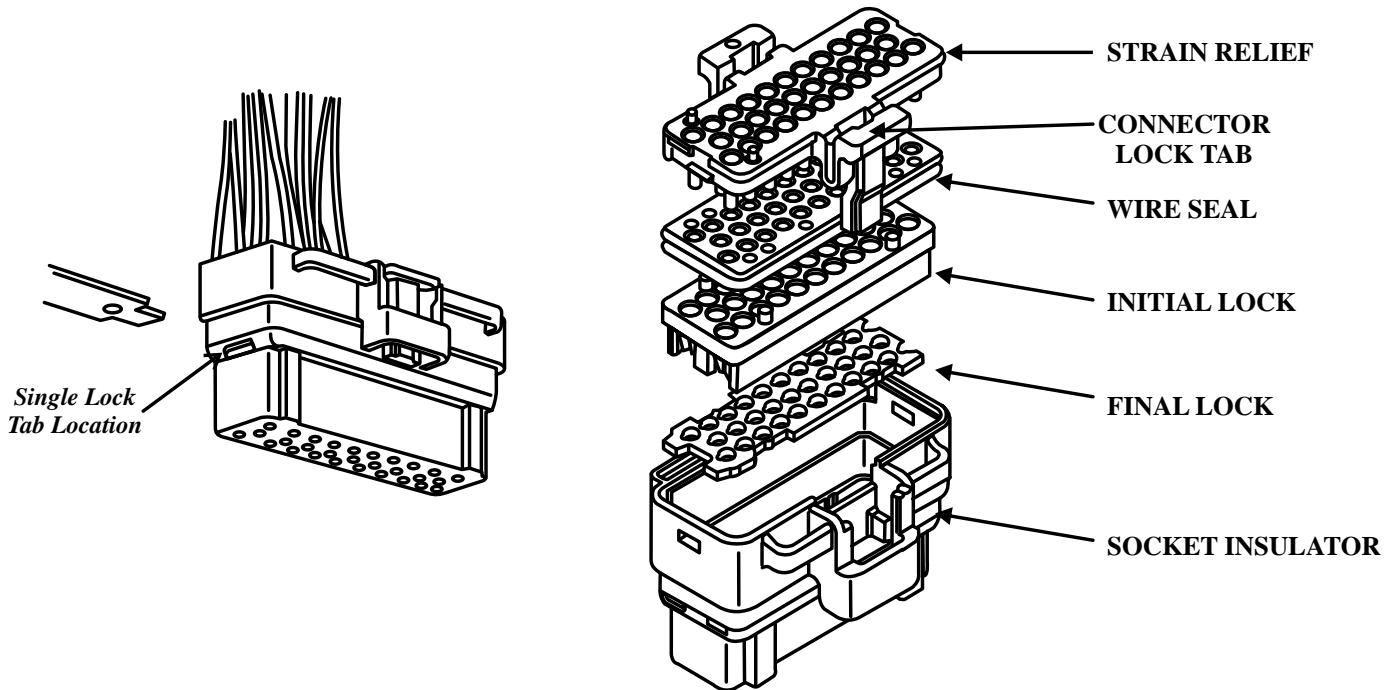
Figure 3

4. Locate and inspect the connector lock tab and insulator for damage (See Figure 3). If it is damaged, the entire connector will need to be replaced.
5. Write down each wire color to its appropriate cavity location within the connector before disassembling the connector.

9. With all the wires removed from the connector, inspect the entire connector assembly as seen in Figure 3. If any of the parts are damaged, replace the connector assembly.

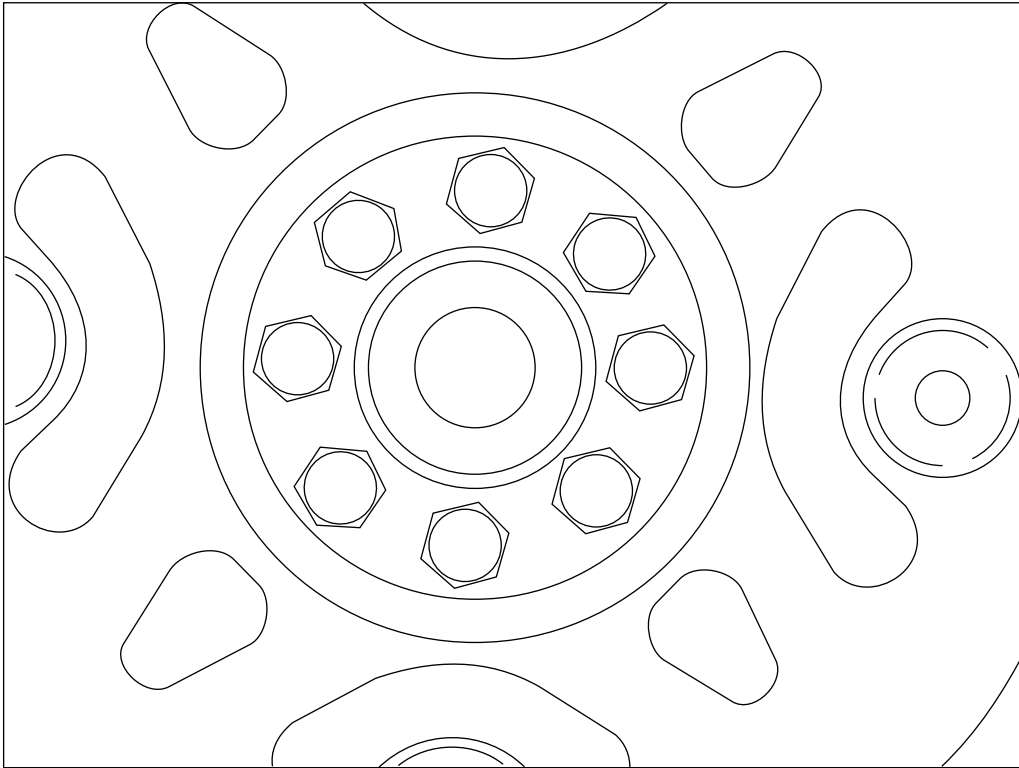
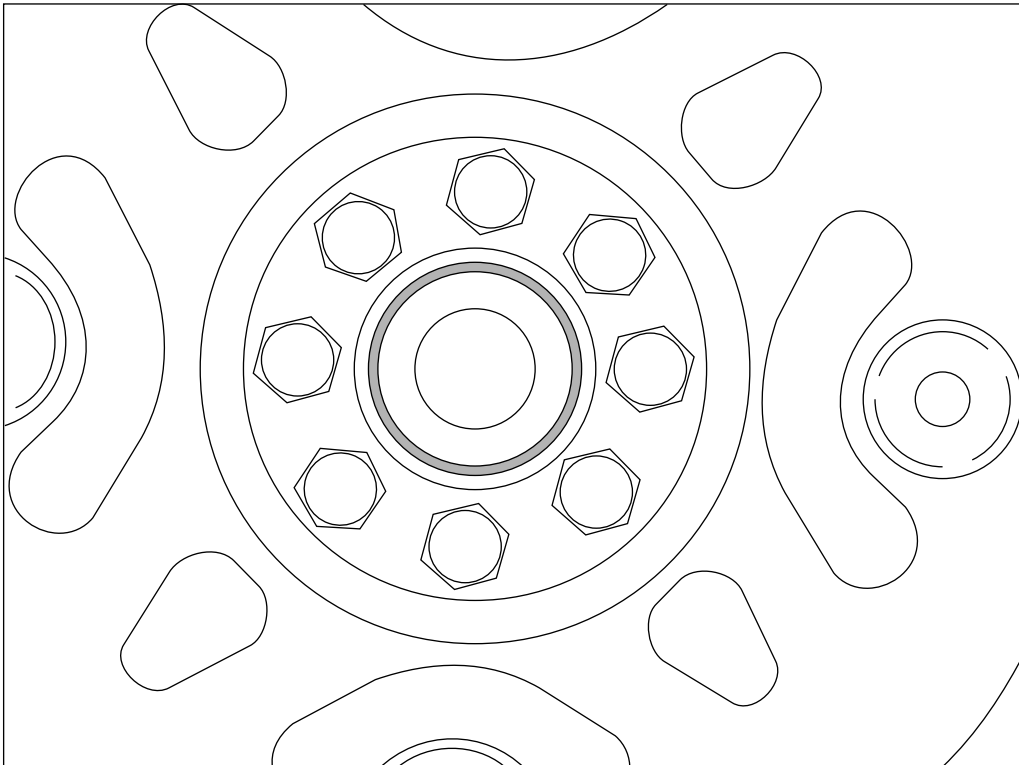
Figure 1  
Automatic Transmission Service Group

**COMPLAINT:** A 2003 Jeep Liberty with a 3.7 Liter engine and 42RLE transmission was sent to the transmission shop after the engine was replaced. After engine replacement a complaint of an engine vibration developed. Disconnecting the torque converter eliminated the vibration. After a preliminary inspection, it seemed that the converter or flywheel may be the cause of the vibration, the transmission was removed.

**CAUSE:** The Crankshaft Pilot Sleeve was left in the original engine and not transferred to the replacement engine, therefore, the nose of the converter had no support which resulted in the vibration, (Refer to Figure 1).

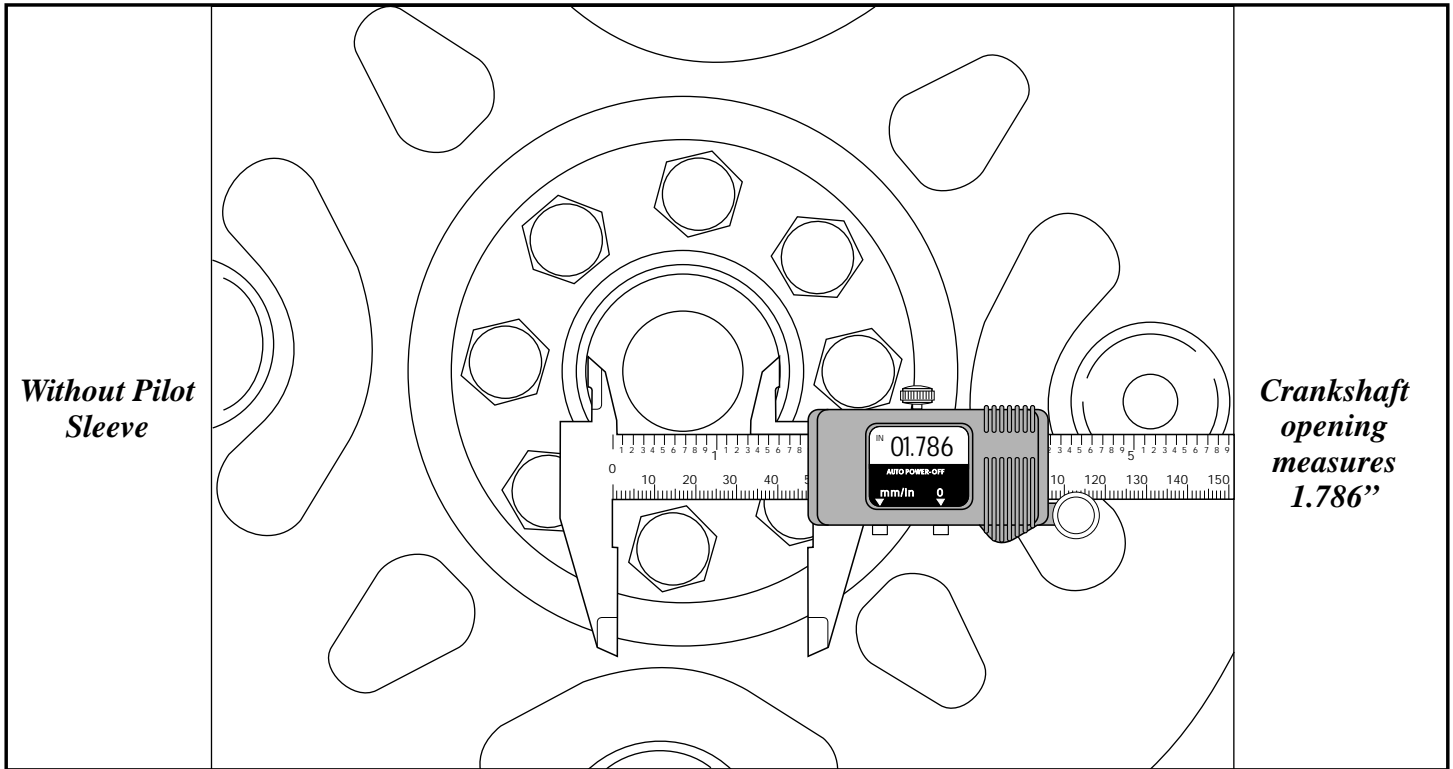
Figure 2

**CORRECTION:** The crankshaft opening measures about 1.786" with out the sleeve. The converter nose O.D. measures 1.324", lots of room for wobble, (Refer to Figures 2 and 3). The pilot sleeve I.D. measures 1.334".  
Make certain the Crankshaft Pilot Sleeve is in place when the engine replaced. Make certain the sleeve has not come out of the crankshaft and is stuck on the nose of the converter, (Refer to Figure 4).

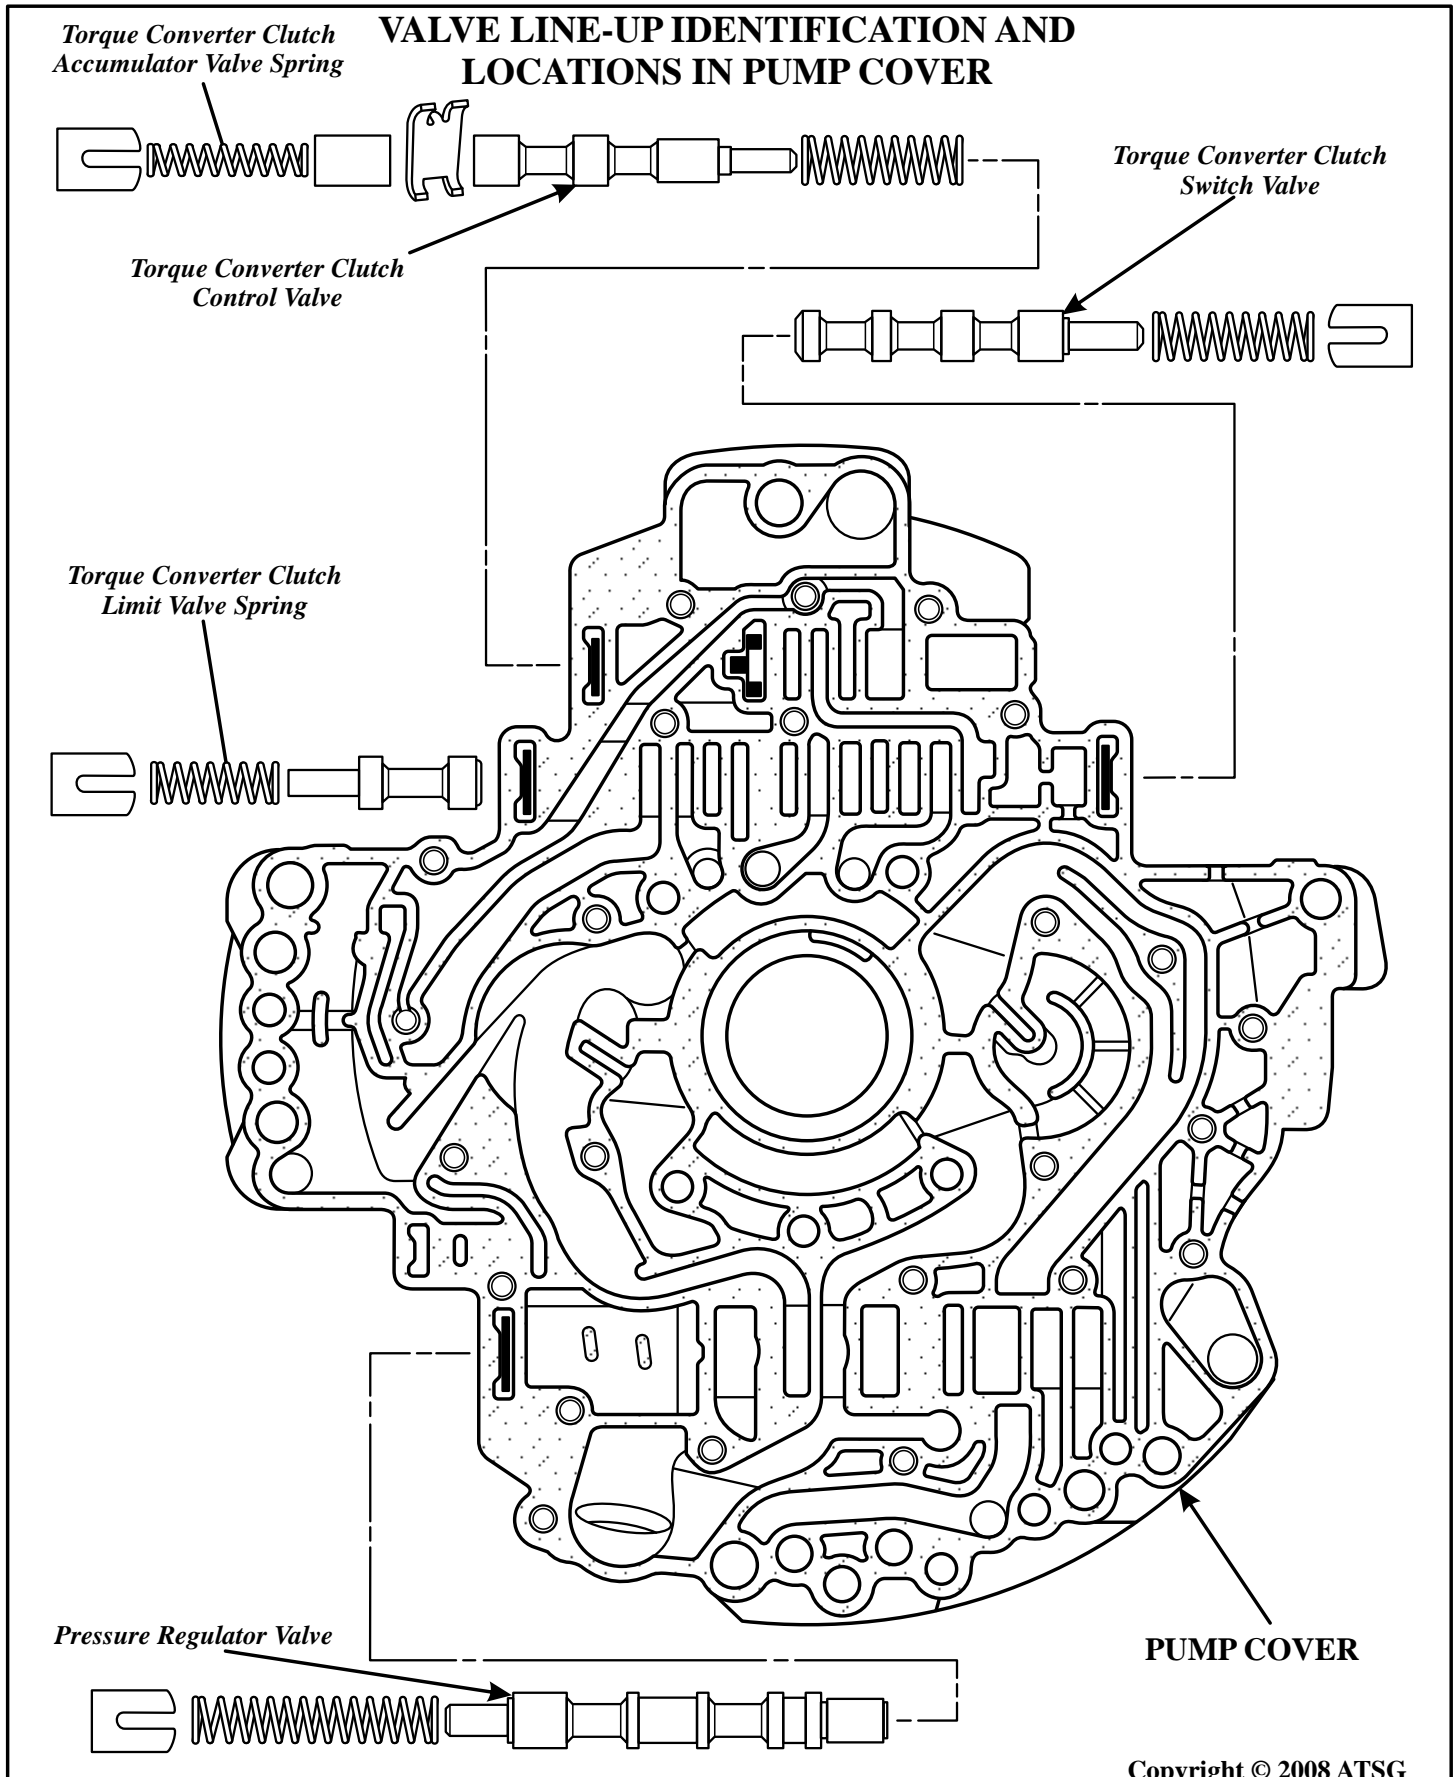
Figure 1  
Automatic Transmission Service Group

**CAUSE:** One cause may be broken springs in the Pump Assembly. A broken TCC Accumulator Valve Spring may cause a harsh engagement during TCC apply. A broken TCC Converter Limit Valve Spring may cause the engine to stall or stumble during a garage shift into Reverse or Drive.

**CORRECTION:** Replace the TCC Accumulator Valve Spring for harsh TCC apply. Replace the TCC Converter Limit Valve Spring for engine stall or stumble during garage shifts.

TCC Accumulator Valve Spring (Sonnax Part Number).....44912-01  
TCC Converter Limit Valve Spring (Sonnax Part Number).....44912-02
