Technical Service Information

THM 3T40 (125C) 1988 - 1989 NO SECOND GEAR

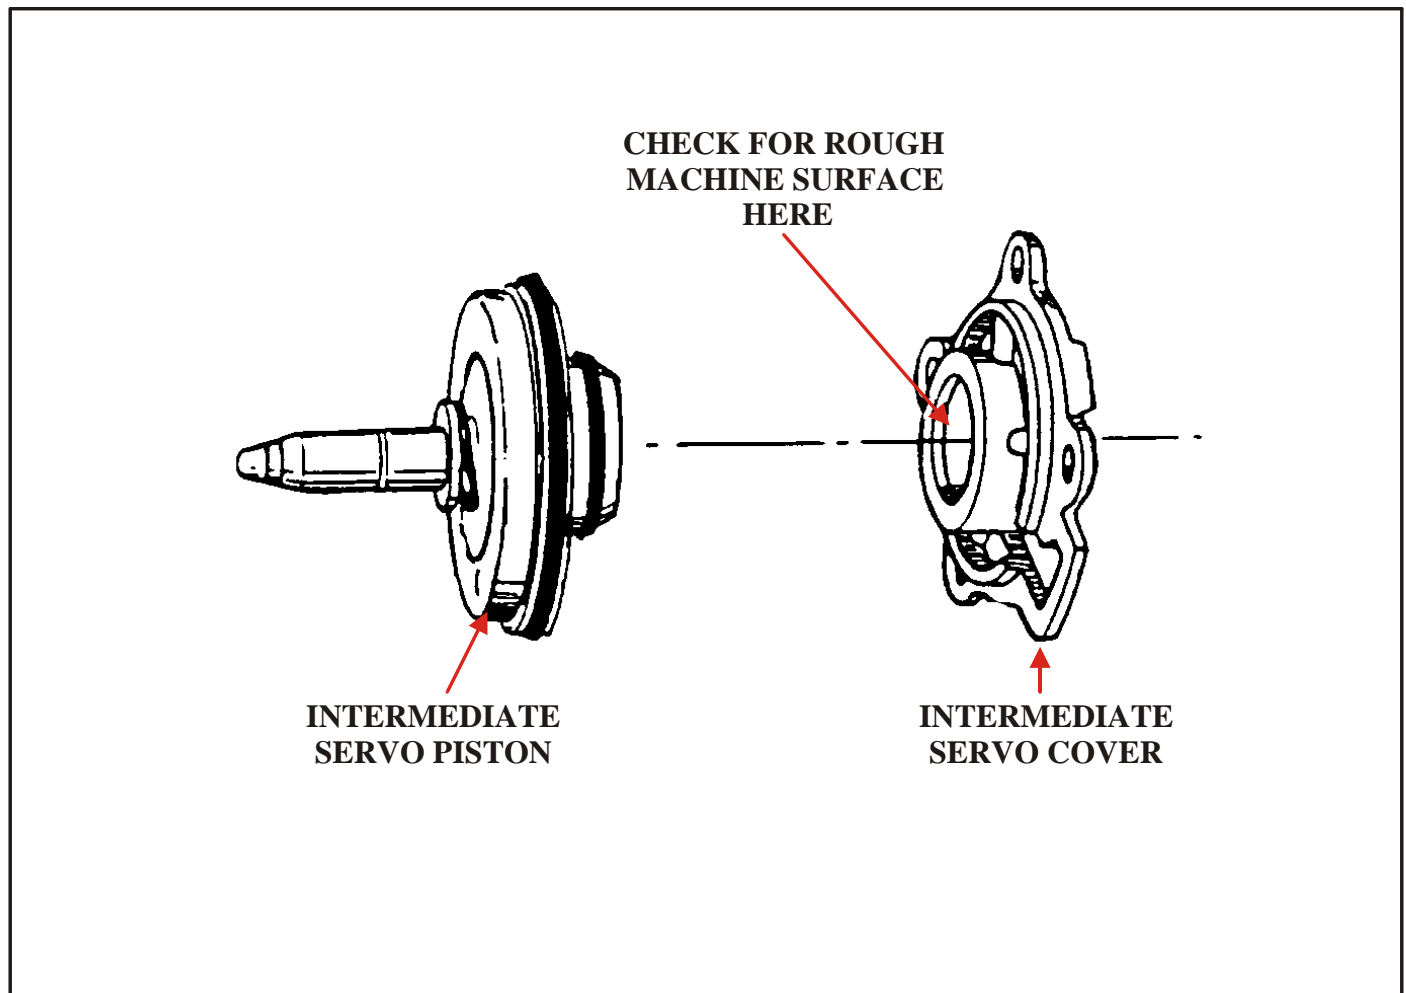
Figure 1

COMPLAINT: No second gear, manual or automatic, 1-3 shift only.

CAUSE: The cause may be a worn or torn lip seal (Small) on the intermediate servo piston, and created by a rough surface machine finish in the bore of the intermediate servo cover (See Figure 1). This rough finish will wear the lip off the (Small) intermediate servo seal.

CORRECTION: Replace the intermediate servo cover and intermediate servo piston lip seals.

Intermediate Servo Cover (1.260" Bore Diameter)	8631702
Intermediate Servo Cover (1.495" Bore Diameter)	8631703
Intermediate Servo Cover (1.672" Bore Diameter)	8631704
