# Technical Service Information

## DODGE, CHRYSLER, HYUNDAI & MITSUBISHI BROKEN PUMP F4A41/42/51 SERIES TRANSAXLE

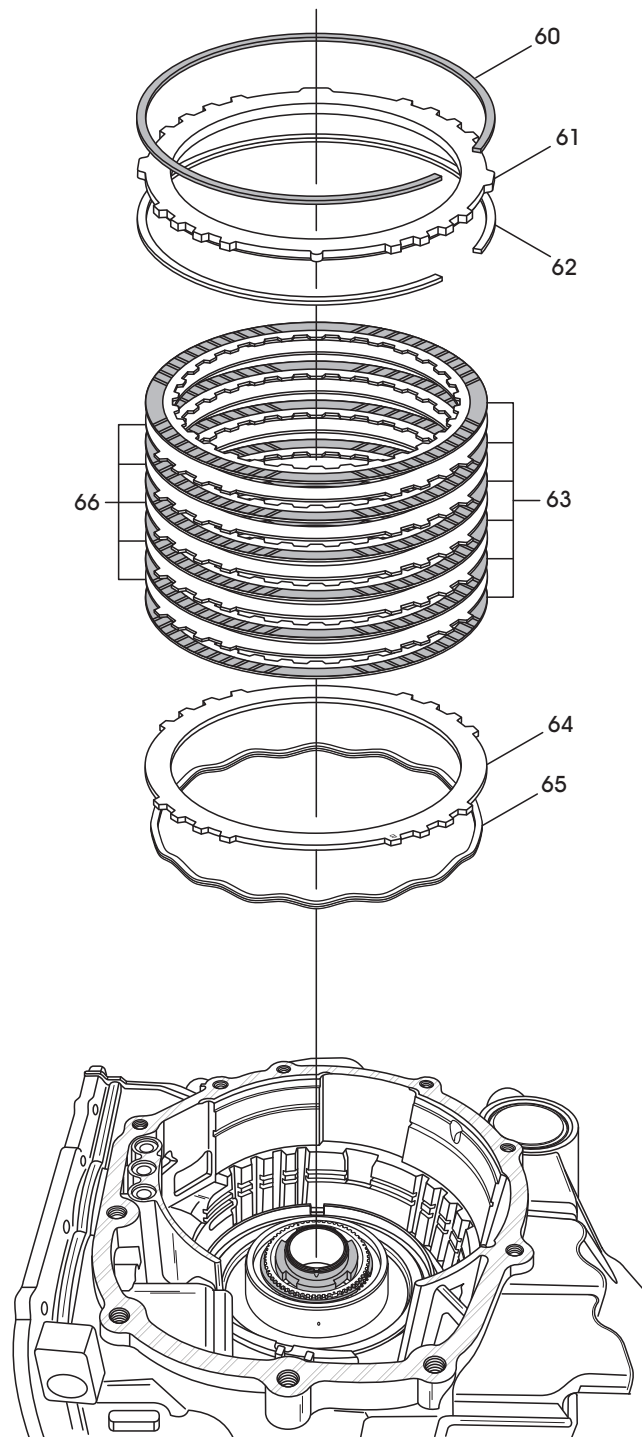
Figure 1

**CAUSE:** The cause may be broken pump gears and or severely damaged pump assembly. Pieces of Low/Reverse spiral cushion wave spring (Figure 1) located on top of the Low/Reverse clutch assembly may be found lodged between the pump gears (Figure 2). When the filter is cut open, there is a 3 to 4 inch section of filter media that is not crimped along edge of filter halves during assembly, see Figure 3 for location of filter. This allows the broken wave spring to enter the pump assembly .

**CORRECTION:** Replace pump and filter, and update Low/Reverse spiral cushion wave spring to a one piece circular wave spring.

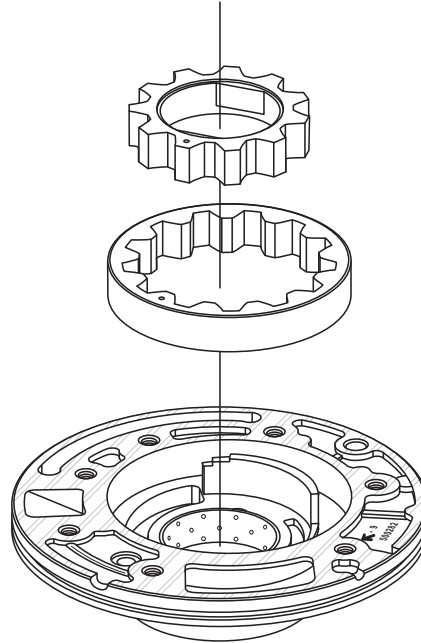
Figure 2

**COMPLAINT:** Vehicles equipped with the F4A51 transaxle may exhibit a no move condition. Fluid level may read high and line pressure is "0".

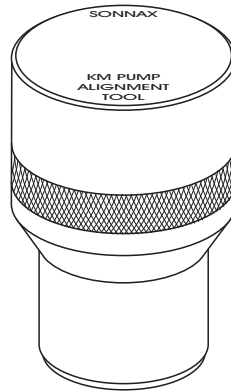
Figure 4

**Note:** One other issue that plagues this transmission is front seal leak and or damaged pump bushing after rebuild within as little as a few minutes during road test or in a couple of days. The original pump assembly is aligned during manufacturing and there are no leading edges or alignment pins to align the pump. There is an alignment tool available from Sonnax part number #41005-TL (Figure 4). With the alignment tool in place torque the pump bolts to 80 - 85 inch pounds as shown in Figure 5.

**SONNAX® KM PUMP  
ALIGNMENT TOOL  
#41005-TL**
