# Technical Service Information

## FORD AX4S OVERDRIVE BAND FAILURE

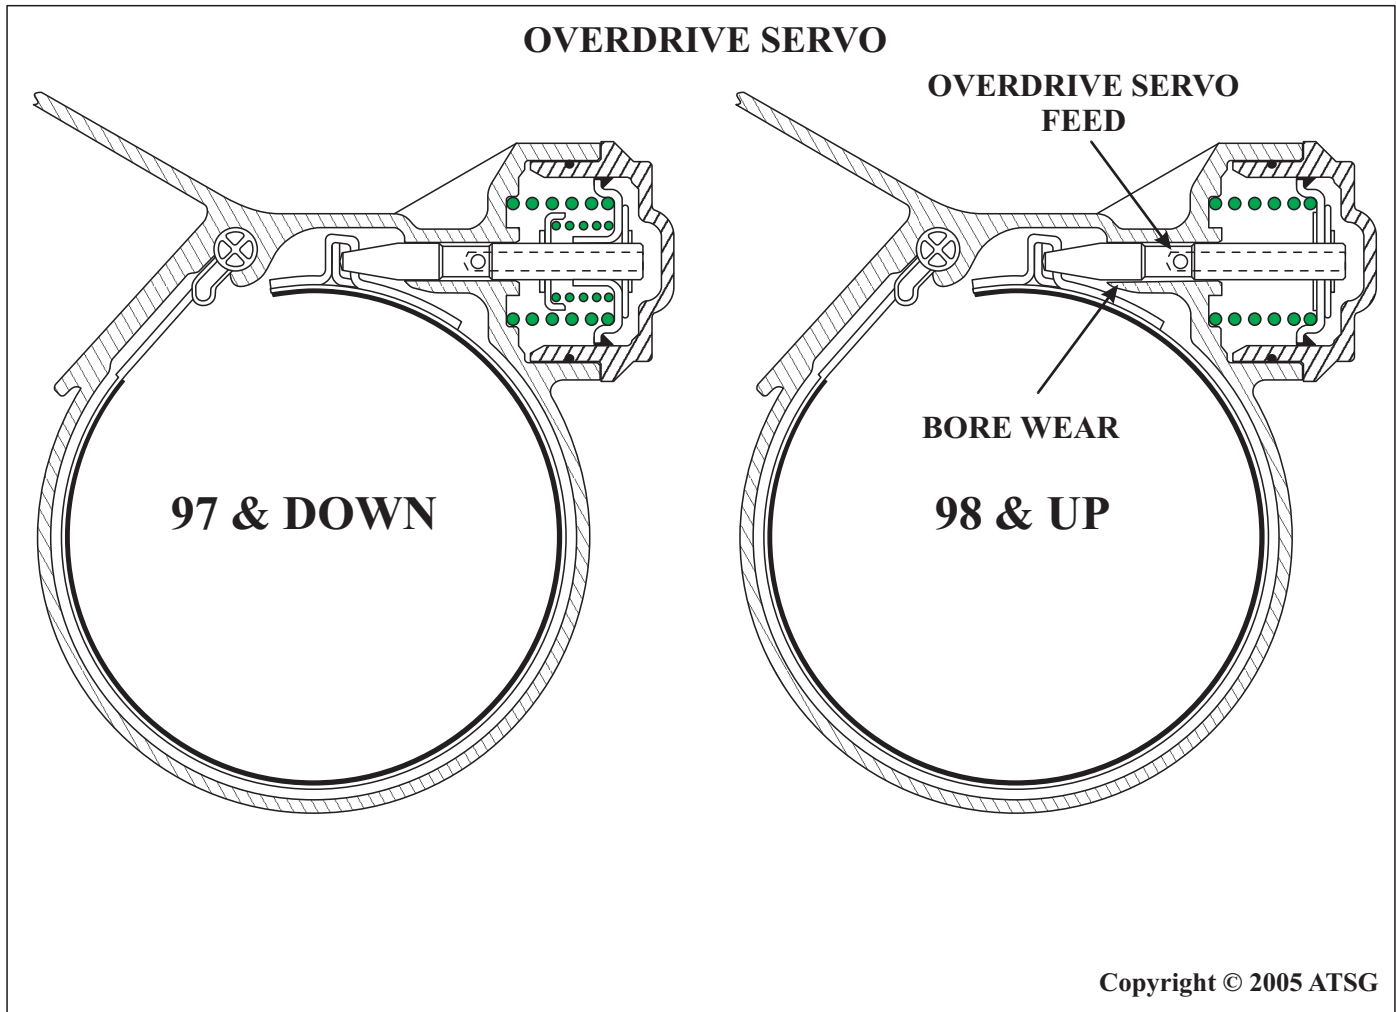
Figure 1

**CAUSE:** The cause may be, a worn servo bore. The Overdrive servo is fed thru the center of the apply pin. Wear in the case, where the servo pin rides, may cause a pressure loss, creating the band failure. See Figure 1. ***NOTE: ATSG has found that this is very common on 98&up models.***

**CORRECTION:** To correct this condition there are currently two options, replace the case or re-sleeve the case where the pin rides and install a bushing for a new sealing surface. ***Northland transmission Inc. has a Re-boring kit available to repair the case bore, with a bushing, to fix the leak.***  
***Phone: 715-458-2617***
