# Technical Service Information

## THM 440-T4 EXTERNAL 1-2 SERVO LEAK

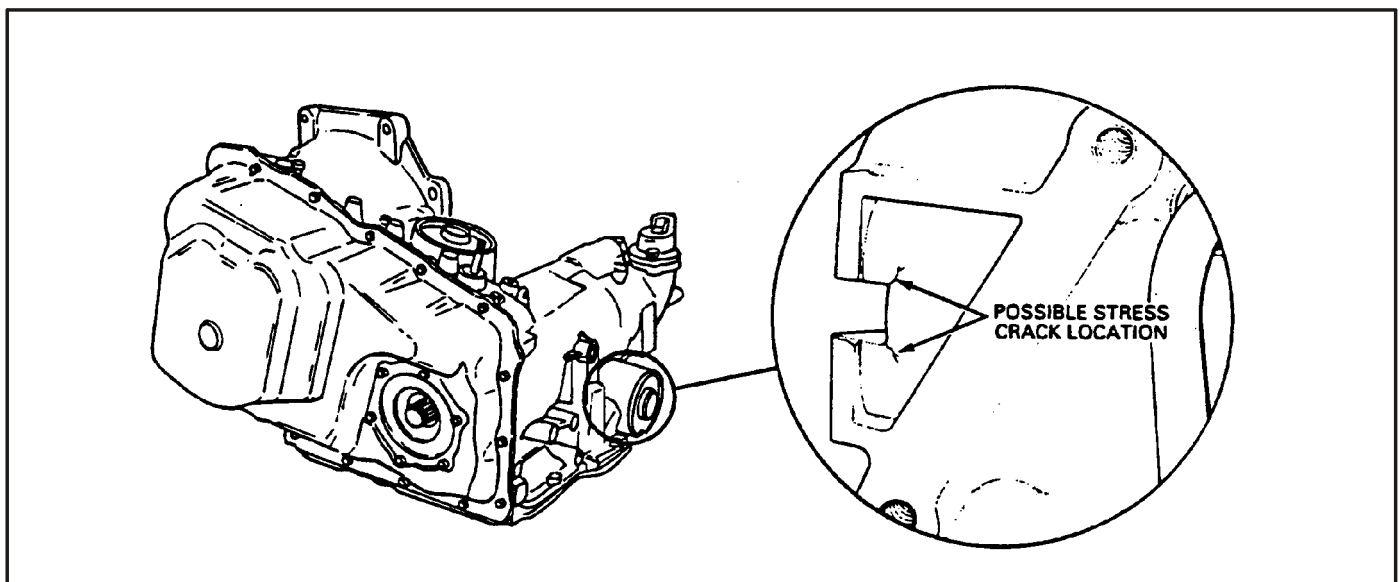
Figure 1

**COMPLAINT:** On some 1991 models only, the 1-2 servo may exhibit an External oil leak even after the o-ring on the cover has been replaced.

**CAUSE:** The cause may be due to stress cracks in the case by the Servo window at the 6 o'clock position (see Figure 1). Vehicles prone to having this problem are 1991 Pontiac 6000, Bonnevilles or Grand Prixes that are built between Julian date 172 (June 17, 1991) and 186 (July 28, 1991) (see Figure 2), and has a casting die number of 594 located on the bell housing (see Figure 3).

**CORRECTION:** Replace the case
