# Technical Service Information

## **FORD 4R44E/4R55E DELAYED FORWARD ENGAGEMENT**

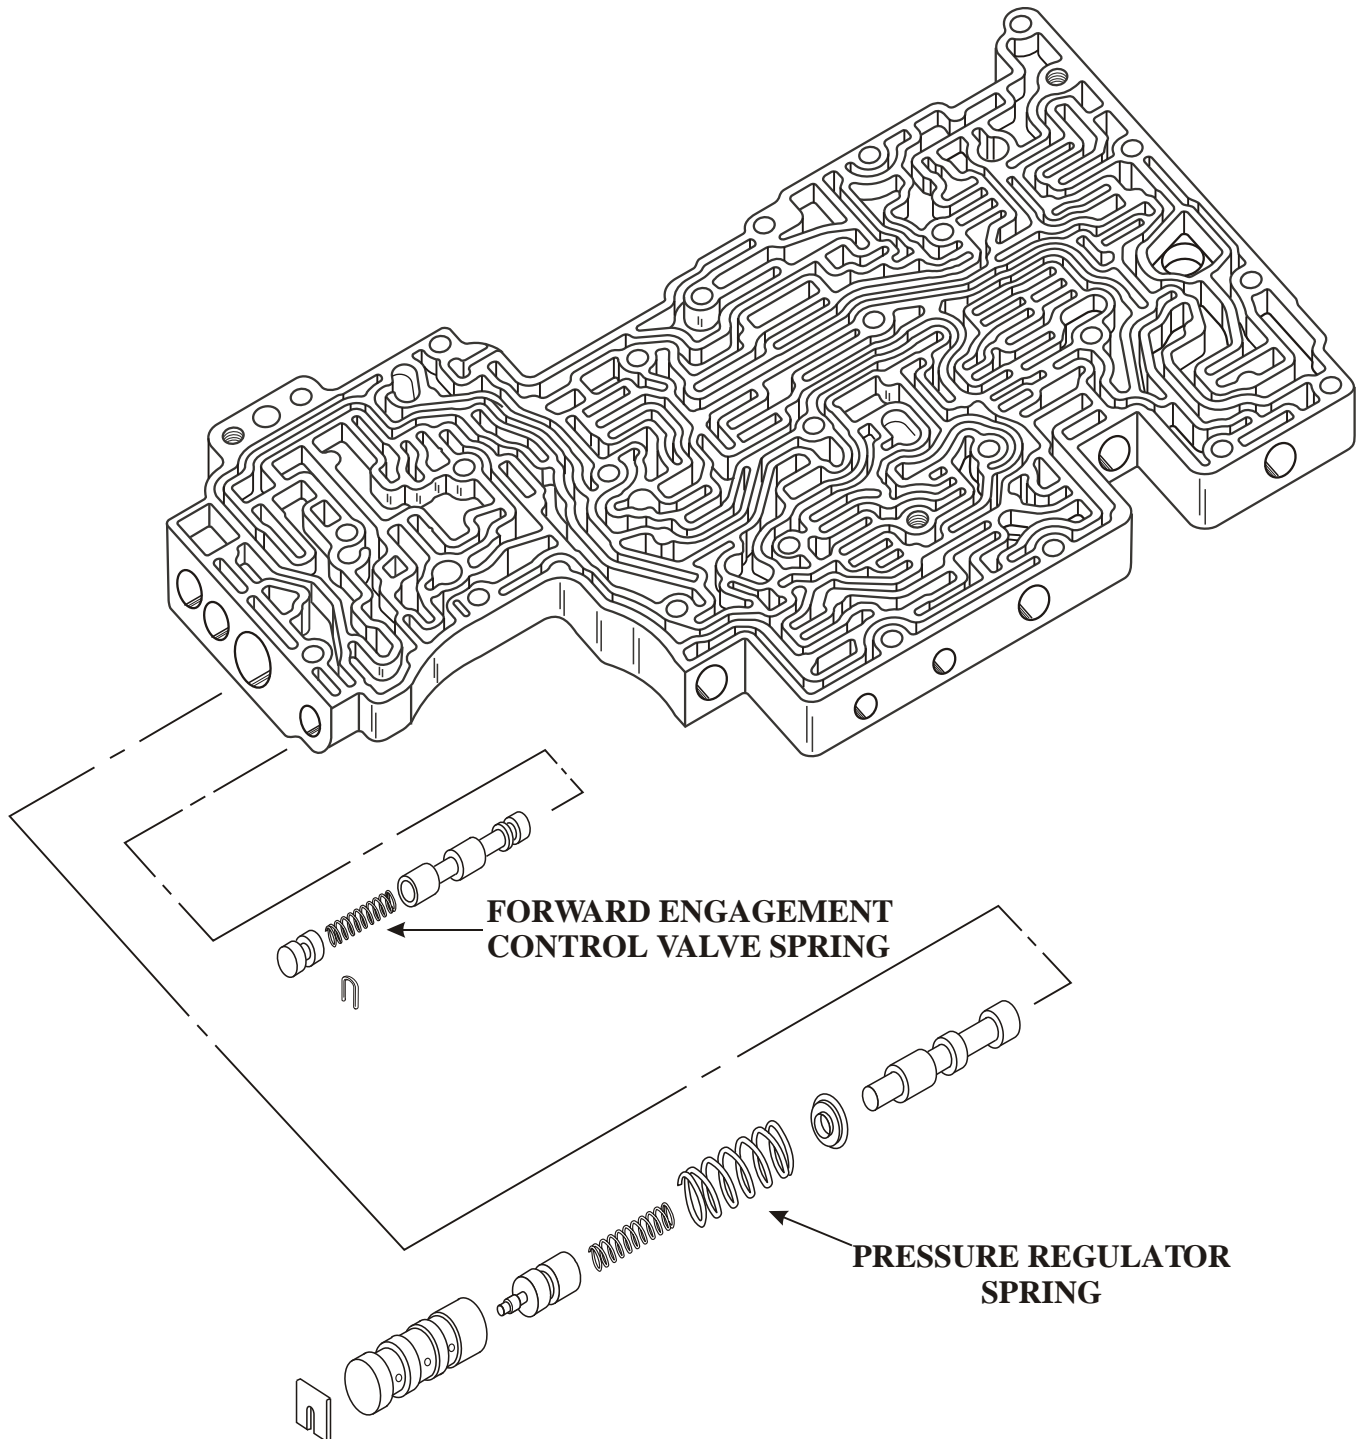
Figure 1

**COMPLAINT:** Some vehicles equipped with the 4R44E/4R55E may exhibit a delayed forward engagement condition.

**CAUSE:** One cause may be, an insufficient volume of oil fed to the forward clutch circuit.

**CORRECTION:** (1) Remove and discard the forward engagement control valve spring as shown in Figure 1.  
Replace the pressure regulator spring with a yellow pressure regulator spring from  
(2) the valve body of an A4LD transmission as shown in Figure 1.

**NOTE:** If the yellow pressure regulator spring from an A4LD valve body is not available, some aftermarket A4LD valve body kits contain a **PURPLE** pressure regulator spring that can be used in place of the yellow A4LD pressure regulator spring.
