Technical Service Information

CHRYSLER A500/A518 LATE OR NO UPSHIFTS, OR NO UPSHIFT AFTER KICKDOWN

01-07R
Page 1 of 2

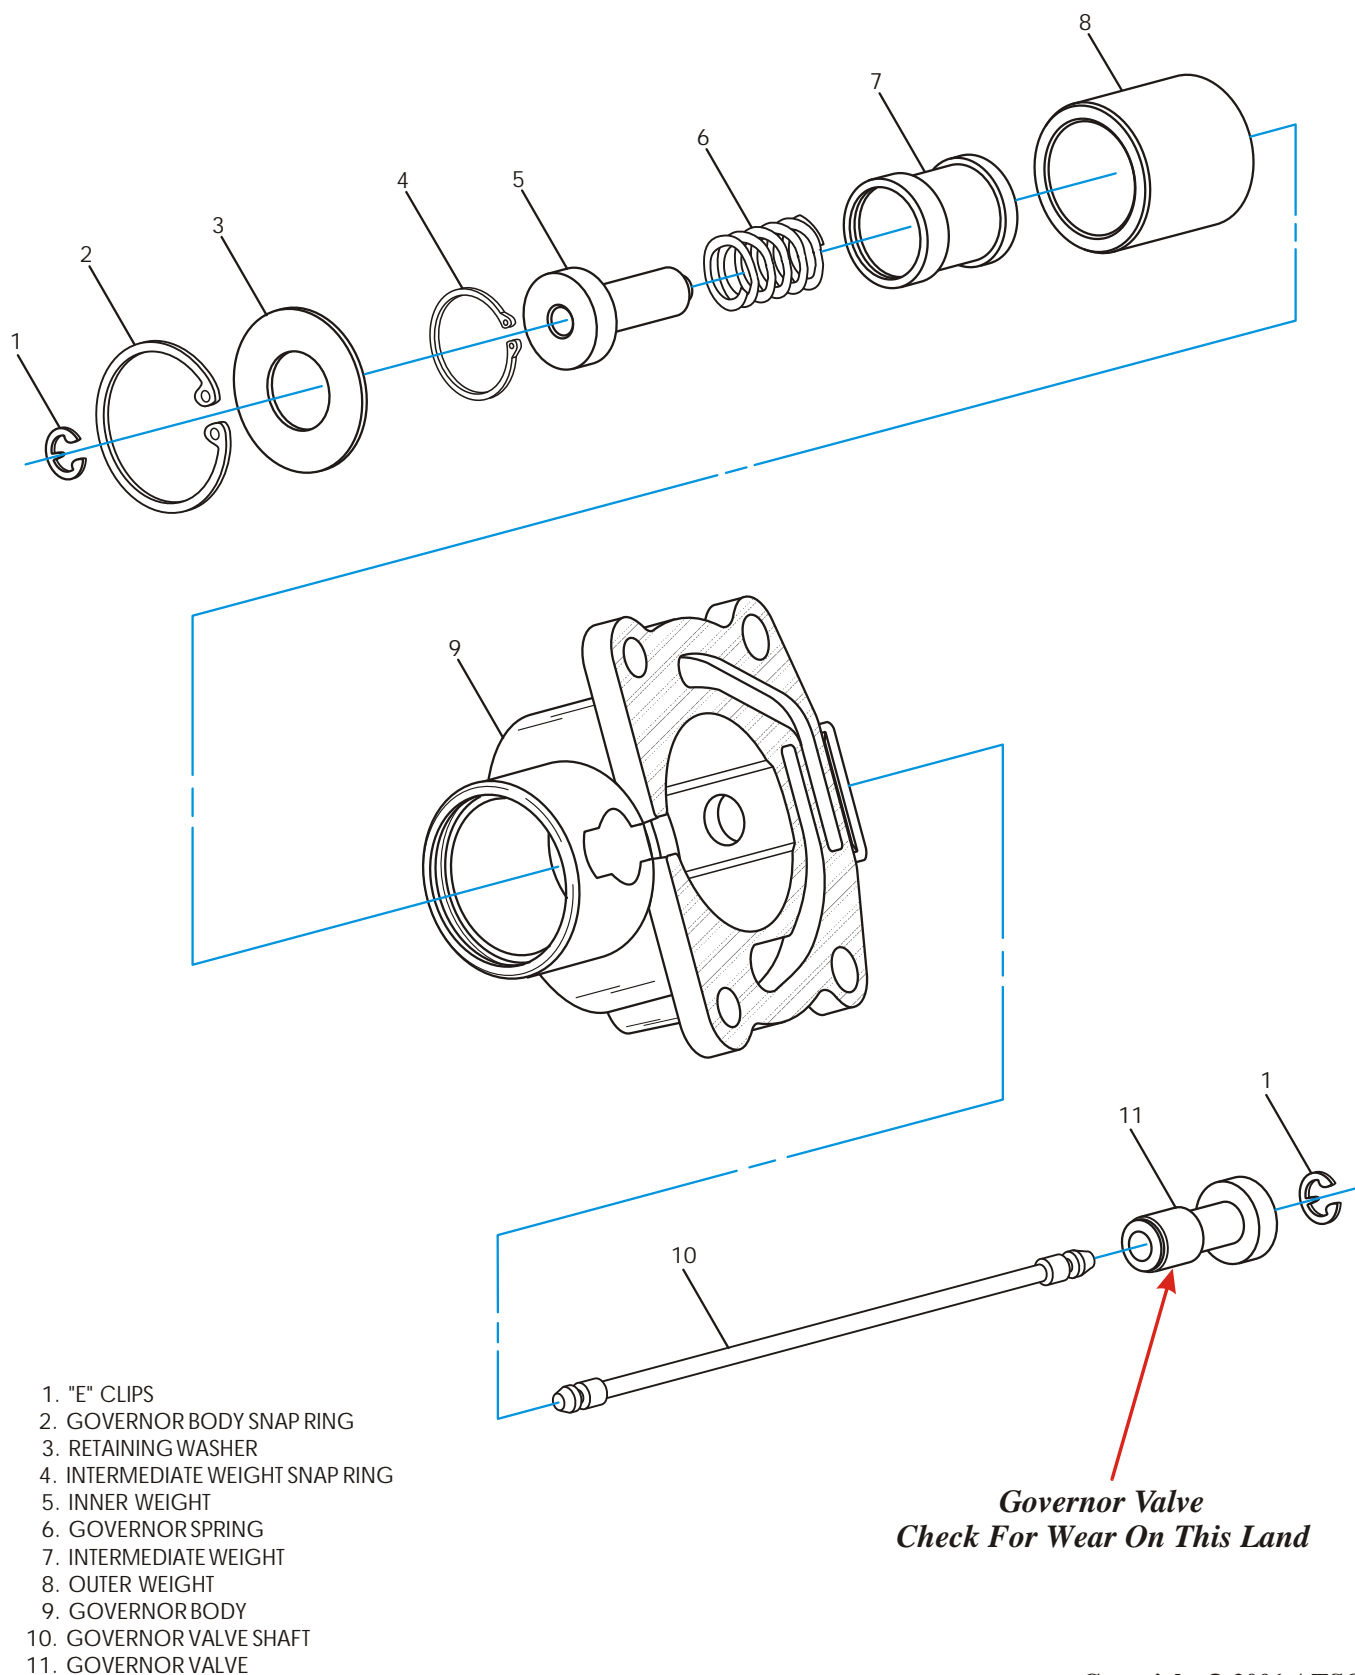
COMPLAINT: Any vehicle equipped with a A500/518 transmission may exhibit a complaint of late, or no upshifts, or no upshift after passing gear.

CAUSE: One cause may be a worn governor valve in the governor assembly, not allowing governor pressure to increase properly. Refer to Figure 1 for identification of the governor valve.

CORRECTION: Replace the governor valve, as shown in Figure 1.

Governor Valve 4617064
