Technical Service Information

AISIN SEIKI 450-43LE

NO REVERSE

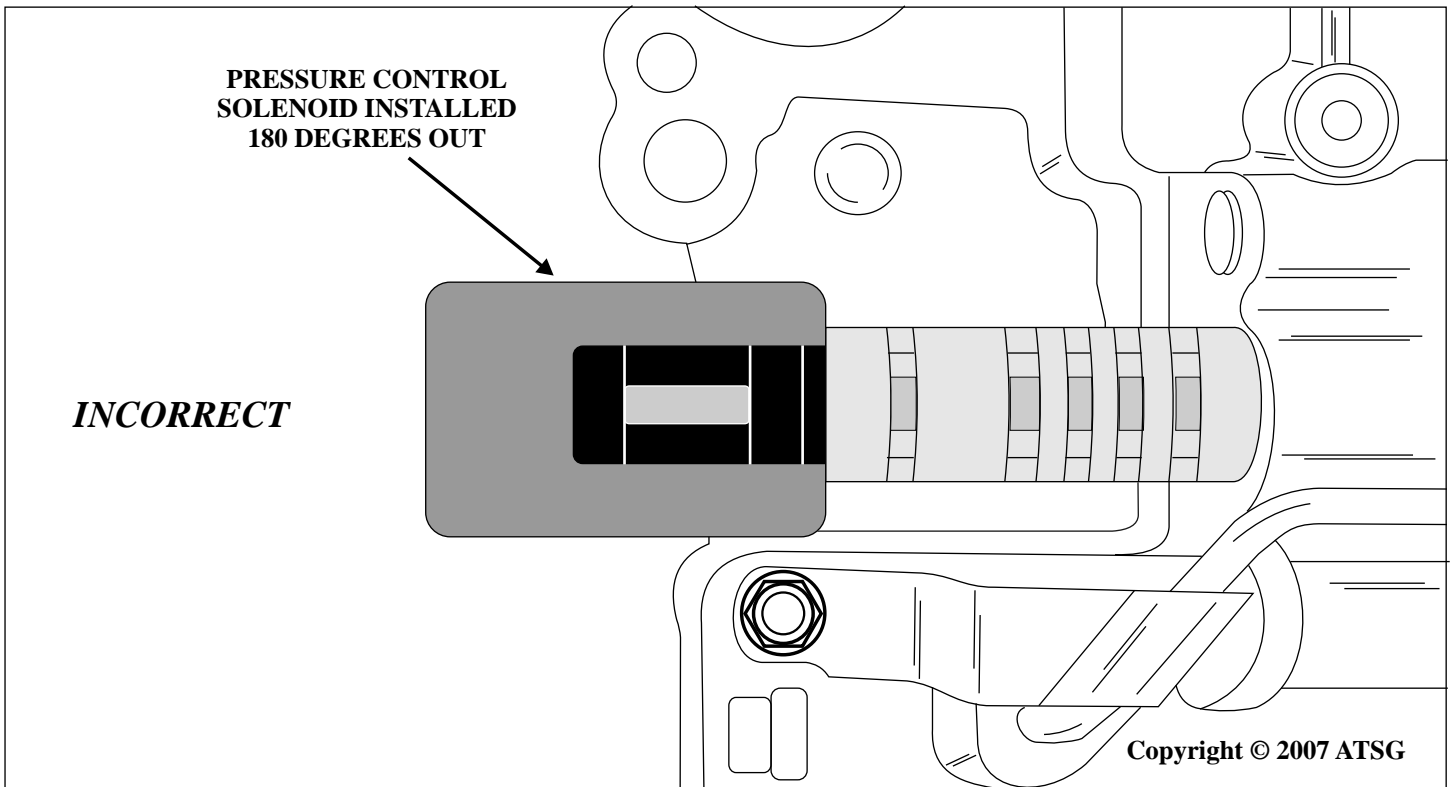
Figure 1

CAUSE: The pressure control solenoid has been installed 180 degrees out as shown in Figures 1 and 2.
